NIST NCSTAR 1-3

**Federal Building and Fire Safety Investigation of the
World Trade Center Disaster**

**Mechanical and Metallurgical
Analysis of Structural Steel**

September 2005

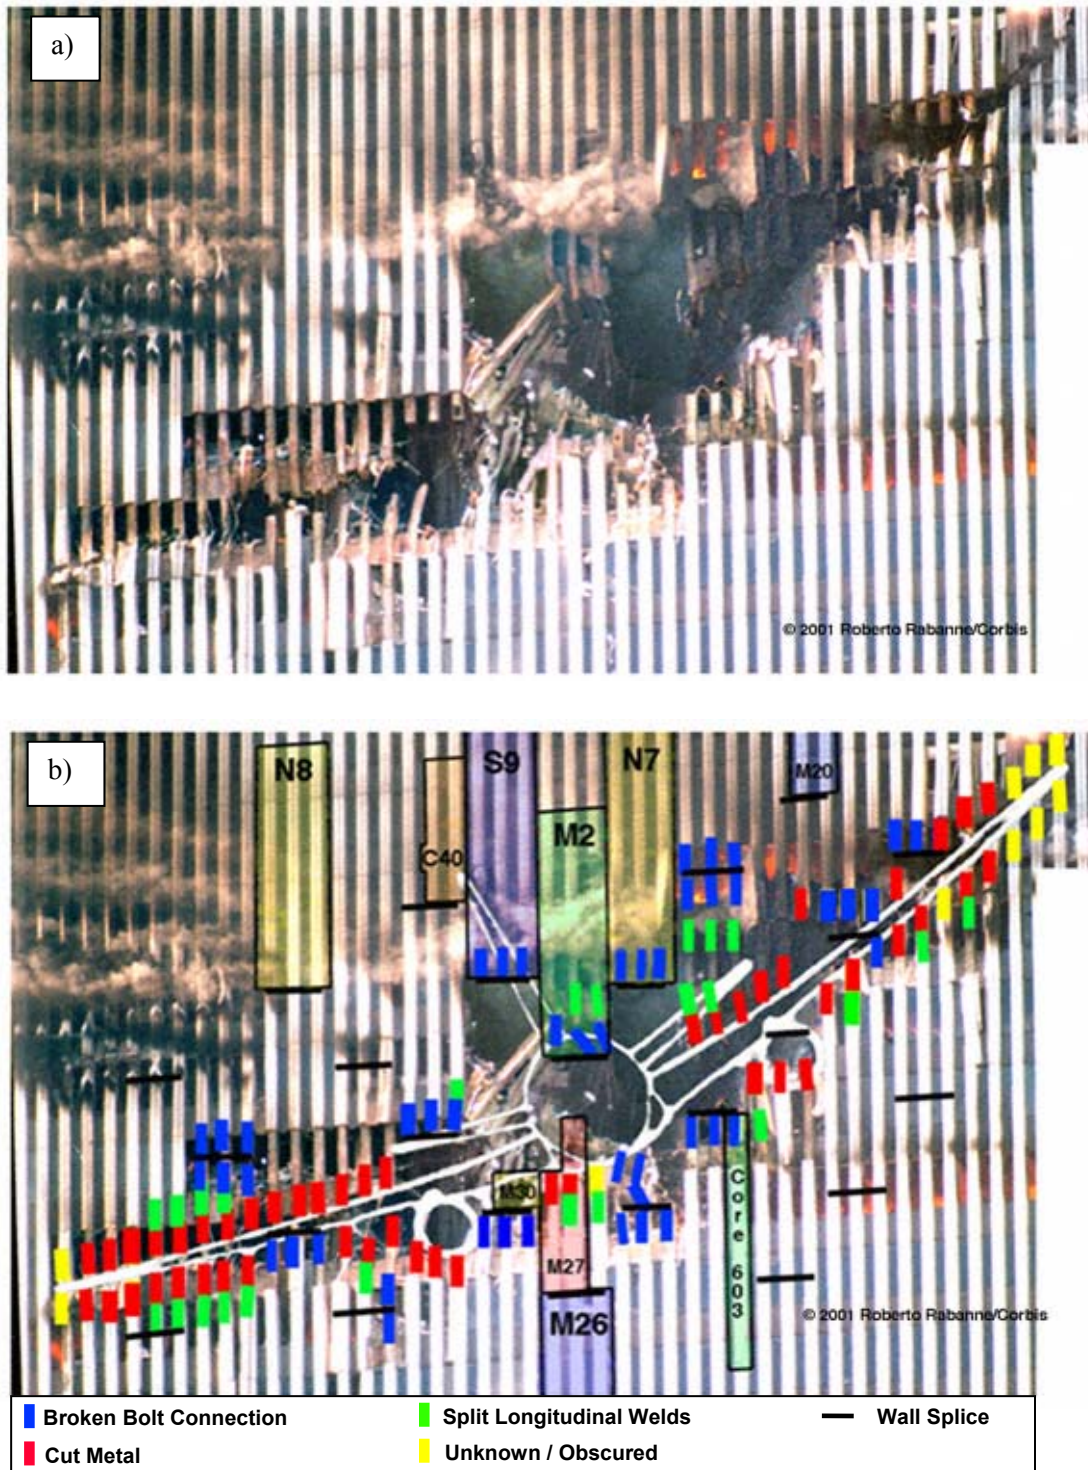
Figure 6-1. (top) Enhanced image showing the impact hole in the north face of WTC 1, and (bottom) overlay of an outline of a Boeing 767 that has been distorted to get a best approximate fit with damage to WTC 1. The location and type of localized damage has been indicated.

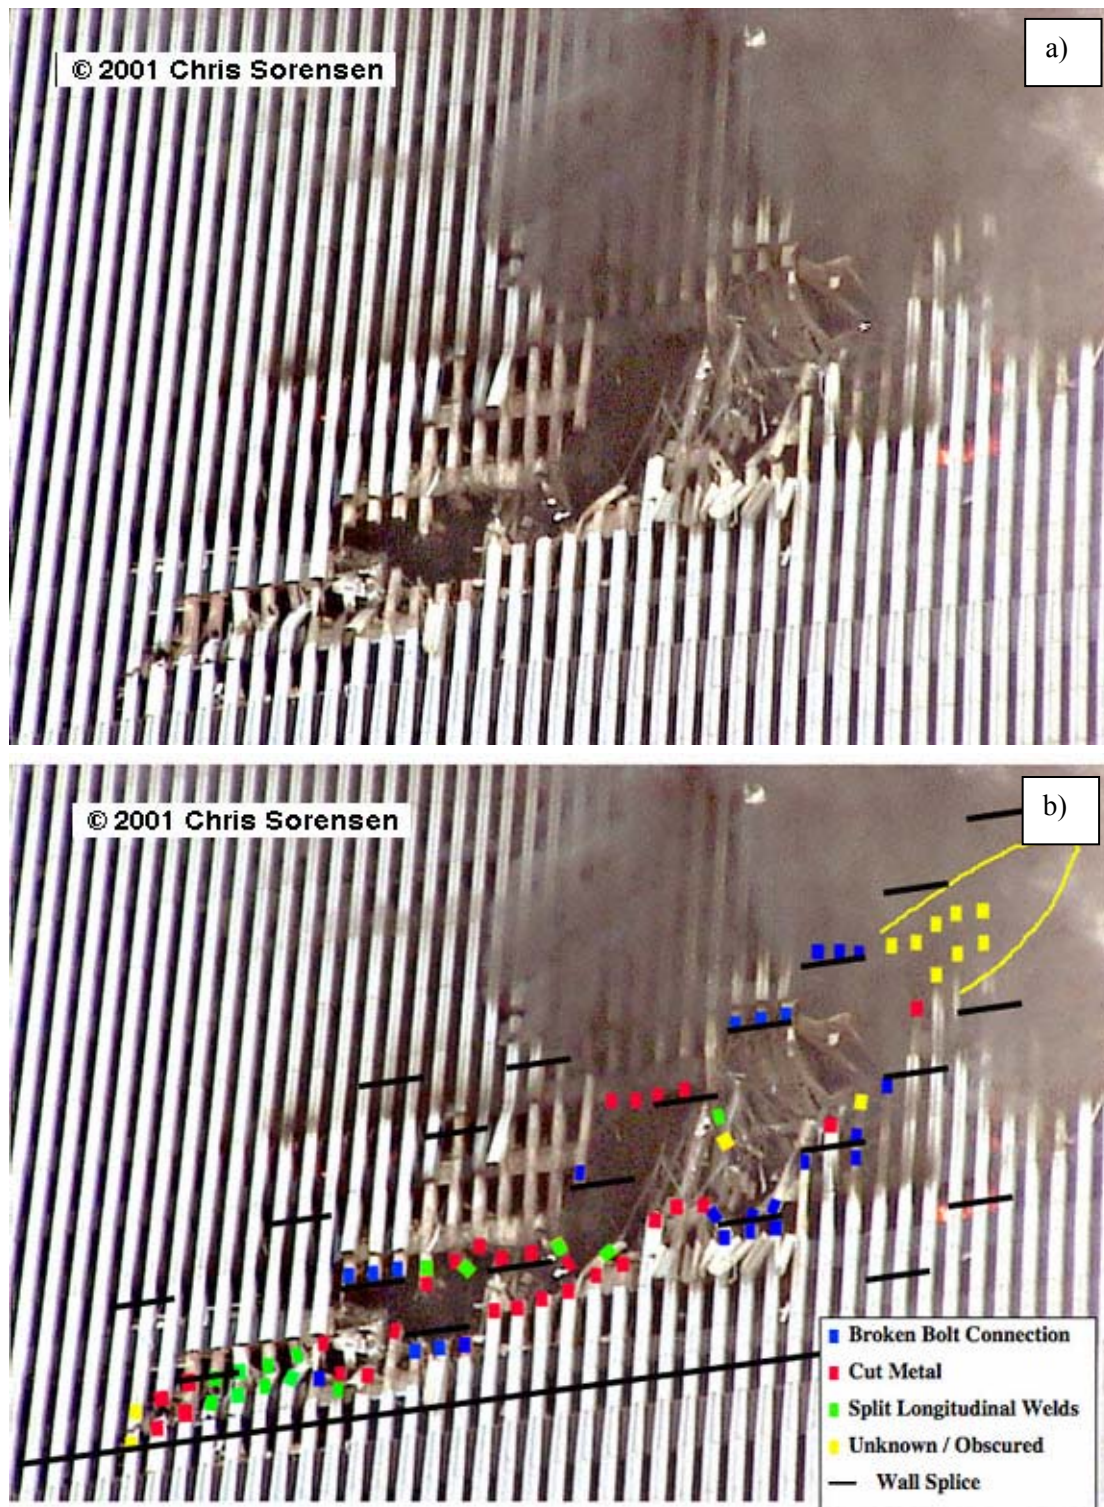
Figure 6-2. (top) Enhanced image showing the impact hole in the south face of WTC 2 and (bottom) overlay of the location and type of localized damage.

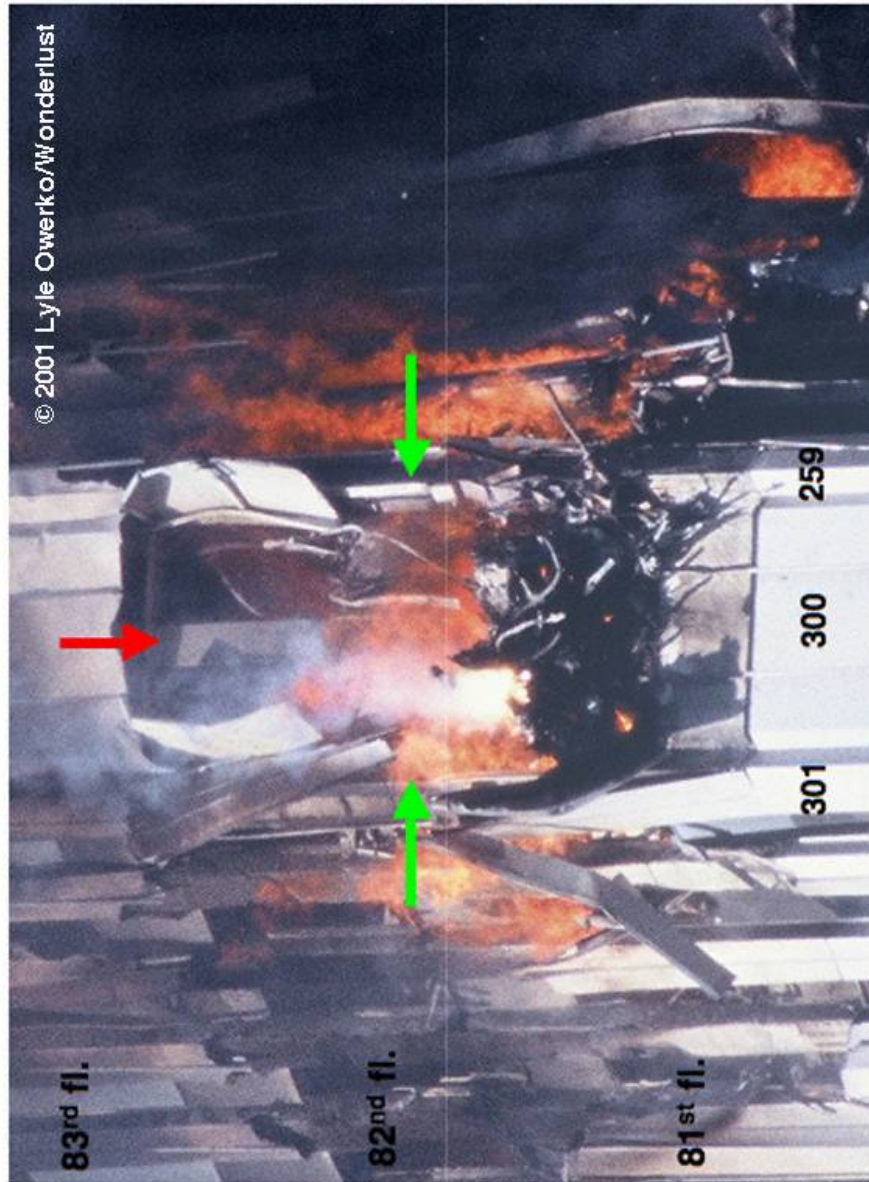
Figure 6-3. Damage to northeast corner of WTC 2 at 81st floor. The red arrow indicates an intact column 300 at the 82nd floor. Other photographs confirm that the spandrel connecting column 300 to columns 259 and 301 is also intact (location indicated by green arrows).

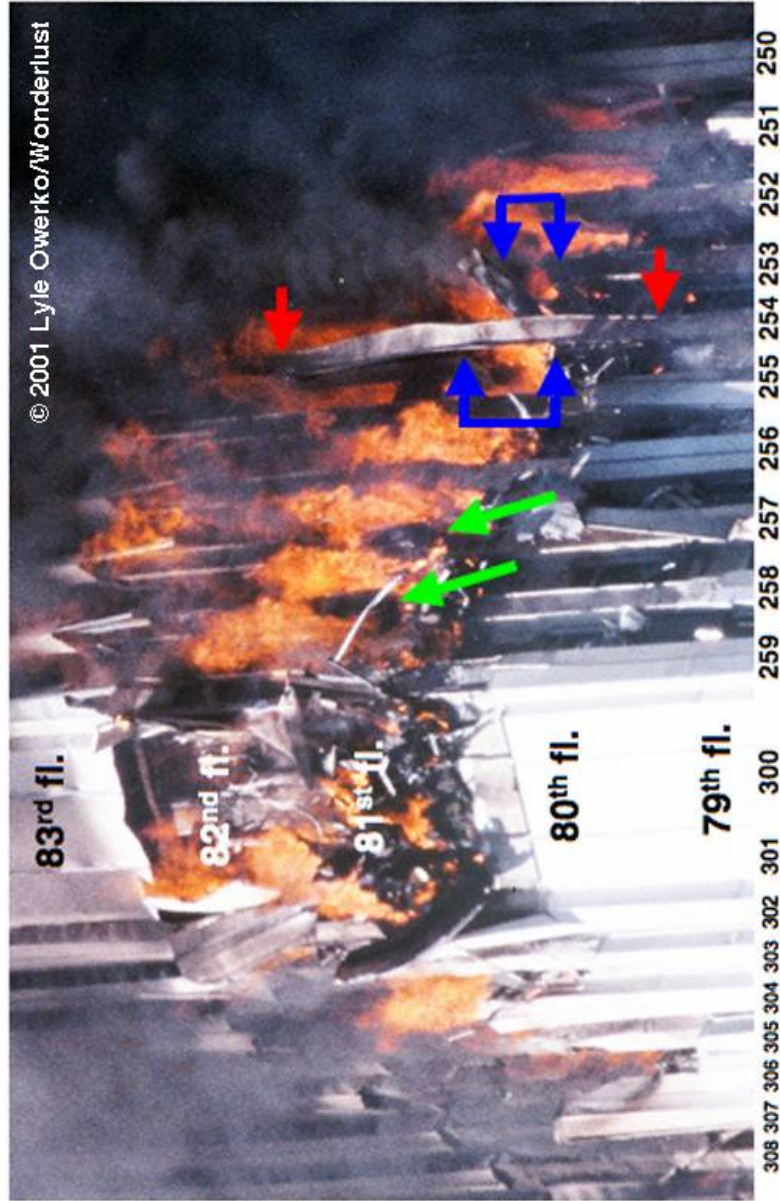
Figure 6-4. Damage to columns on north face of WTC 2 near northeast corner due to internal impact by debris. Broken vertical column bolted connections (green arrows) are visible, along with an intact outer web on column 254 (red arrows) and missing column sections (blue arrows).

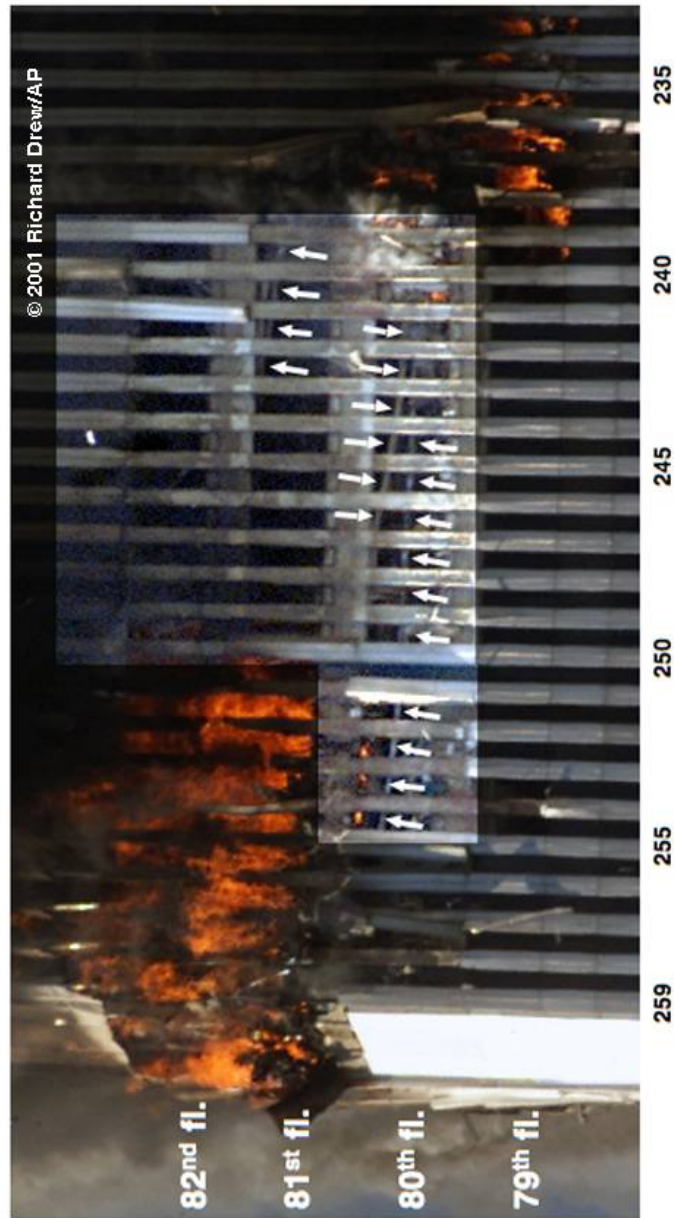
Figure 6-5. Dropped floors on north face of WTC 2.

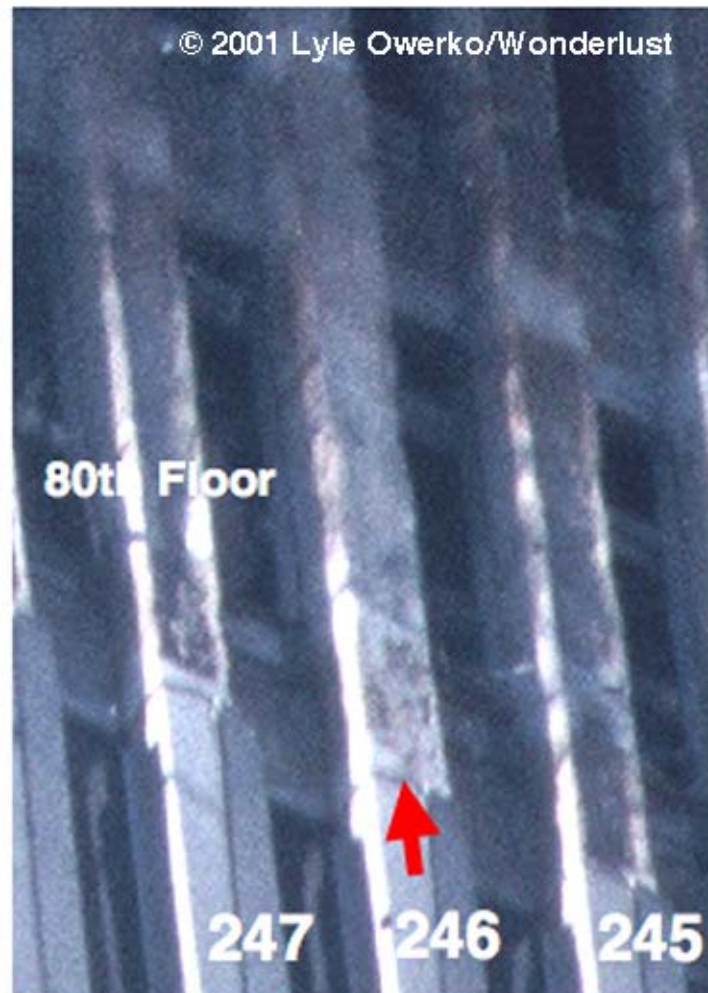
Figure 6–7. Fireproofing that had been applied to the exterior columns. The depression formed by the outer web and the flange tips are completely filled in with fireproofing at the arrow. North face of WTC 2.

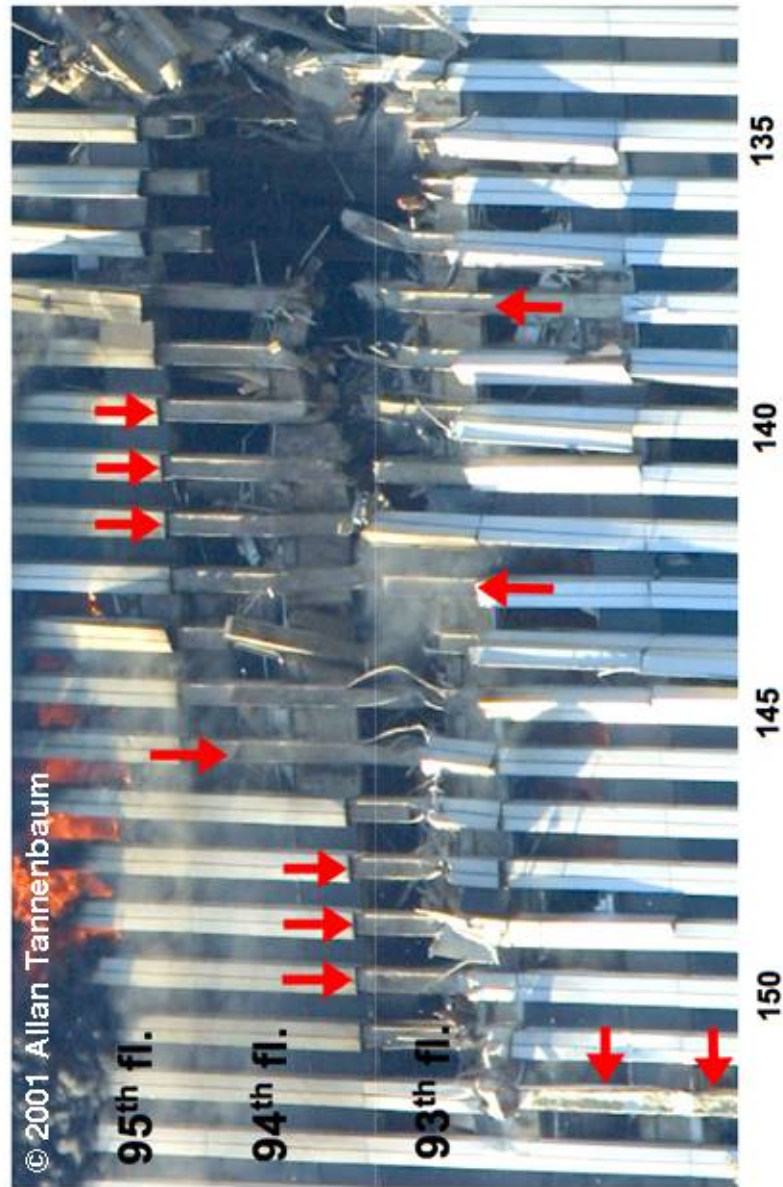
Figure 6–8. Port side of impact hole in north face of WTC 1 showing missing fireproofing. The red arrows indicate a few of the many instances of missing fireproofing around the impact hole. The region roughly approximated as the area where the aluminum panels were dislodge has been digitally enhanced for clarity.

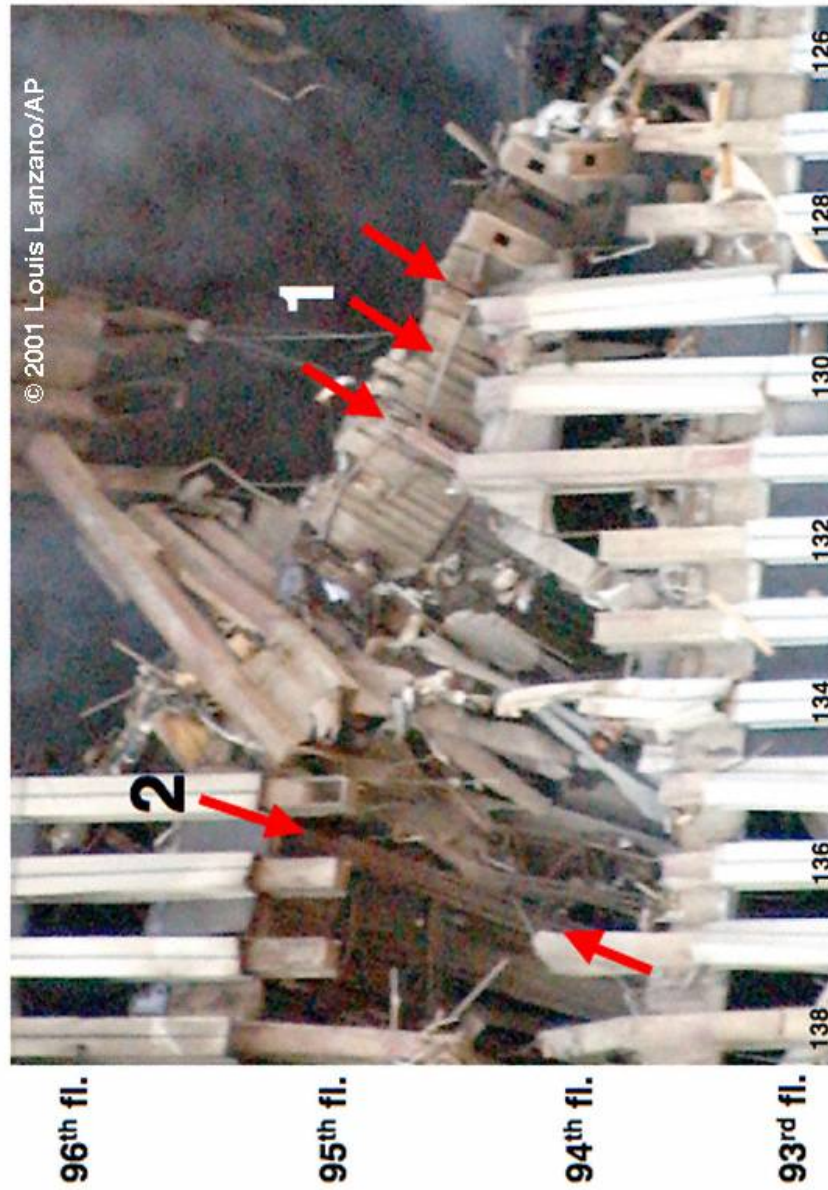
Figure 6-9. Missing fireproofing on floor trusses that fell into impact hole on north face of WTC 1. The arrows labeled "1" are three trusses where the lower or upper chords can be seen, and can distinguish the line that separates the two angle iron components. The arrows labeled "2" lie at either end of a lower chord of a truss that fell farther inside the building, and is made up of four angle irons (a double truss). The red paint color being visible and the fact that the line between the angle iron can be seen indicated that the fireproofing was displaced.

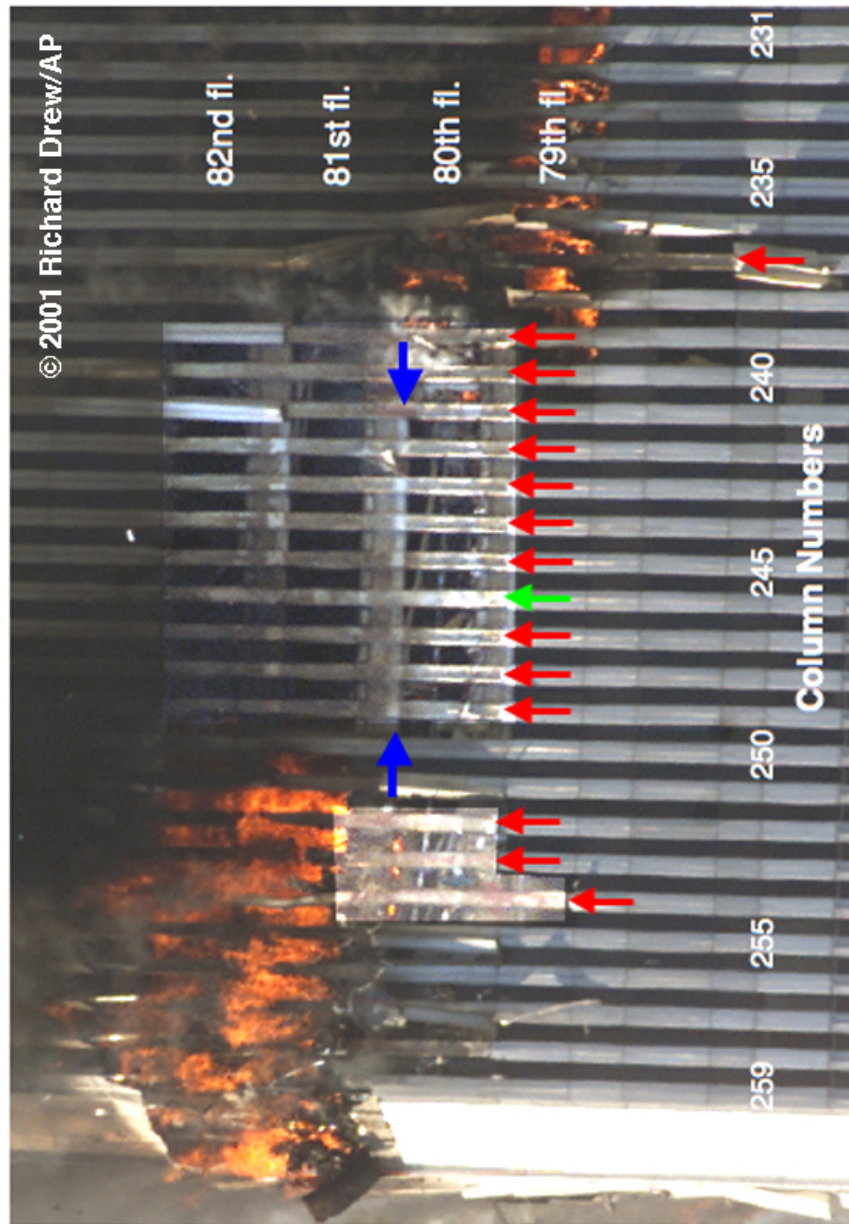
Figure 6–10. Missing façade and fireproofing on north face of WTC 2. Two regions have had contrast and gamma adjusted to enhance visibility of the features. Red arrows indicate columns with missing or damaged fireproofing. Missing or damaged fireproofing determinations were made from this and several other photos taken at different times and angles. Blue arrows indicate white features where some sort of coating has preserved the fireproofing in place.

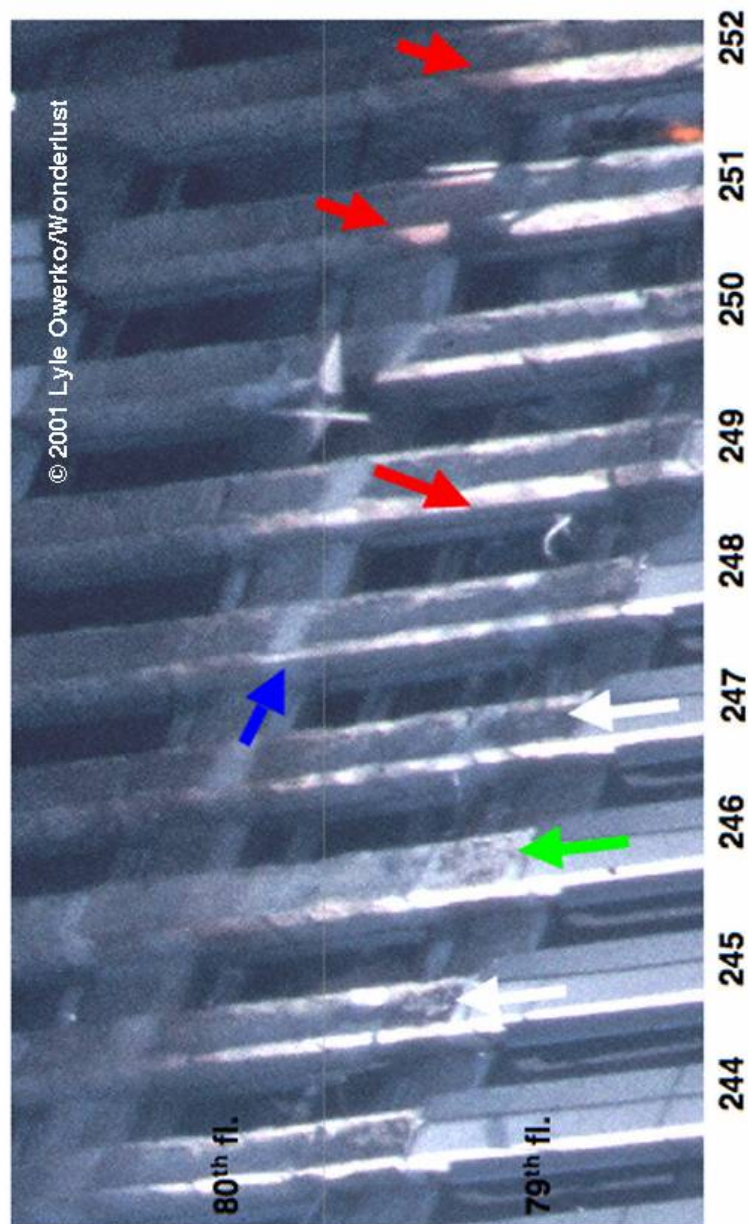
Figure 6-11. Missing fireproofing on flanges of exterior columns of north face of WTC 2. Fireproofing has come off, revealing red Tnemec paint of the column (red arrows). This image also shows how the outer web regions have been partially or completely denuded of fireproofing. Damage is evidenced by shading by sunlight - compare green (undamaged fireproofing) and white (damaged fireproofing) arrows. Blue arrow indicates same type of white coated area of fireproofing as previous figure that adhered when material above and below was dislodged.

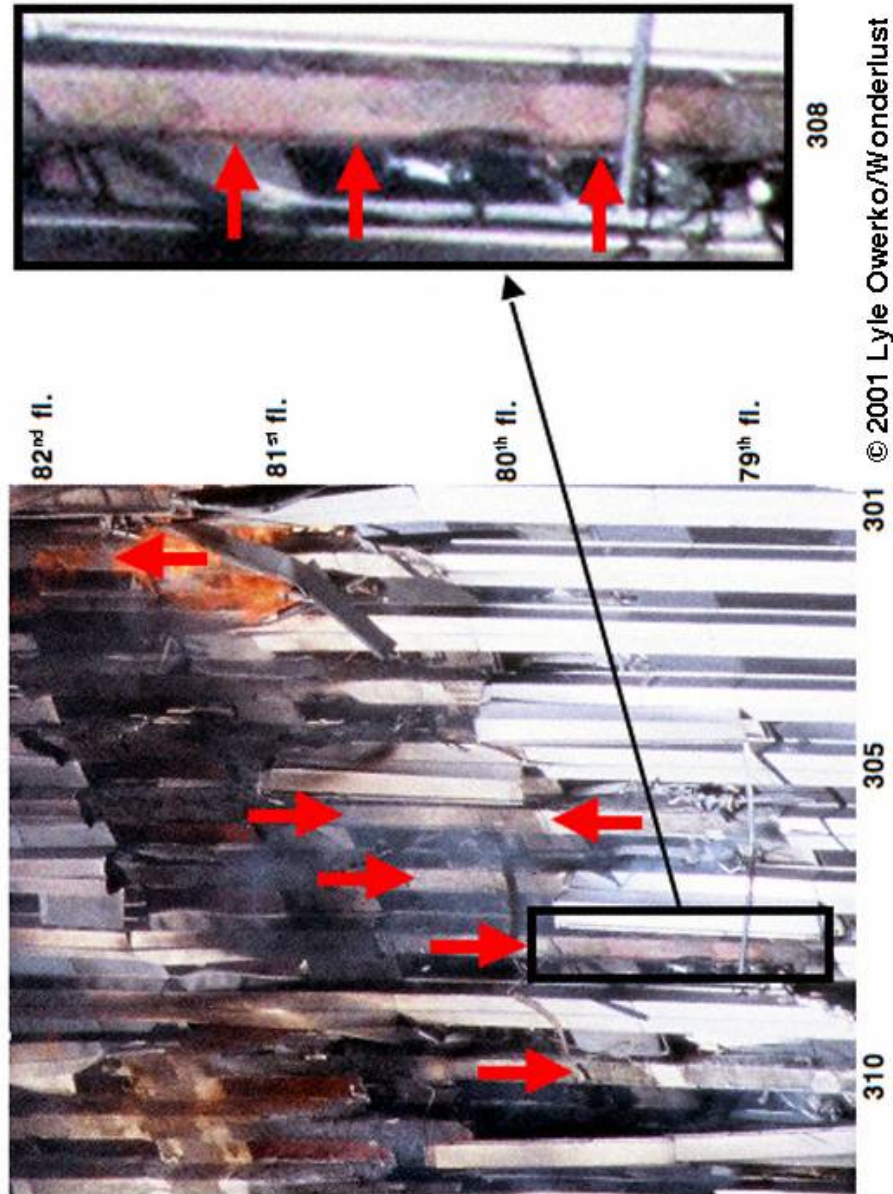
Figure 6-12. Damage to fireproofing on east face of WTC 2 due to internal impact. Red arrows highlight areas where fireproofing has been damaged. The blowup to the right shows a column where the red Tnemec paint of the column is visible.

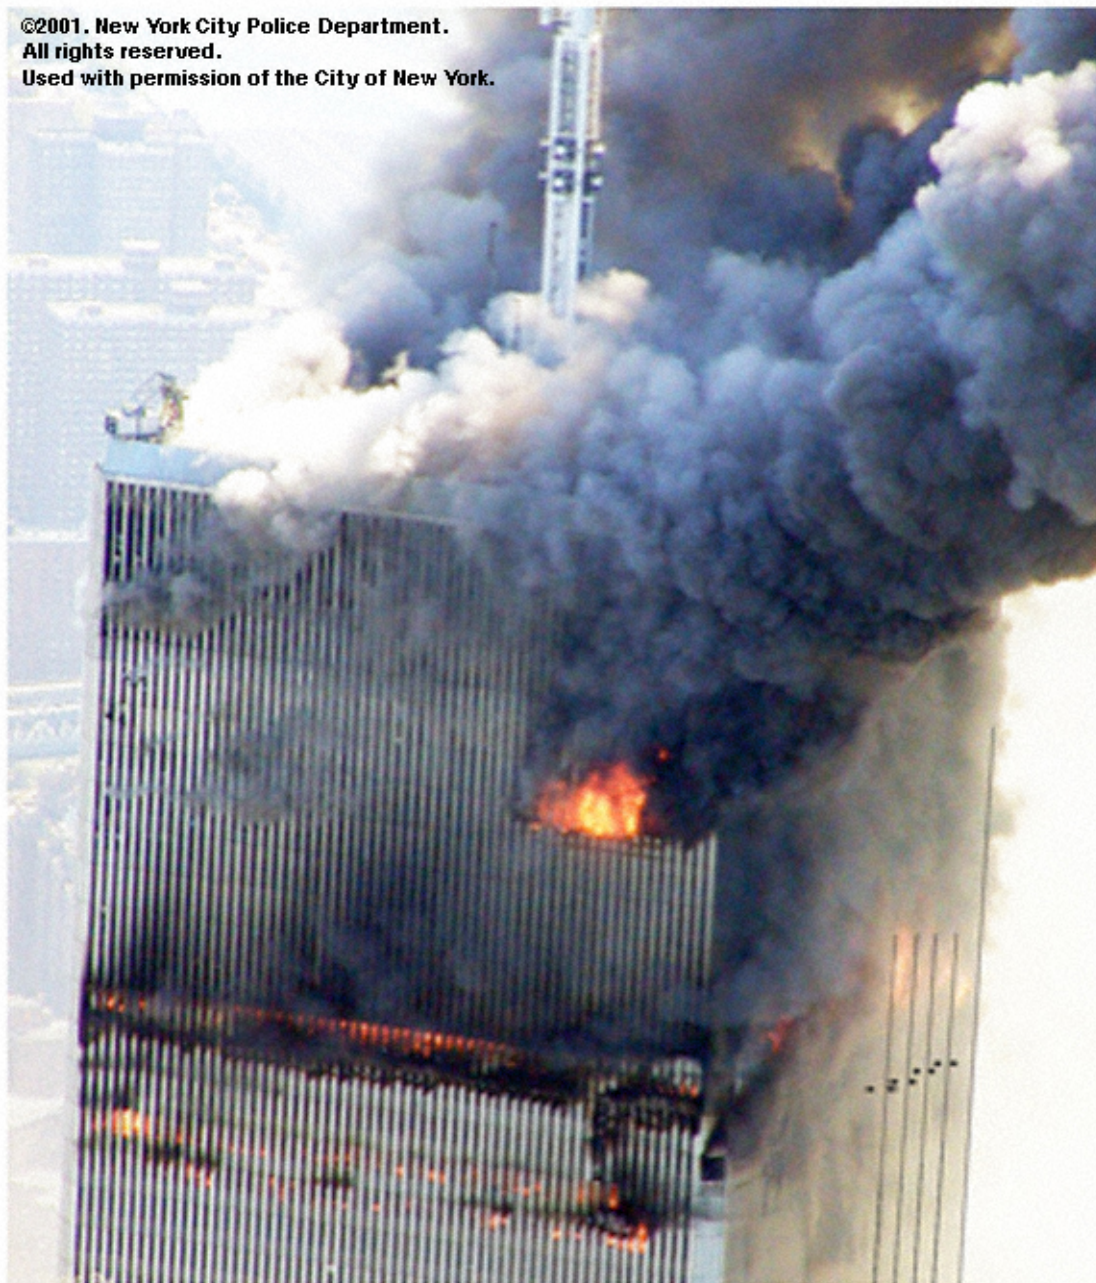
**Figure 6–14. Inward bowing of south face (at right, with dark lines overdrawn) of WTC 1.
Taken at 10:23 a.m. from an NYPD helicopter.**

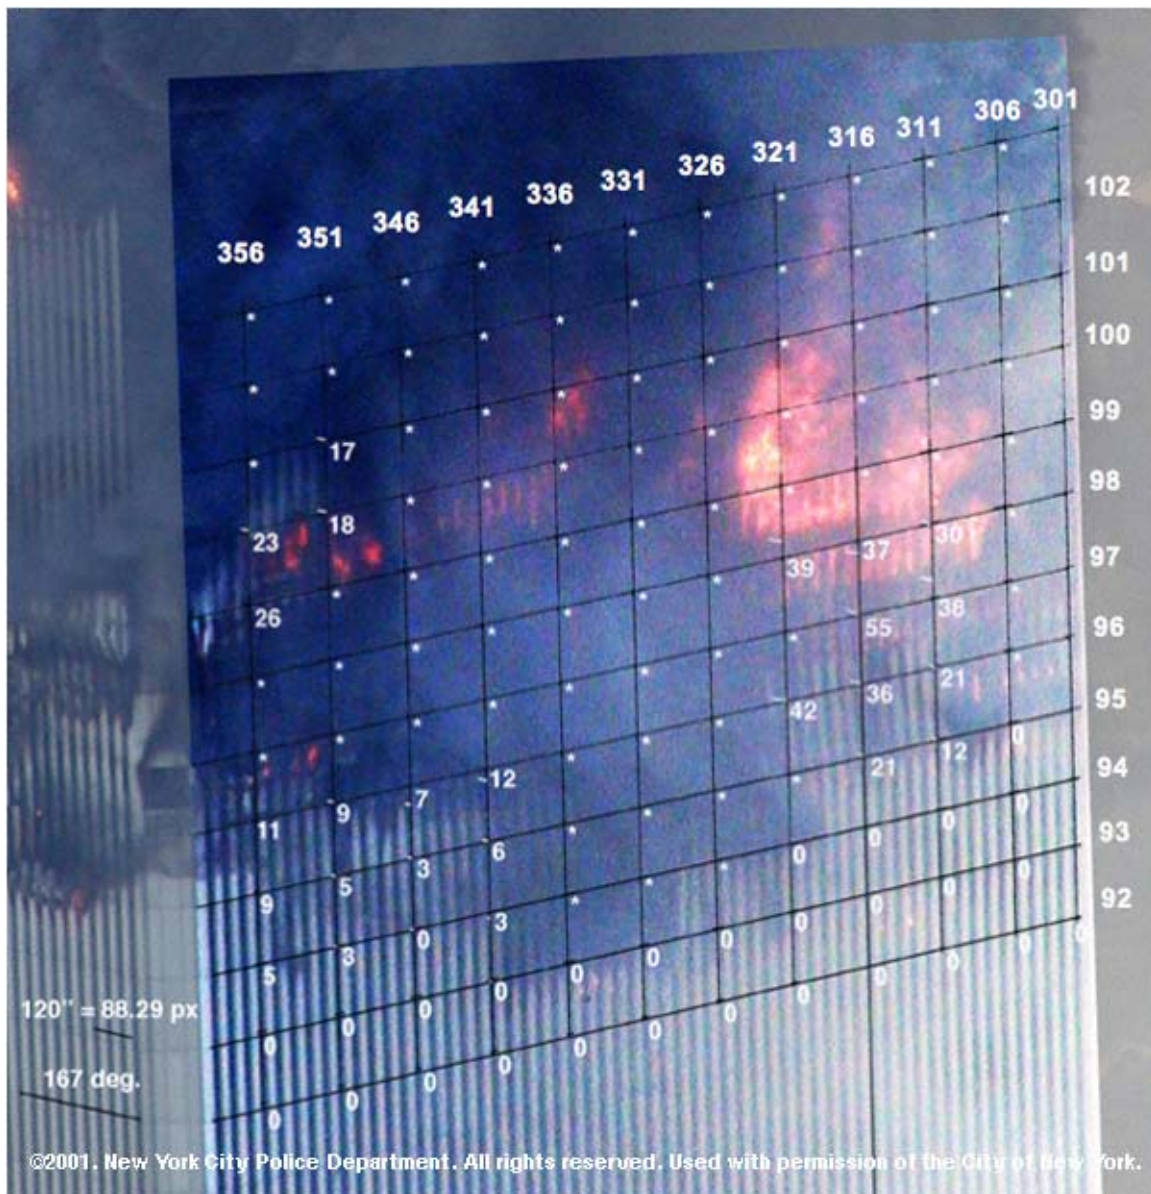
Figure 6–15. Pull in of south face of WTC 1 at 10:23 a.m. showing considerable displacements of outer columns into the building. Faint white vertical features are the aluminum façade of the exterior. Maximum visible inward displacement of the columns is 55 in. +/- 6 in. Poor resolution leads to large uncertainties in measurements; a large fraction of the south face of the building is obscured by smoke.

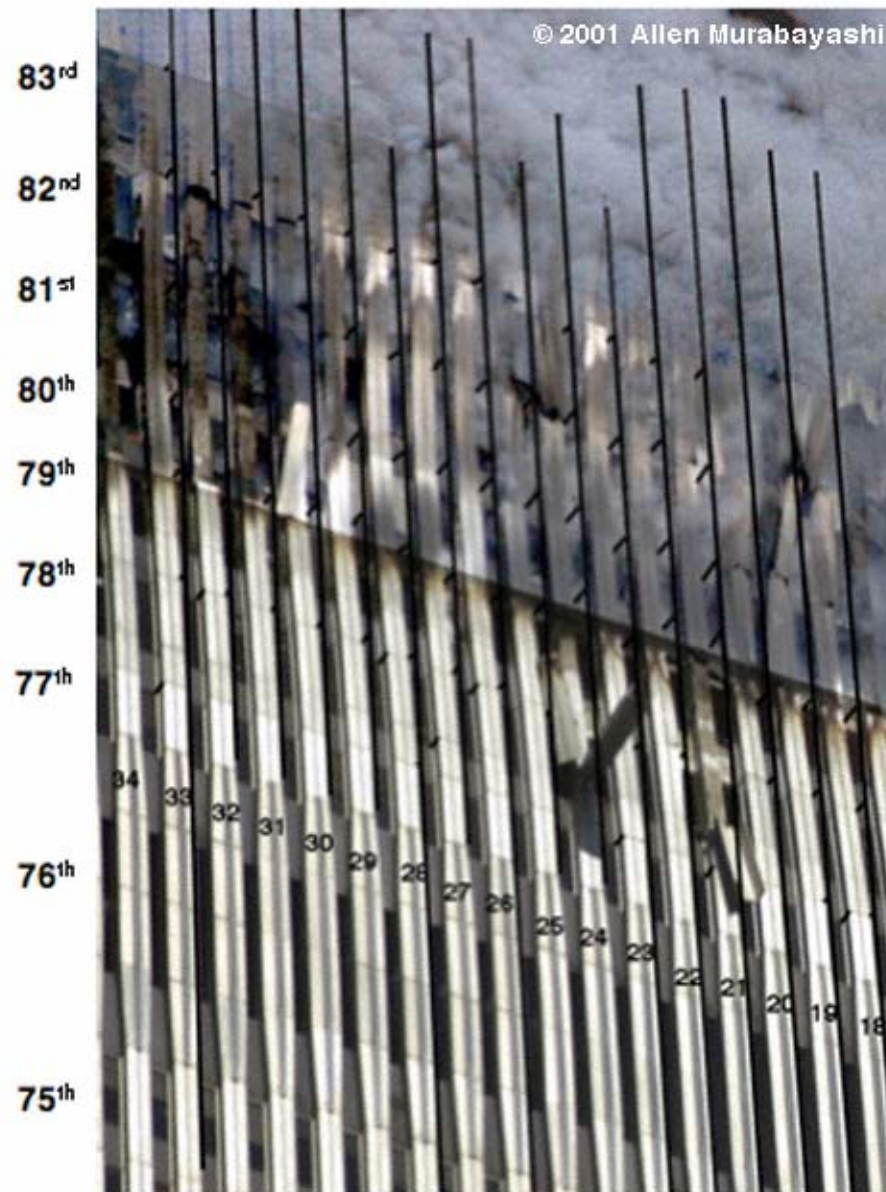
Figure 6–16. East face of WTC 2 at 9:53:04 a.m. showing a larger amount of pull in. The vertical black lines were drawn to establish the original line of the exterior wall columns, and the shorter line segments are drawn at the same angle as the nearest observable joint in the exterior aluminum panels to establish the inward bowing distance. For actual column numbers, add a “3” to the front of the two-digit designations in the image.

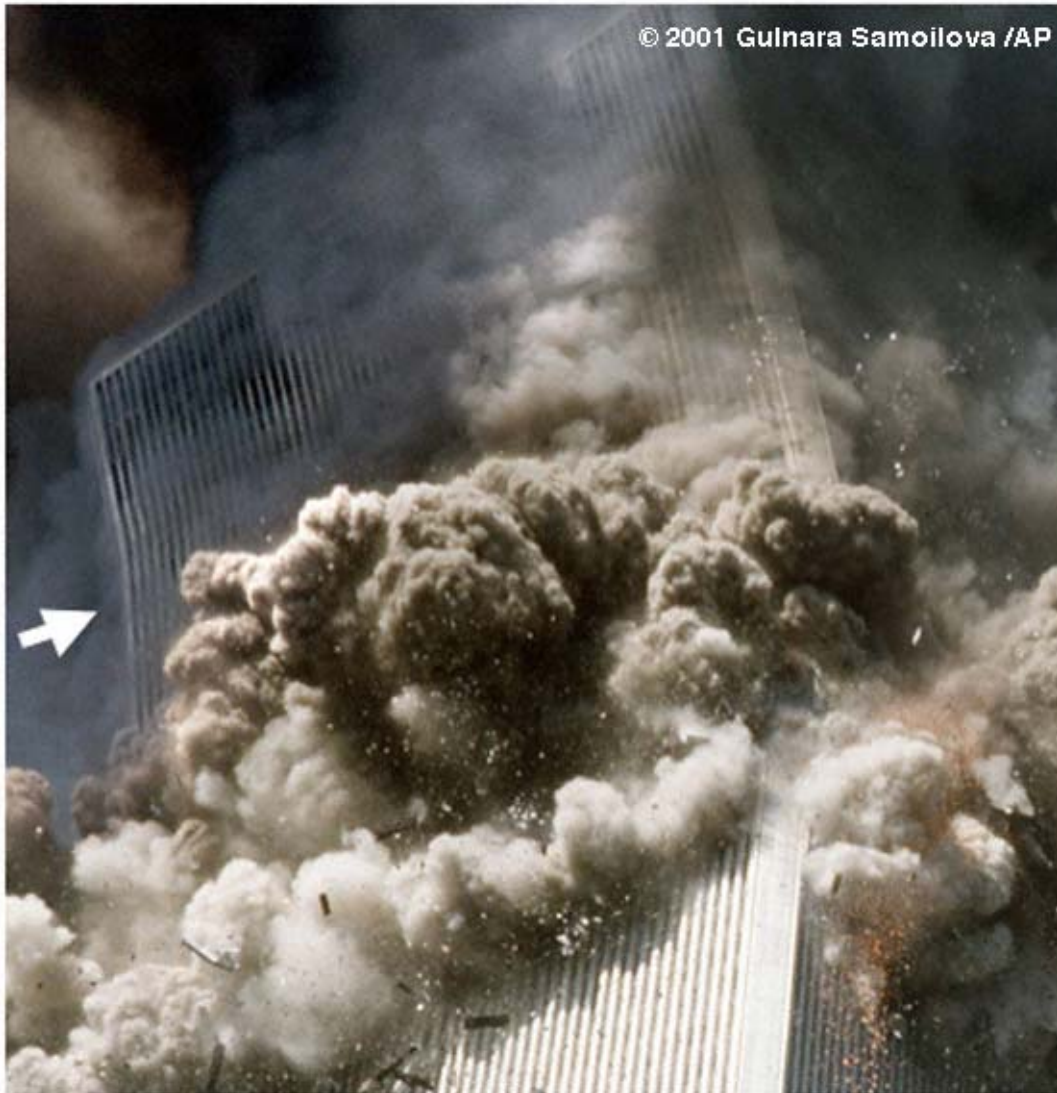
Figure 6–19. Initial seconds of collapse of WTC 2 viewed from the east-northeast, and kink in the southeast edge of the building near the 106th floor (arrow).

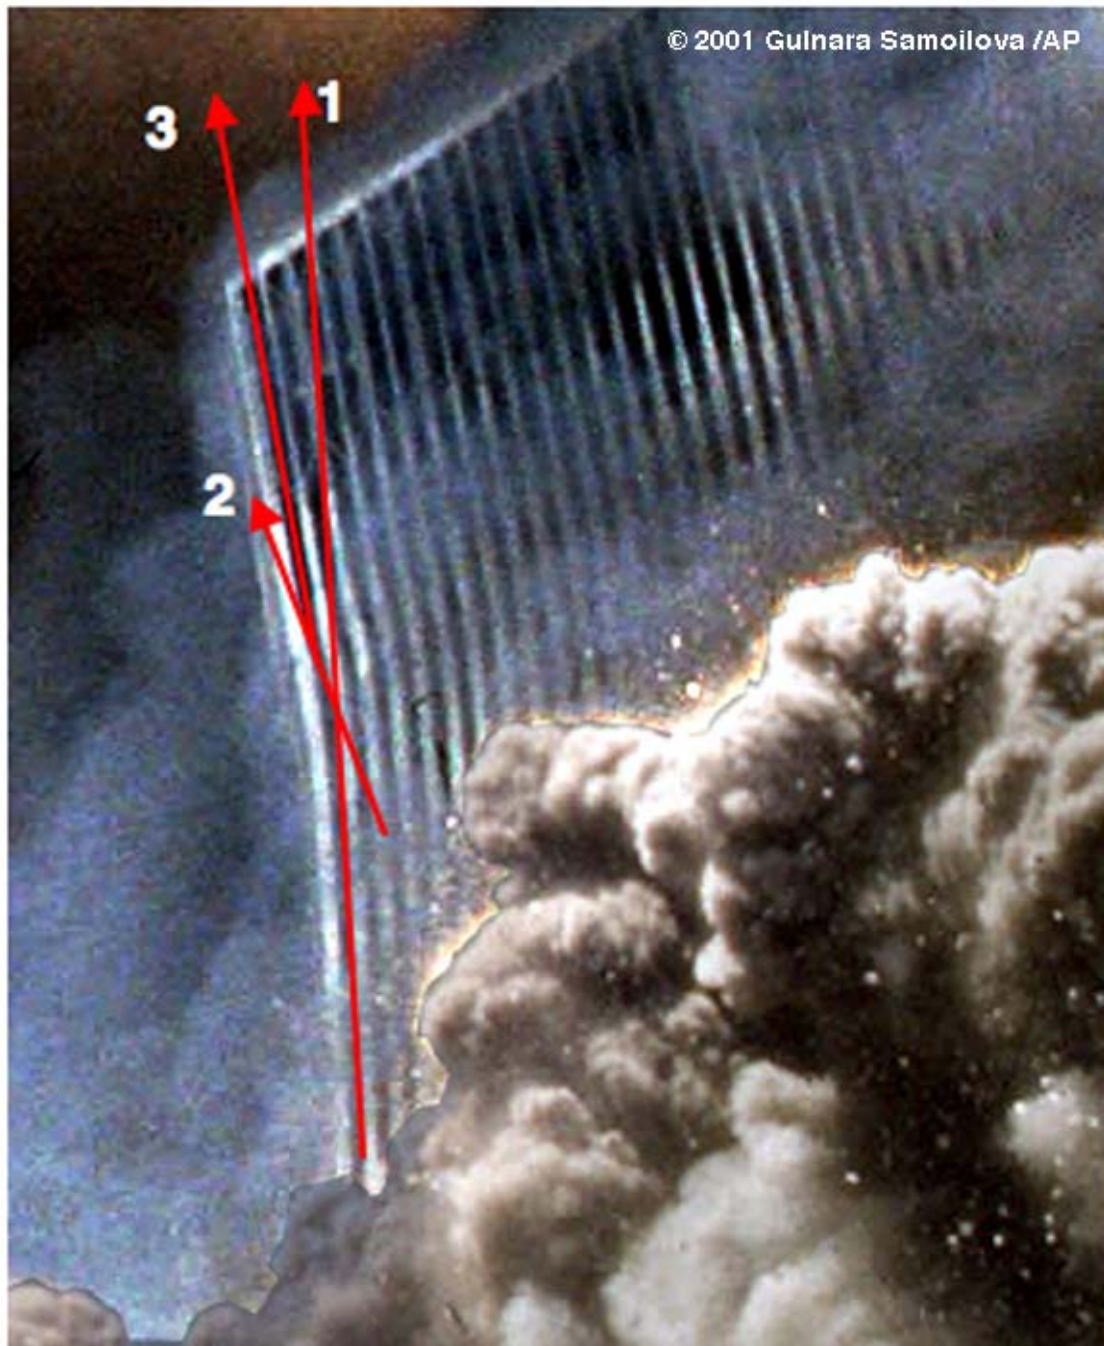
Figure 6–20. A close-up of the kink area in the previous figure (southeast corner, WTC 2), with overlaid lines to highlight the details of the kink geometry. The edge of the building (1) bends an angle to another direction (2), then bends back somewhat toward the original direction (3).

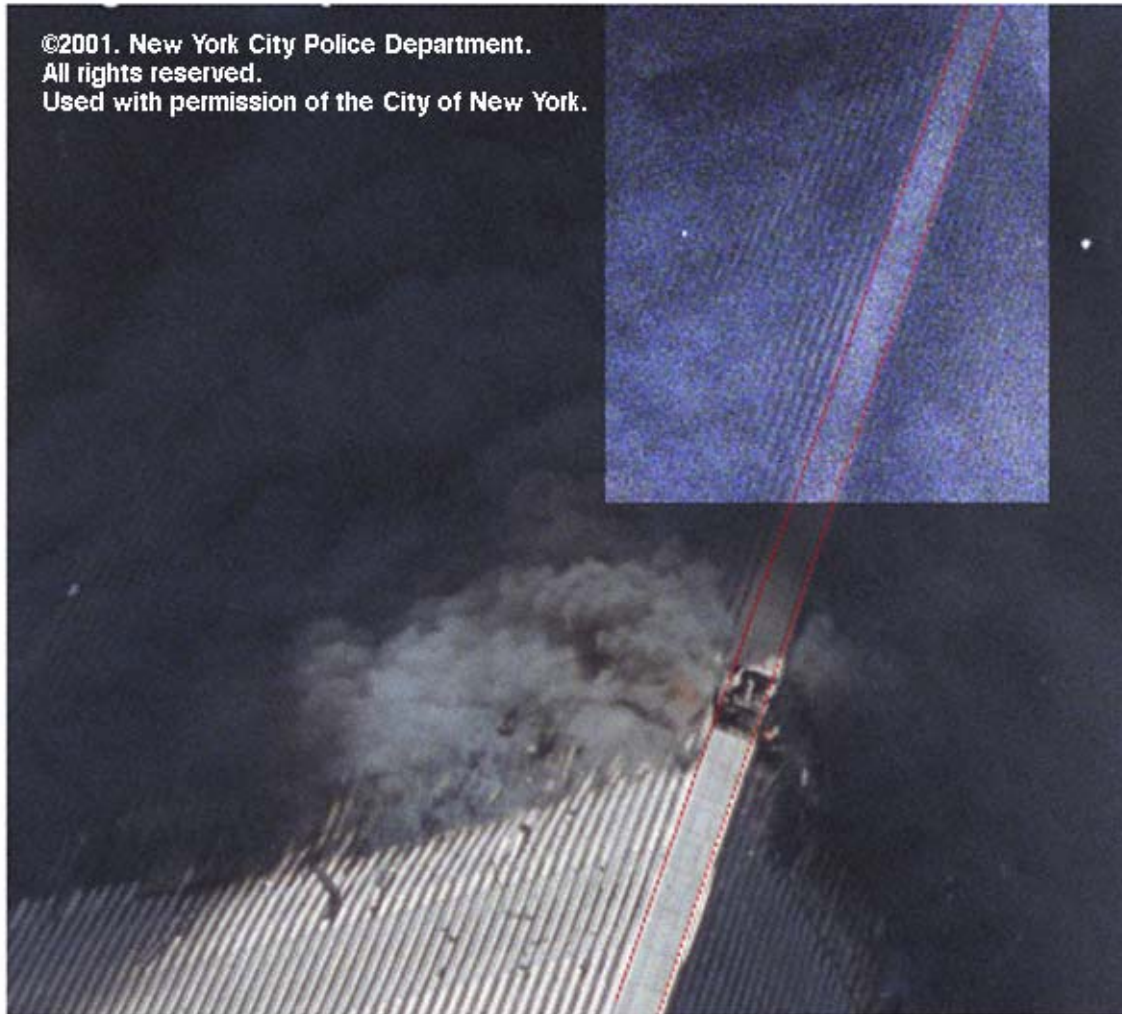
Figure 6–21. Northeast corner of WTC 2, several seconds before collapse. The corner shows no distortion of the type in the previous figure, implying that the distortion accompanied the collapse and did not precede it. The region in the upper right is enhanced for visibility.

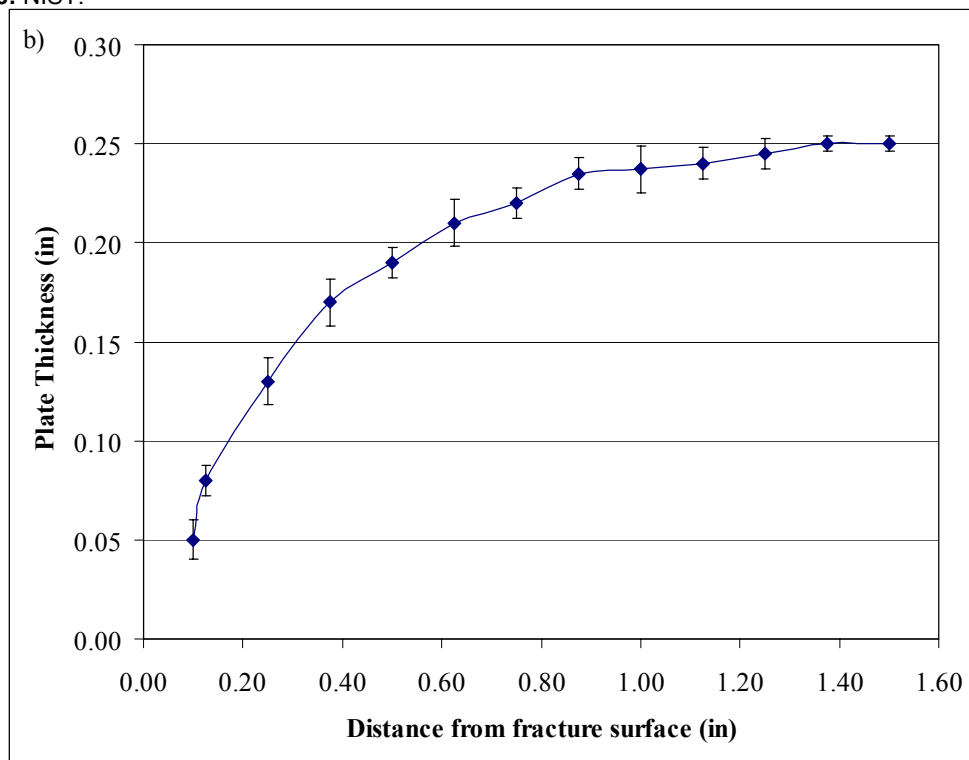
Figure 6–23. Thinning of outer web from column 130 of panel M-2 (A130: 96-99).
a) Photograph showing thinning, b) graph indicating plate thinning near fracture surface.

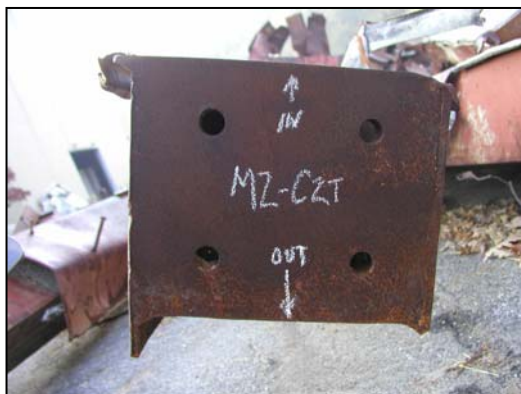
M2-C2T

No change in bolt
hole shape

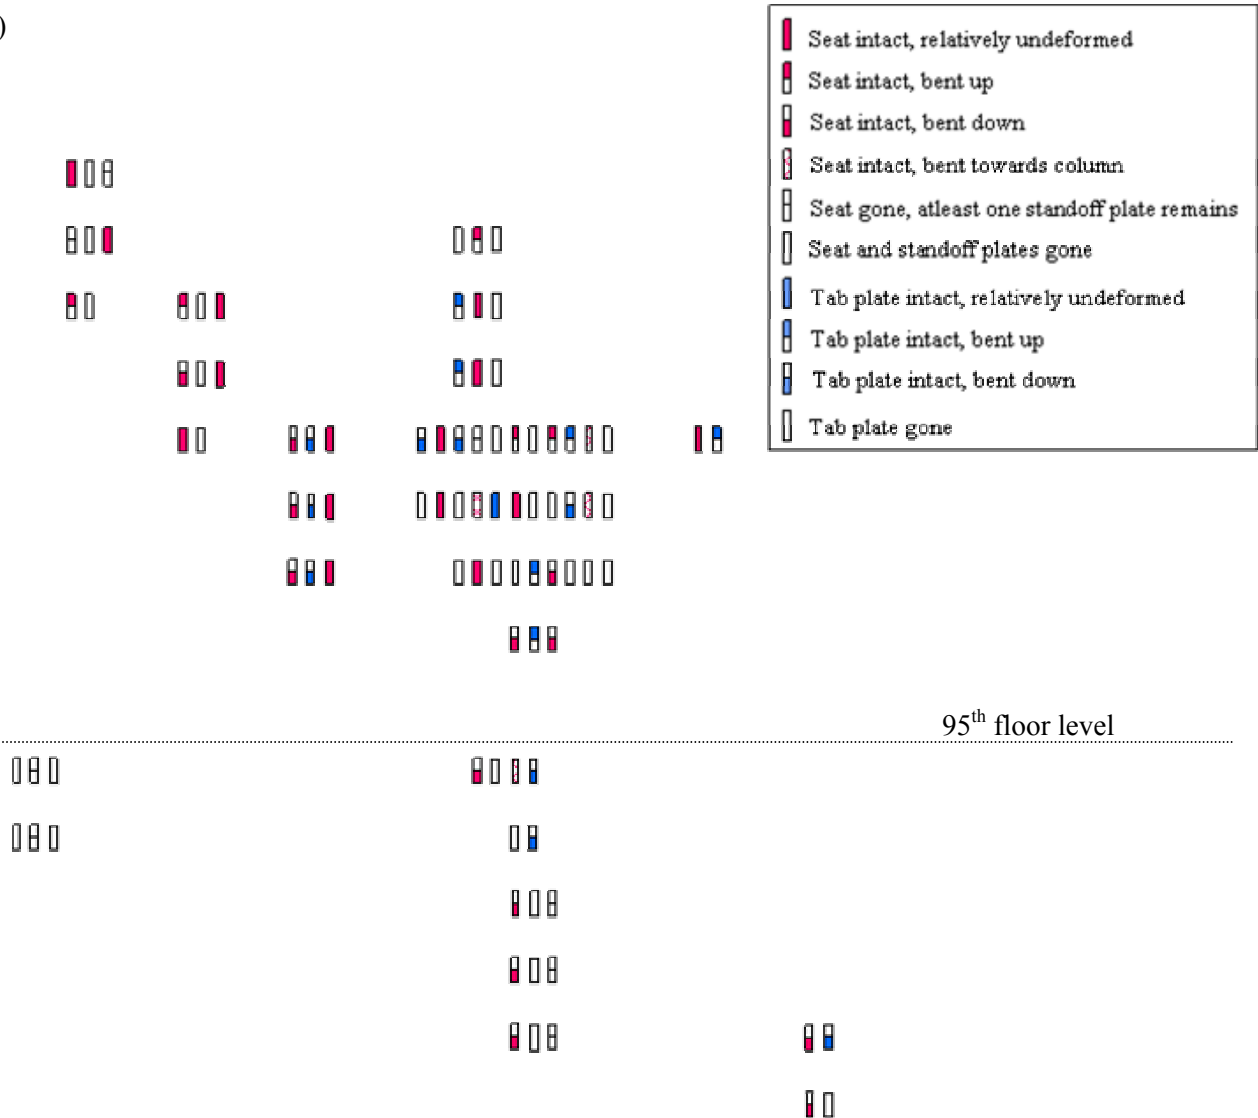
Figure 6–28b. Damage of connectors. At or below the 95th floor, all connectors are either bent down or missing.
