NIST NCSTAR 1-3

**Federal Building and Fire Safety Investigation of the
World Trade Center Disaster**

**Mechanical and Metallurgical
Analysis of Structural Steel**

September 2005

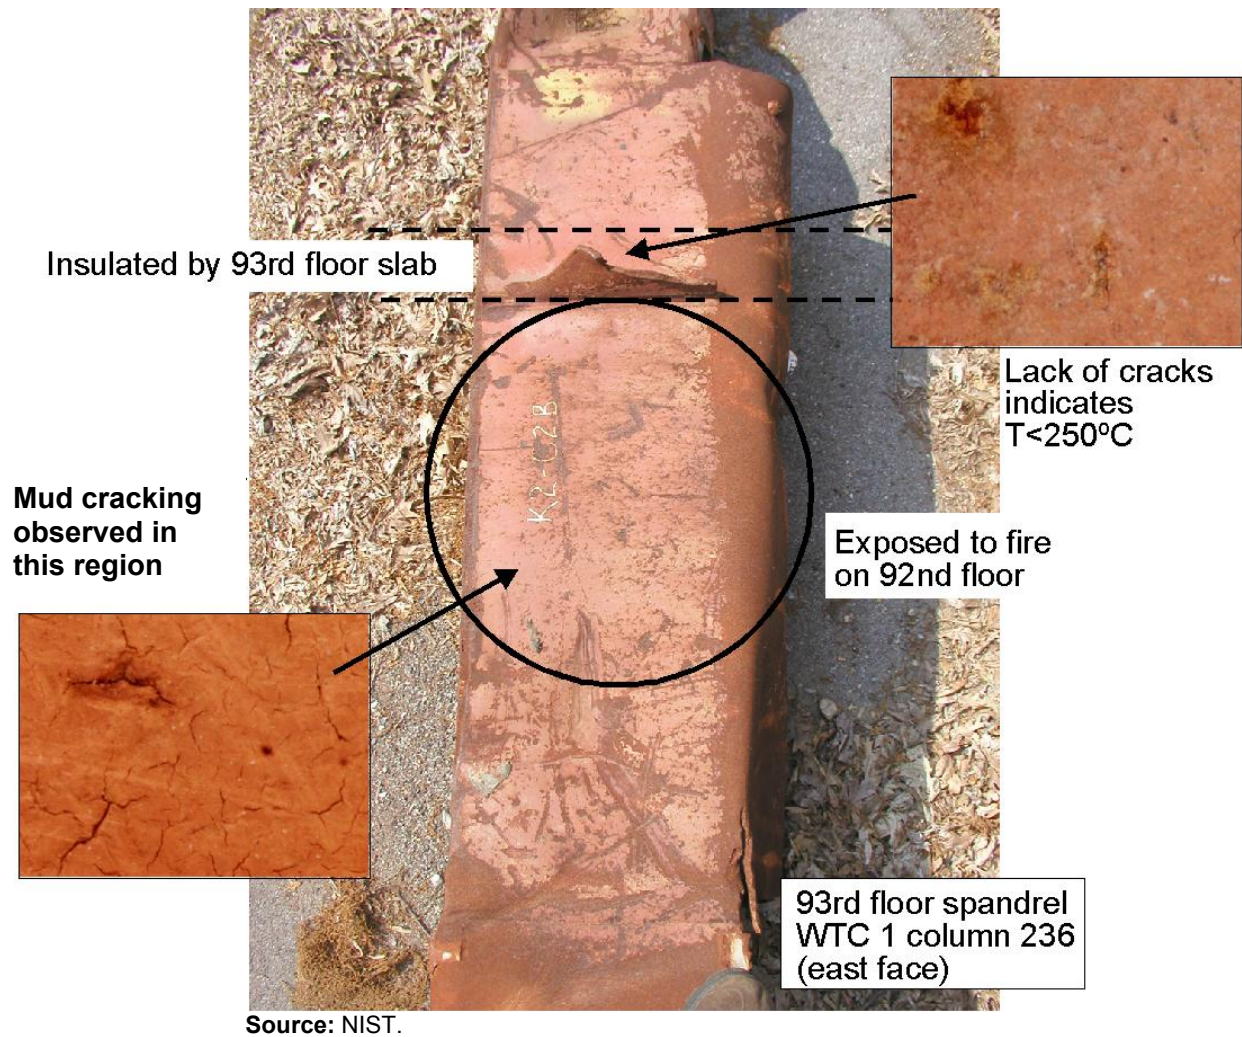
Figure 6–37. Spandrel at the 93rd floor of column 236 from sample K-2 (A236: 92-95). Paint mud cracking was found below the 93rd floor line, no evidence of paint mud cracking was found above floor line.
