# **C** *Limited Metallurgical Examination*

Two structural steel members with unusual erosion patterns were observed in the WTC debris field. The first appeared to be from WTC 7 and the second from either WTC 1 or WTC 2. Samples were taken from these beams and labeled Sample 1 and Sample 2, respectively. A metallurgic examination was conducted.

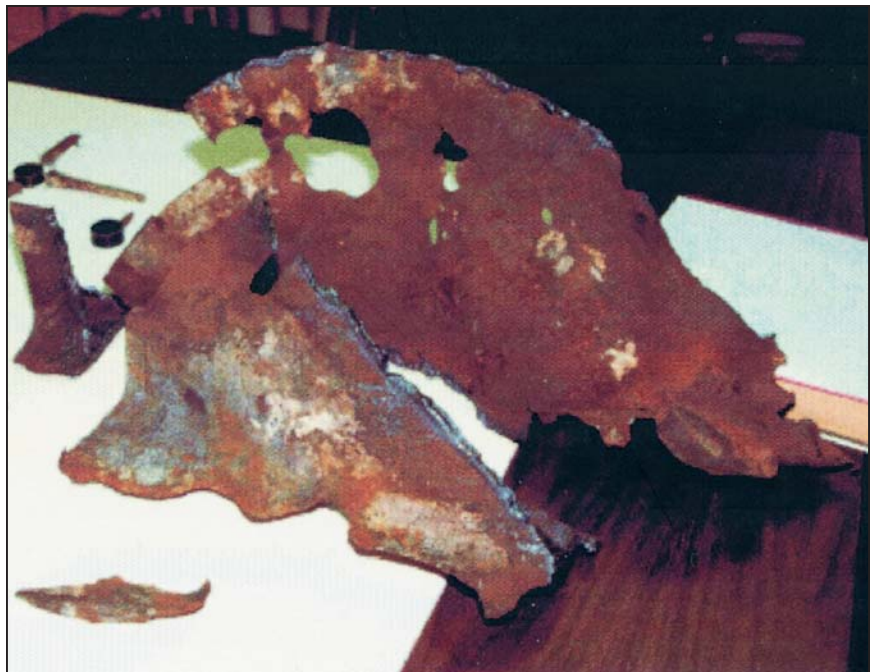
Several regions in the section of the beam shown in Figures C-1 and C-2 were examined to determine microstructural changes that occurred in the A36 structural steel as a result of the events of September 11, 2001, and the subsequent fires. Although the exact location of this beam in the building was not known, the severe erosion found in several beams warranted further consideration. In this preliminary study, optical and scanning electron metallography techniques were used to examine the most severely eroded regions as exemplified in the metallurgical mount shown in Figure C-3. Evidence of a severe high temperature corrosion attack on the steel, including oxidation and sulfidation with subsequent intergranular melting, was readily visible in the near-surface microstructure. A liquid eutectic mixture containing primarily iron, oxygen, and sulfur formed during this hot corrosion attack on the steel. This sulfur-rich liquid penetrated preferentially down grain boundaries of the steel, severely weakening the

*Figure C-1 Eroded A36 wide-flange beam.*

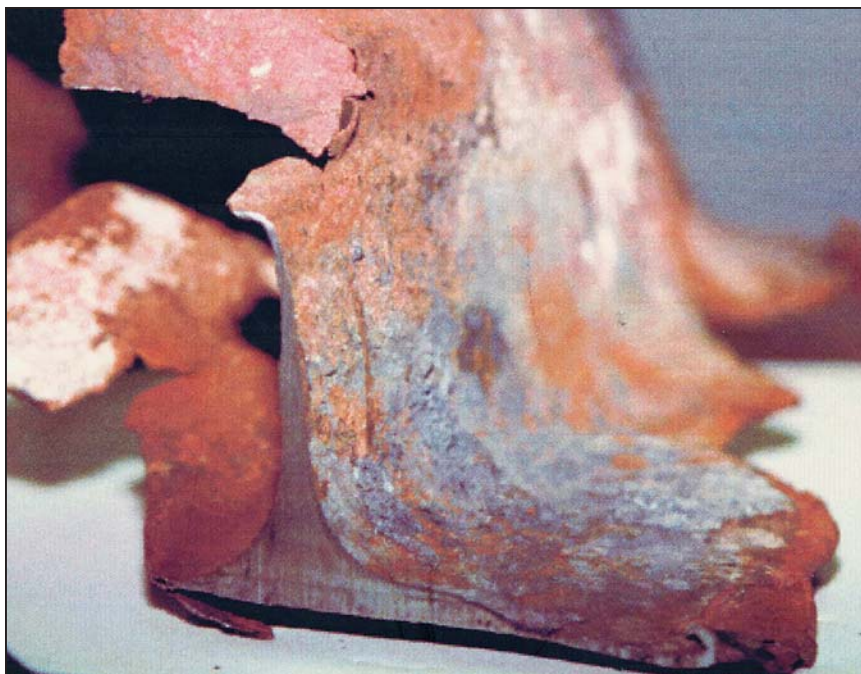
*Figure C-2*  
*Closeup view of eroded wide-flange beam section.*

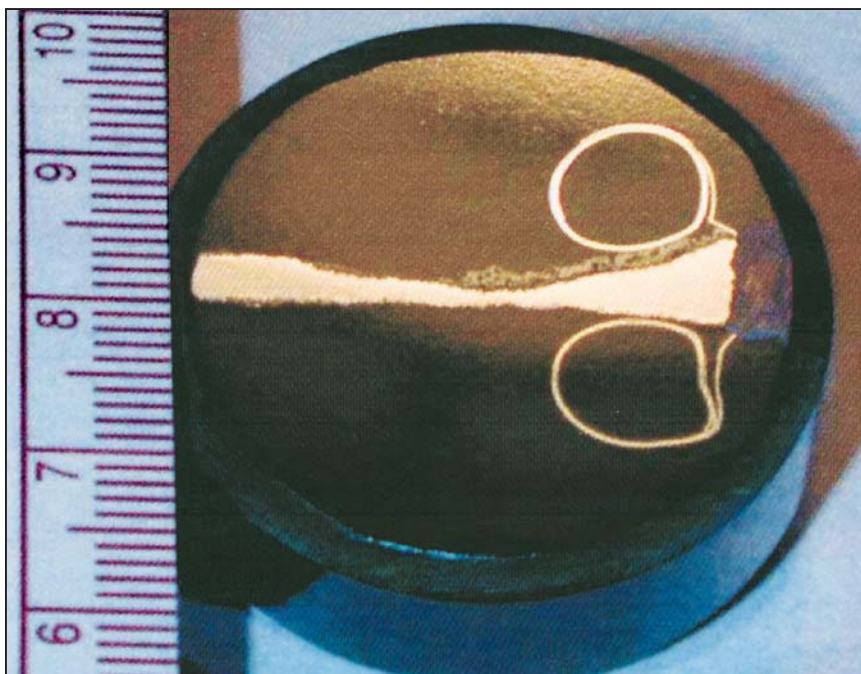
*Figure C-3*  
*Mounted and polished severely thinned section removed from the wide-flange beam shown in Figure C-1.*

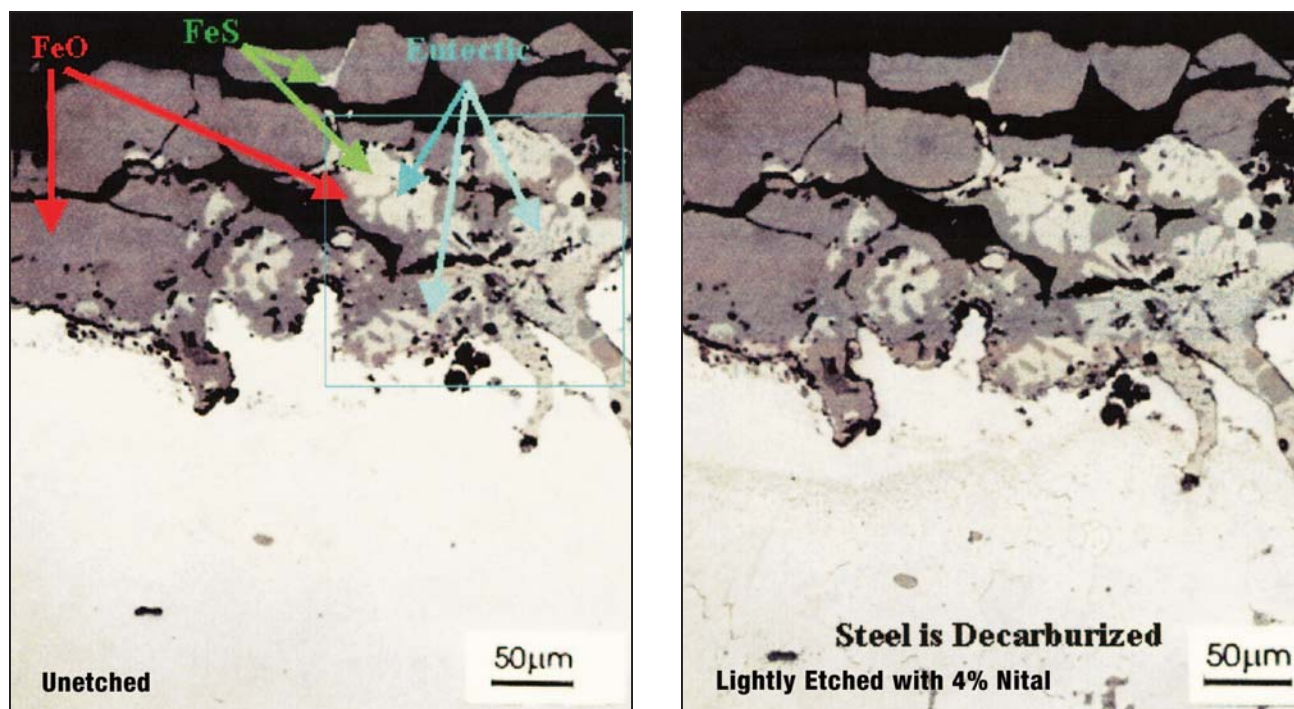
Figure C-4 Optical microstructure near the steel surface.

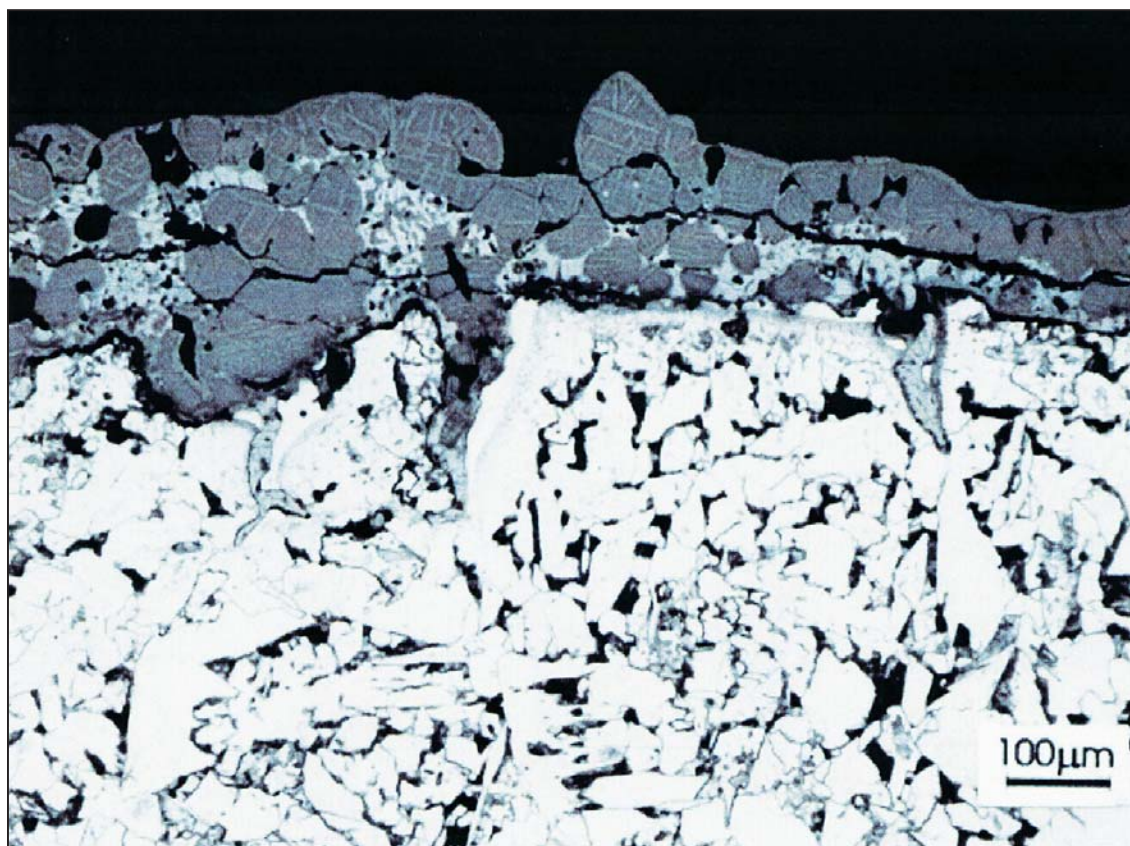
Figure C-5 Another hot corrosion region near the steel surface (etched with 4 percent nital). (Note: (1) Oxide rounding where the FeO-FeS eutectic product is present. (2) Reduction in banding of the steel when re-transformation occurs on cooling from austenite to ferrite and pearlite.)

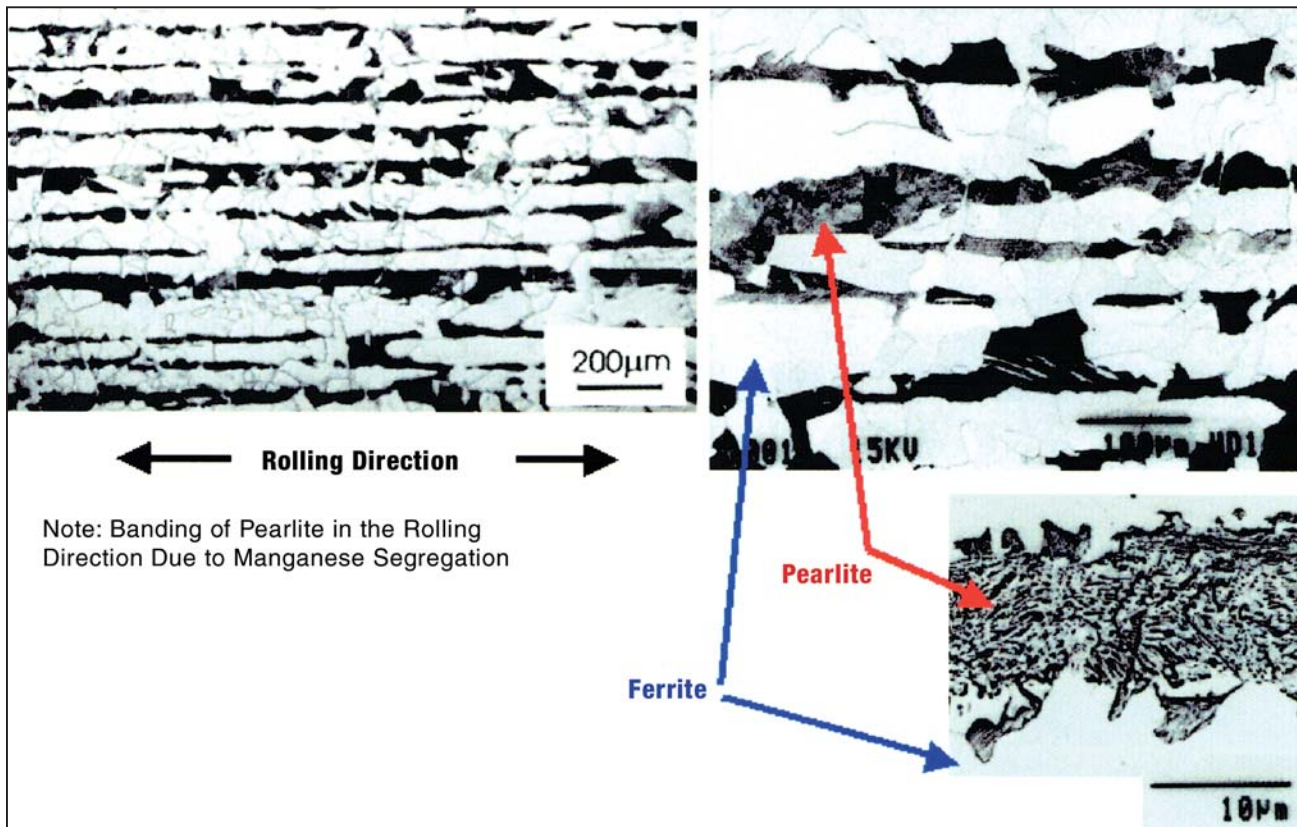
Figure C-6 Microstructure of A36 steel.

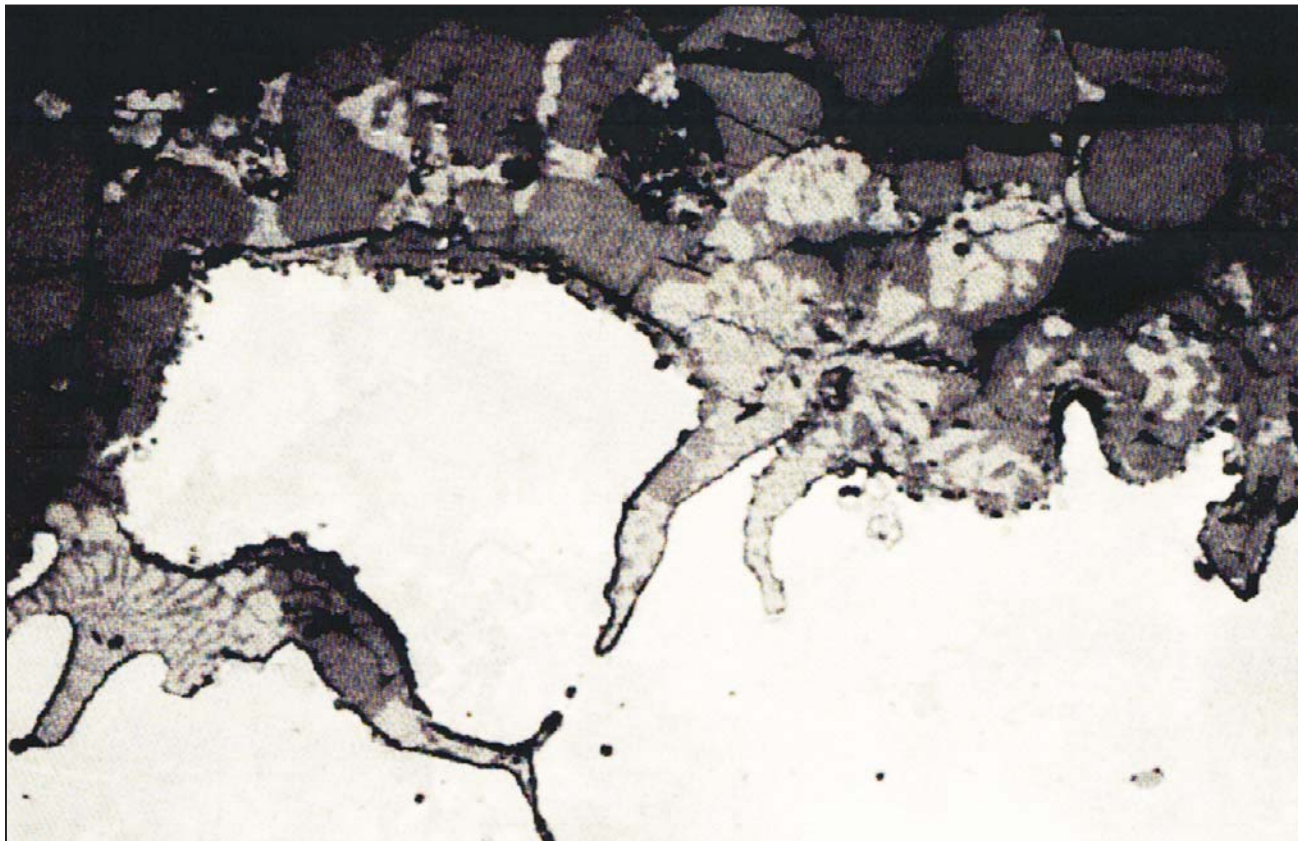
Figure C-7 Deep penetration of liquid into the steel. (Note: Hot corrosion of the steel can produce "islands" of steel surrounded by liquid, which will make erosion of the steel much easier.)

section of the steel that is unaffected by the hot corrosion. Figure C-7 illustrates the deep penetration of the liquid into the steel's structure. In order to identify the chemical composition of the eutectic, a qualitative chemical evaluation was done using energy dispersive X-ray analysis (EDX) of the eutectic reaction products. Figure C-8 illustrates the results of this analysis.

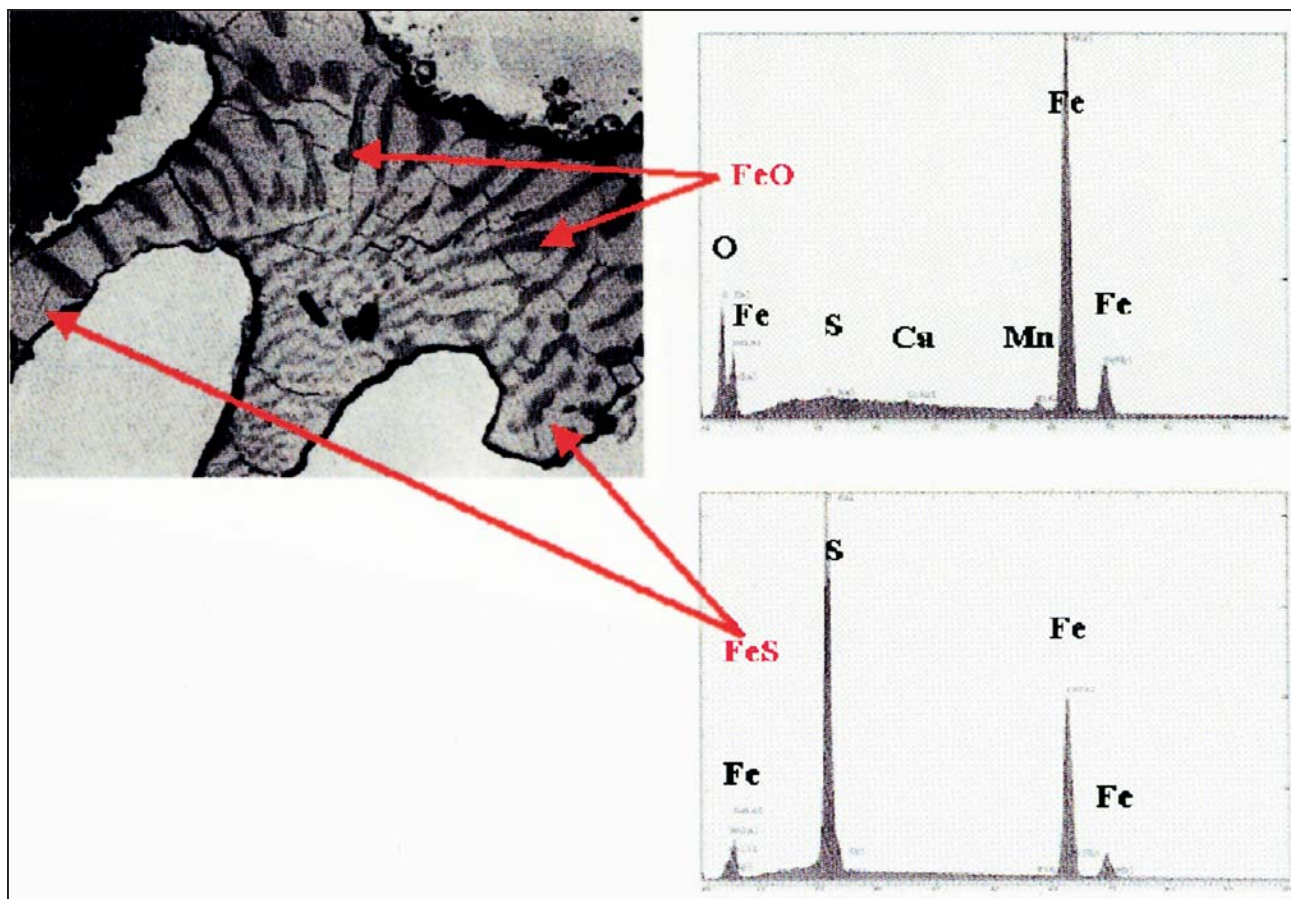
Figure C-8 Qualitative chemical analysis.

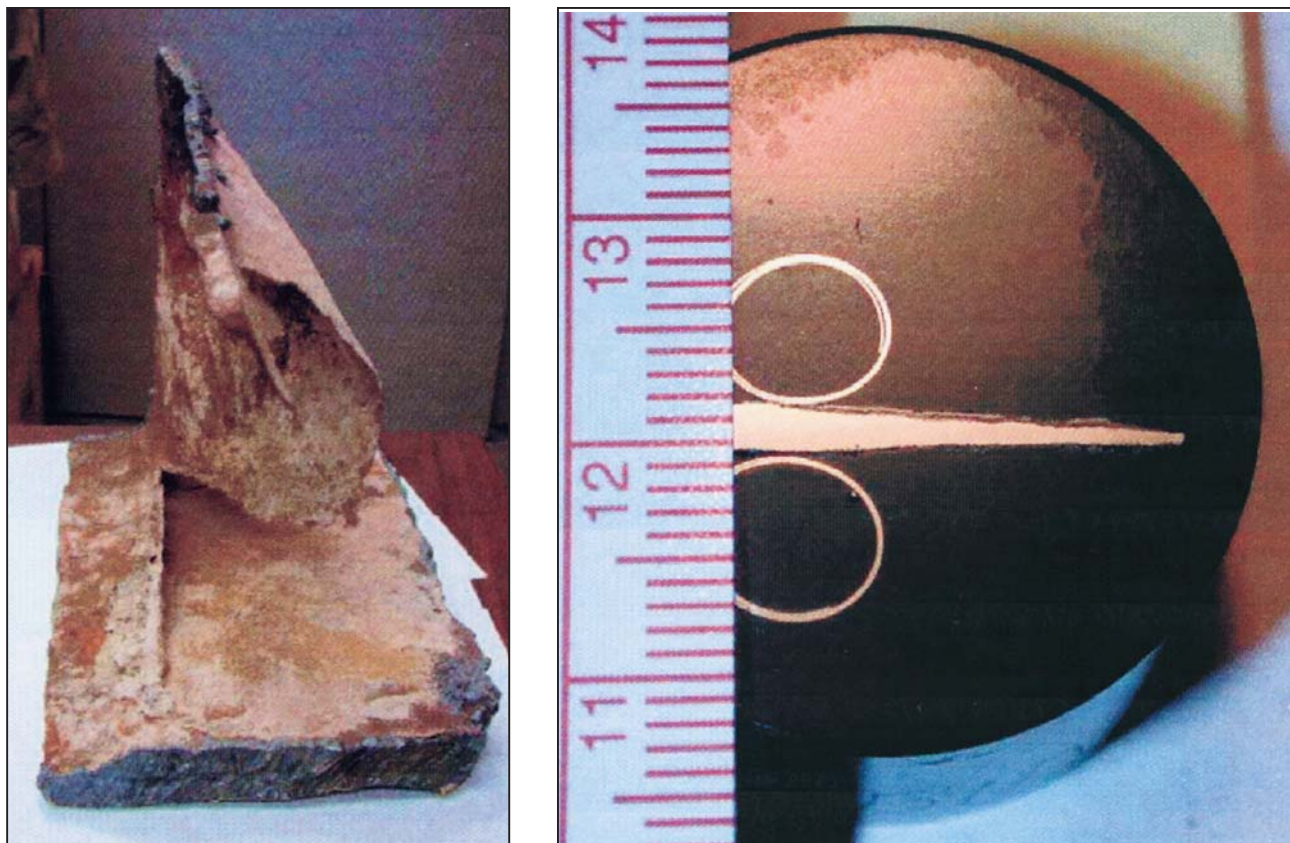
The origin of the steel shown in Figure C-9 is thought to be a high-yield-strength steel removed from a column member. The steel is a high-strength low-alloy (HSLA) steel containing copper. The unusual thinning of the member is most likely due to an attack of the steel by grain boundary penetration of sulfur forming sulfides that contain both iron and copper. Figures C-10, C-11, and C-12 show the region of severe corrosion at different levels of magnification.

Figure C-9 Qualitative chemical analysis.

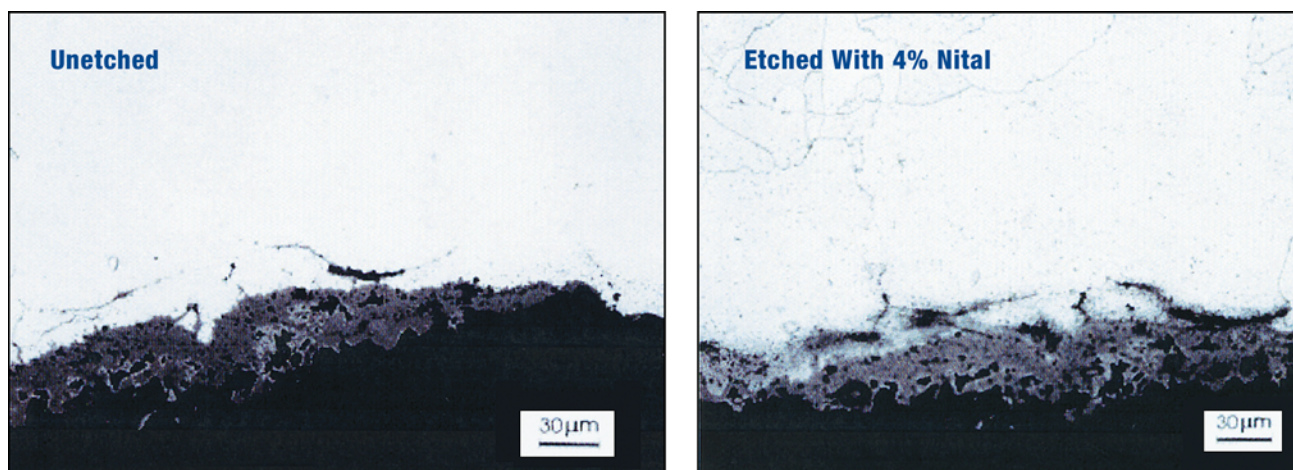
Figure C-10 Grain boundary corrosion attack.

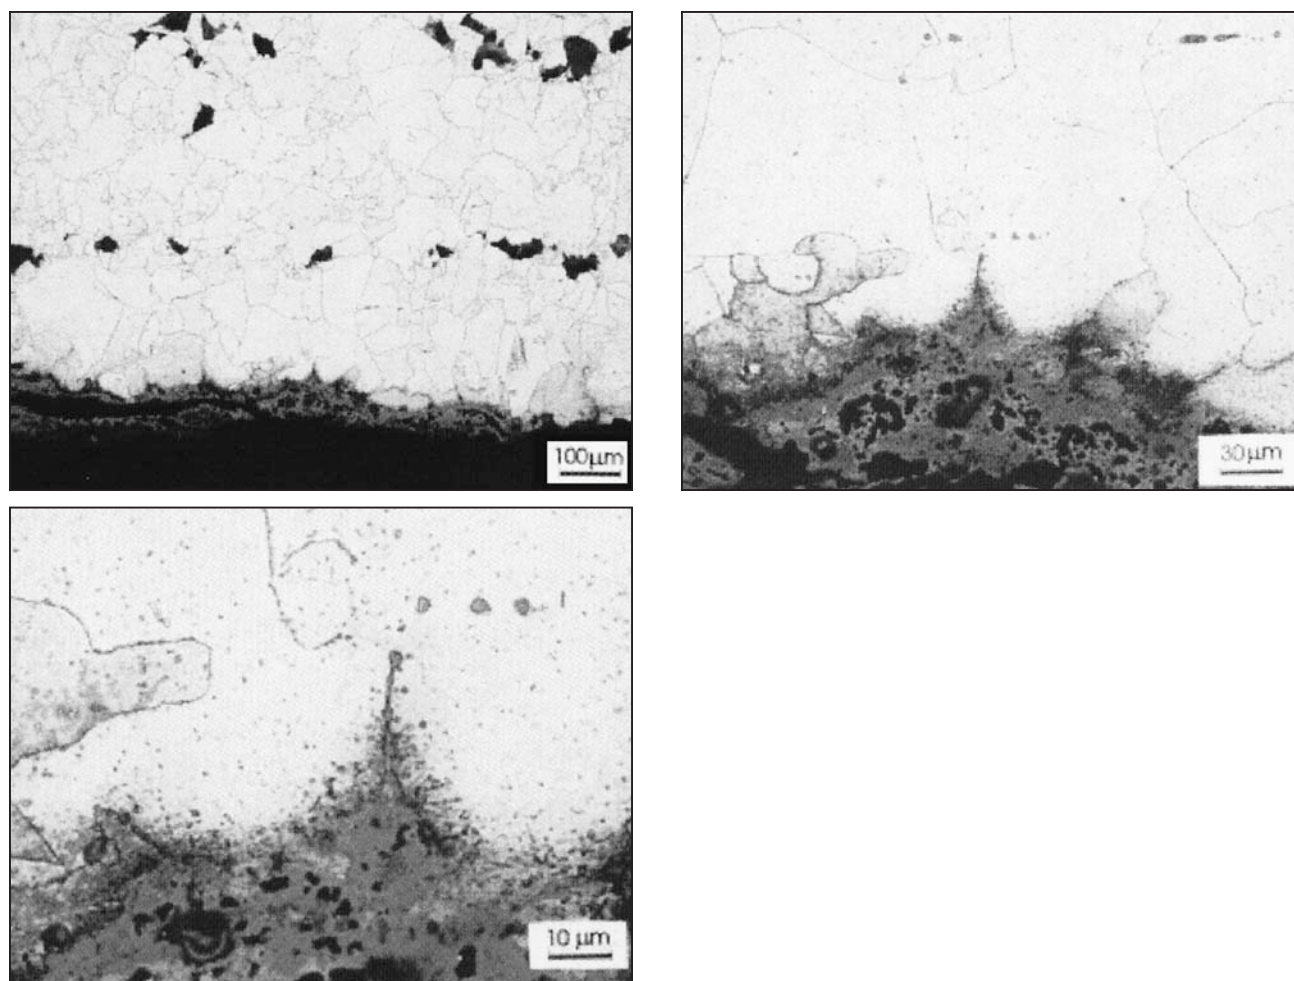
Figure C-11 Microstructure of a typical region showing the surface and grain boundary corrosion attack of Sample 2.

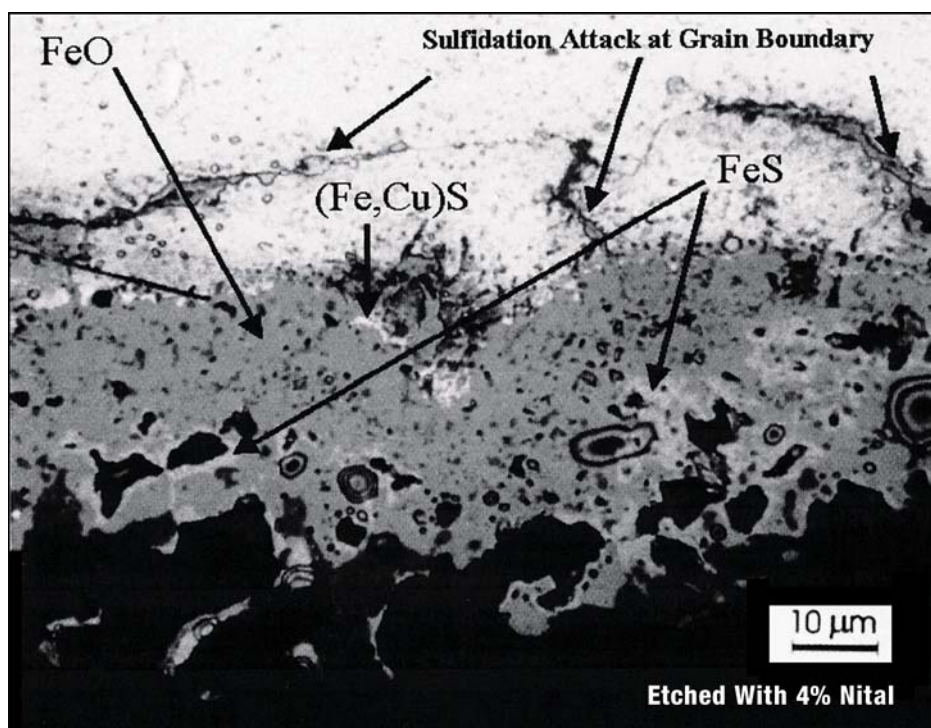
Figure C-12  
Higher magnification of the region  
shown in Figure C-10.

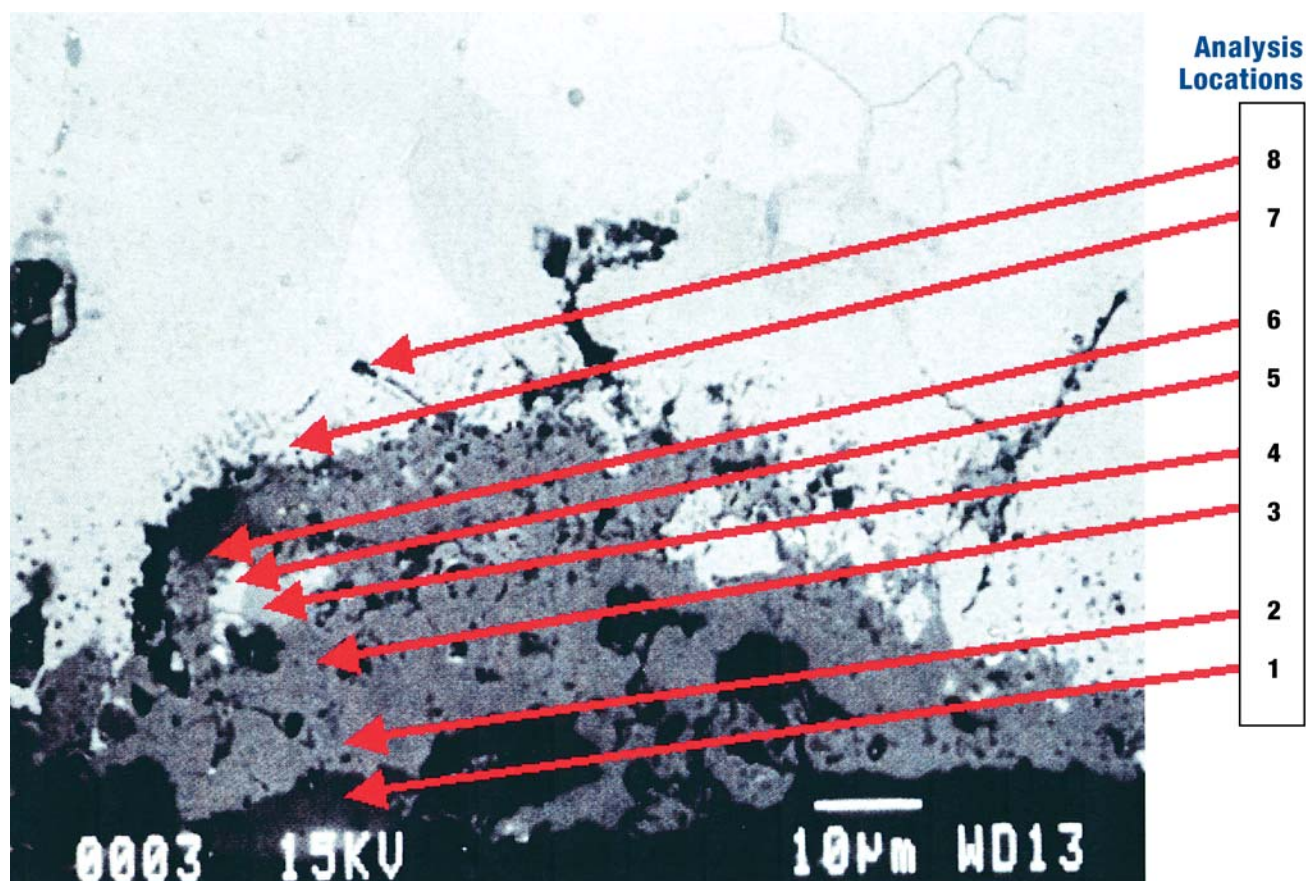
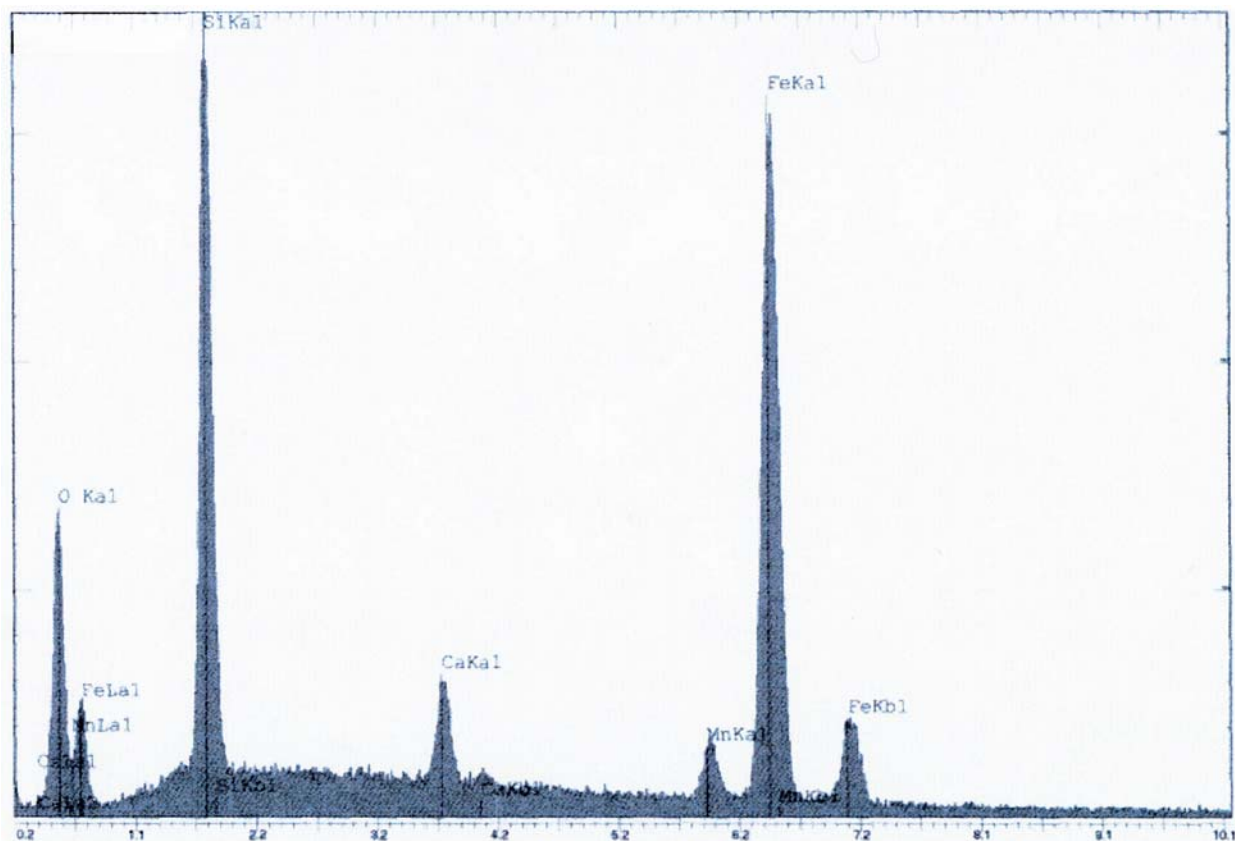
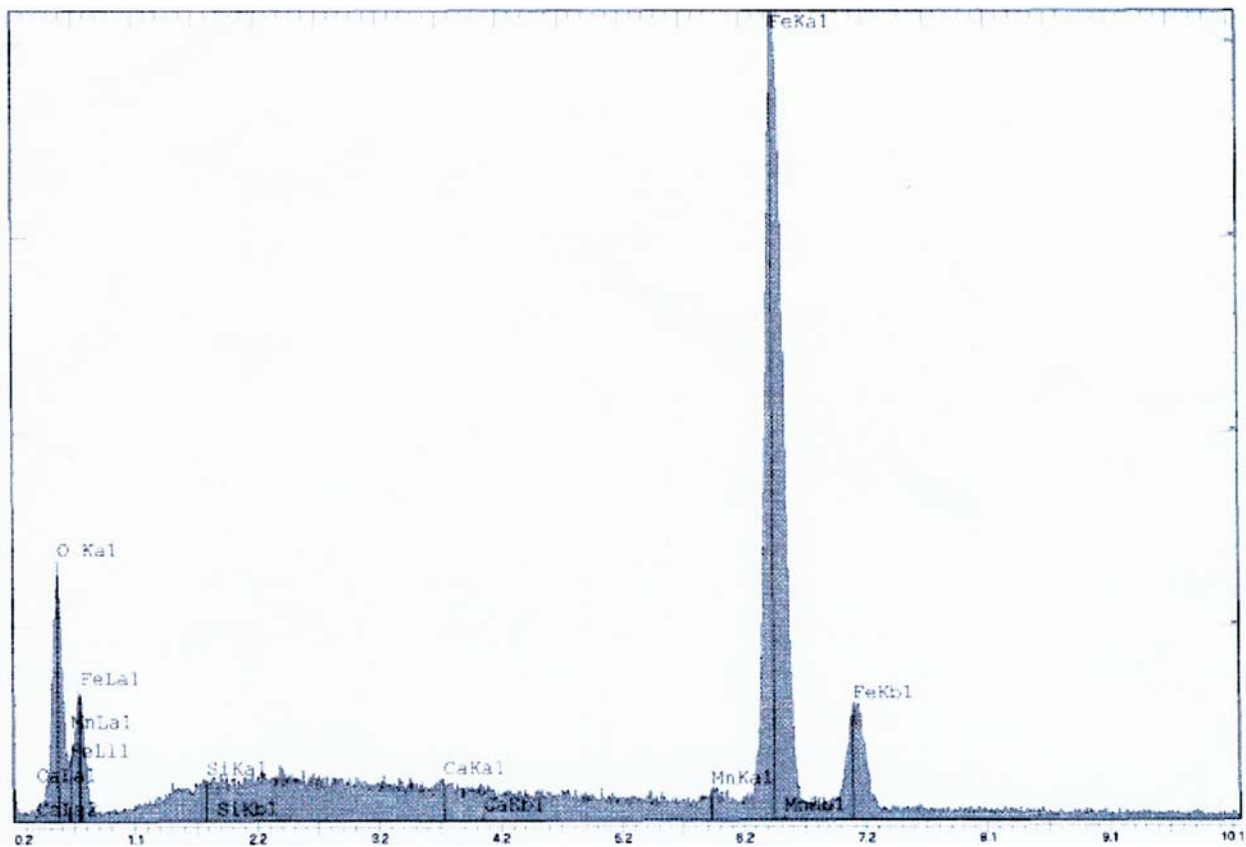
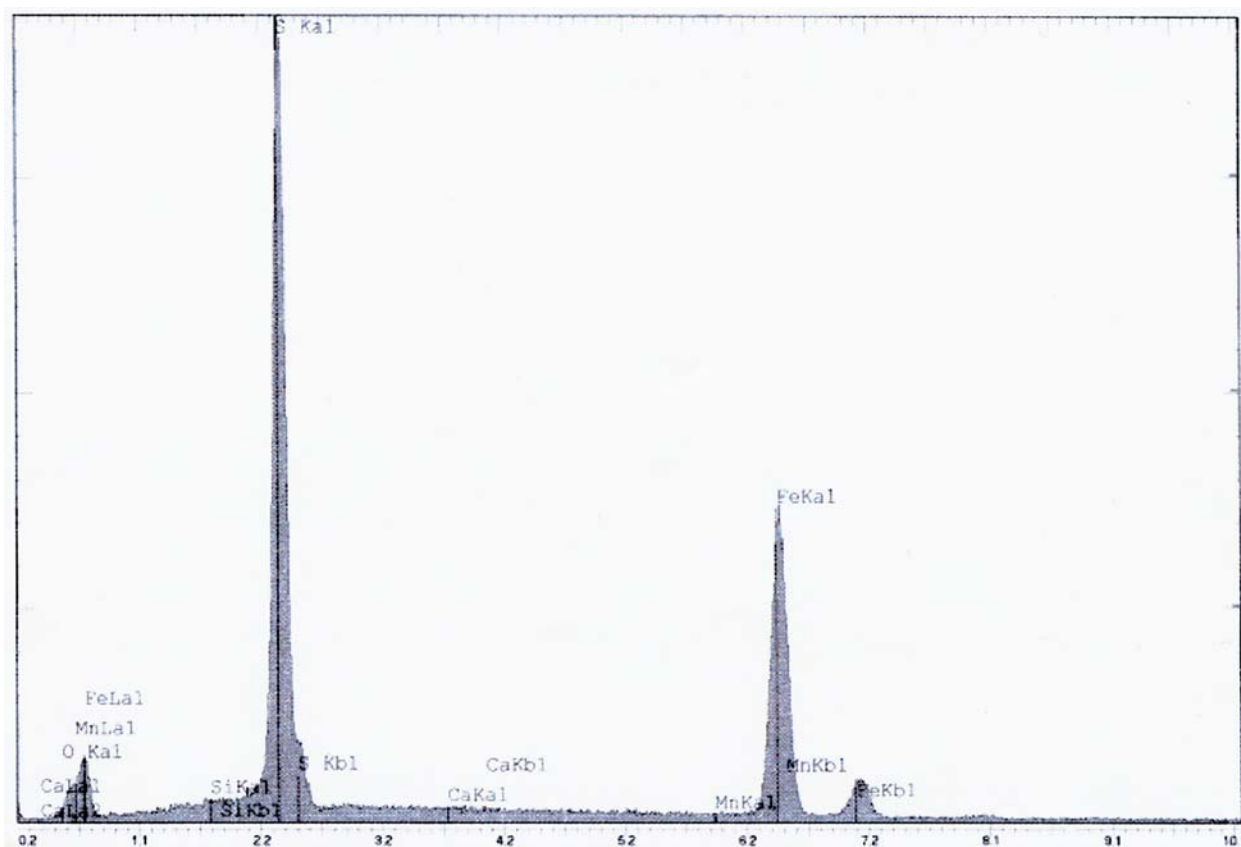
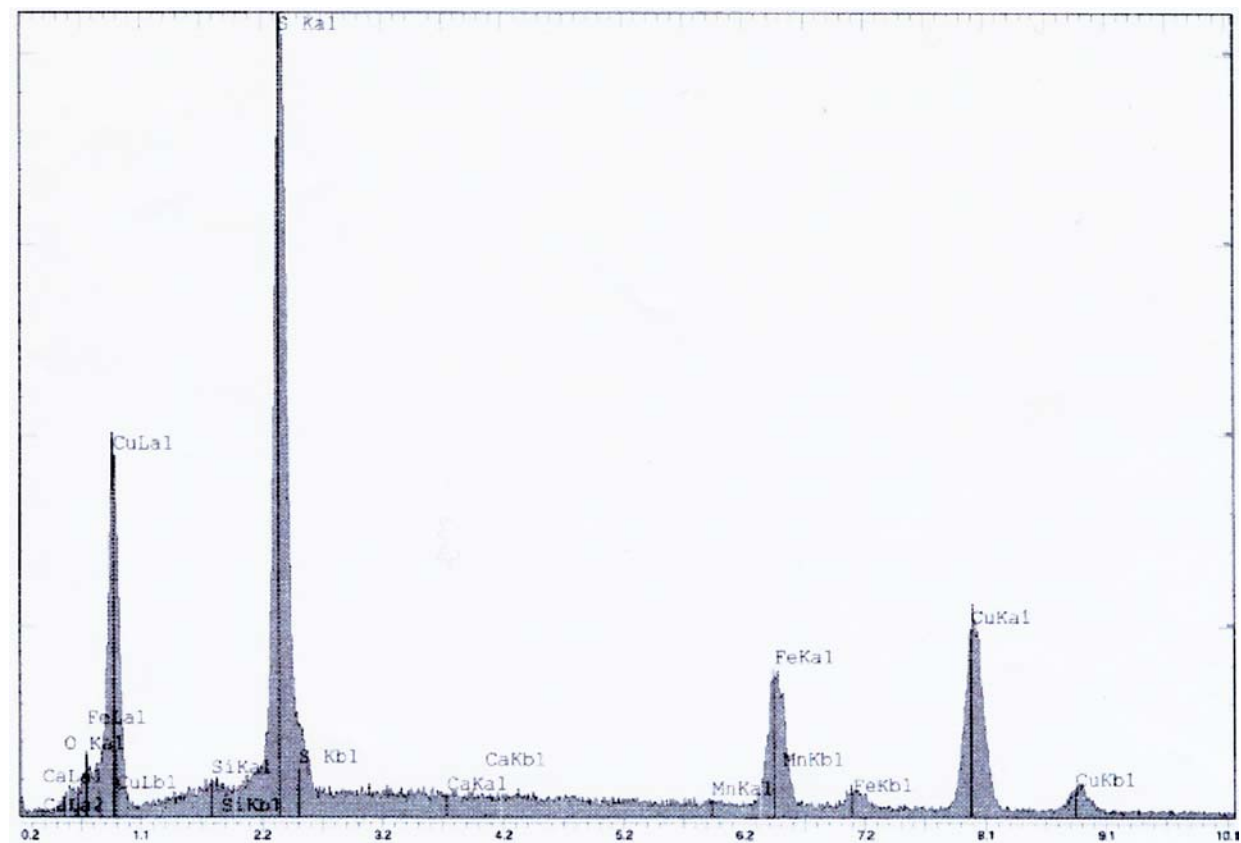
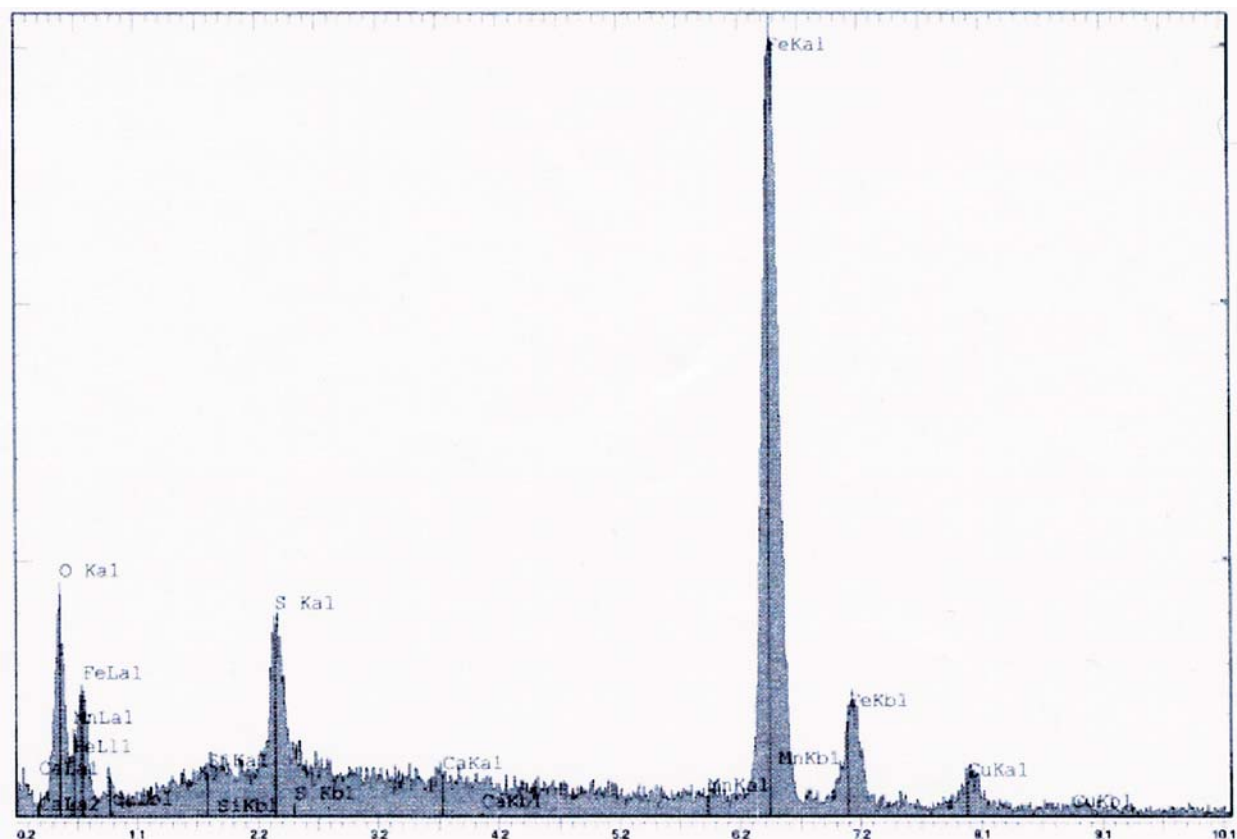
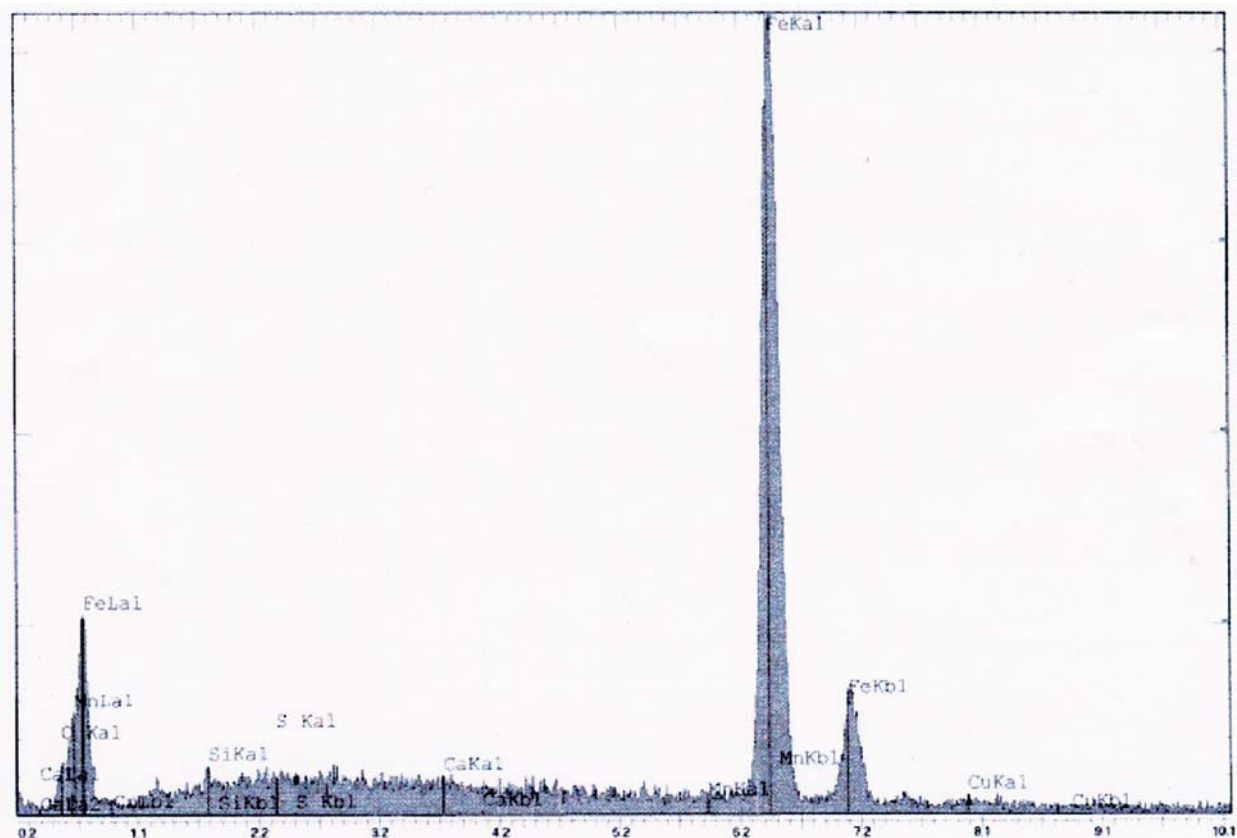
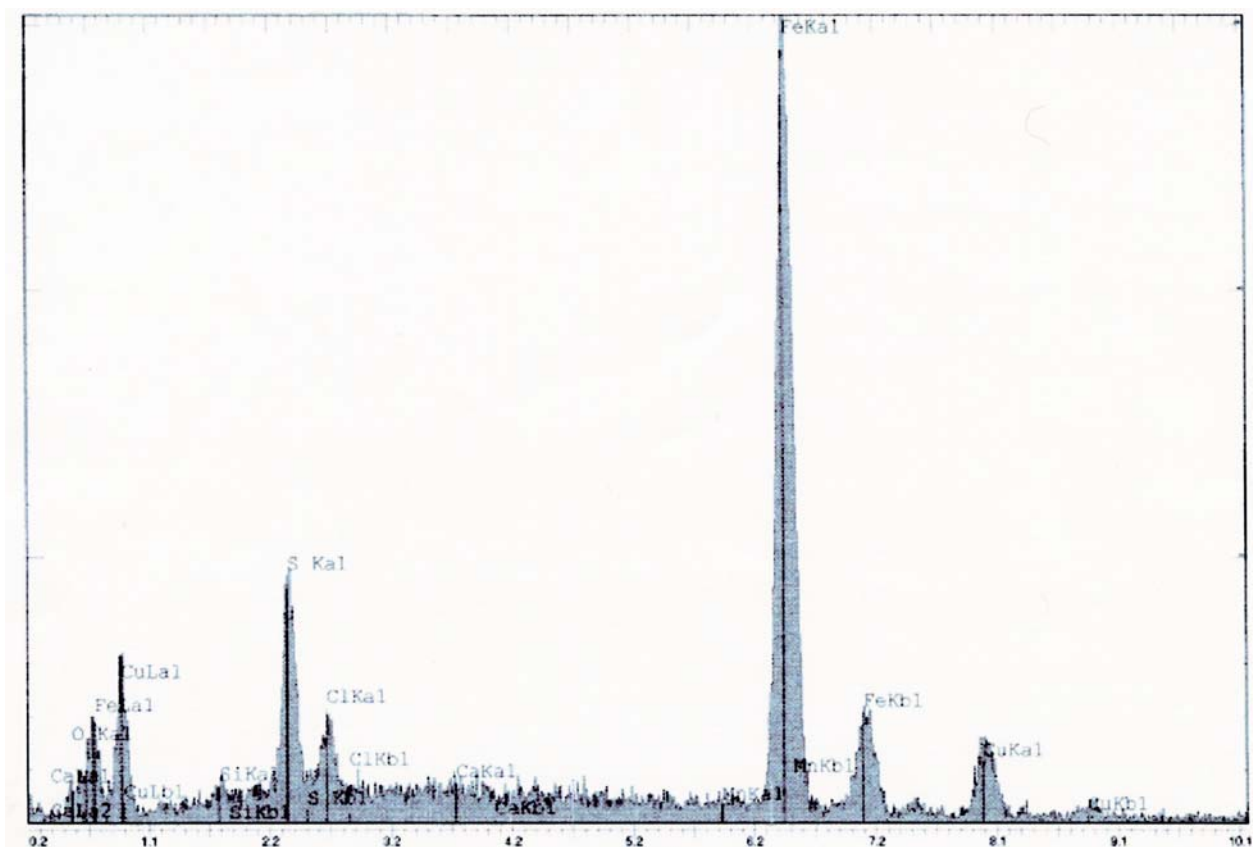
Figure C-13 Regions where chemical analysis was performed.

Figure C-13 shows the region where a qualitative chemical analysis of the eroded region was performed. The comparison of the EDX spectra from the specific regions identified in Figure C-13 shows concentration of copper and sulfur in the grain boundaries in addition to iron sulfide formation adjacent to iron oxide in the oxidized surface layer. Sulfide formation within the steel microstructure increases in concentration as the oxidized region is approached from the steel side. This is clearly shown in Figure C-14.

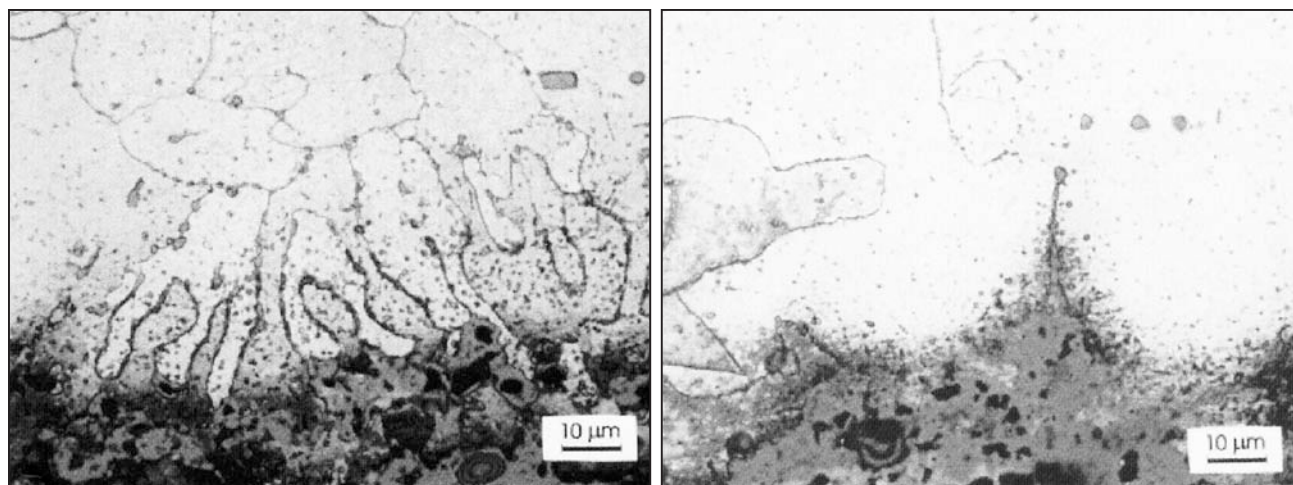
The larger sulfides further into the steel are the more stable manganese sulfides that were formed when the steel was made. The smaller sulfides that have formed as a result of the fire do not contain significant amounts of manganese, but rather are primarily sulfides containing iron and copper. These sulfides have a lower melting temperature range than manganese sulfide. It is much more difficult to tell if melting has occurred in the grain boundary regions in this steel as was observed in the A36 steel from WTC 7. It is possible and likely, however, that even if grain boundary melting did not occur, substantial penetration by a solid state diffusion mechanism would have occurred as evidenced by the high concentration of sulfides in the grain interiors near the oxide layer. Temperatures in this region of the steel were likely to be in the range of 700–800 °C (1,290–1,470 °F).

Figure C-14 Gradient of sulfides into the steel from the oxide-metal interface.
