**Damage Assessment  
130 Liberty Street Property**

**Report Date: December 2003**

**WTC Dust Signature Report  
*Composition and Morphology***

**RJ LeeGroup, Inc.**

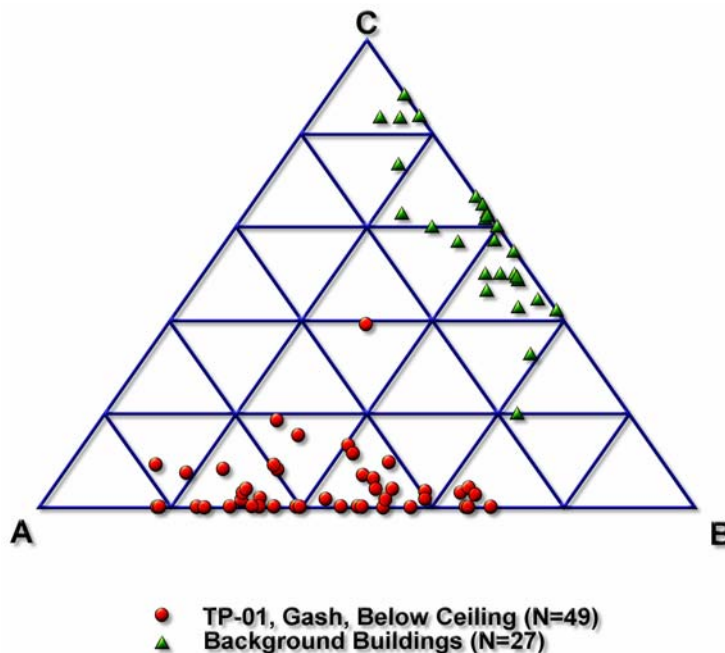
Figure 1. Ternary plots of TP-01 *gash* below ceiling and Background Building samples.

Class A consists of the major building materials and particles influenced by high temperature. These particles include characteristic particulate derived from the WTC Event. Class B consists of carbonate and silicate minerals. These are commonly derived from soil, but also represent building materials and could have been derived from the WTC Event. Class C consists of carbon-rich materials. This class includes fibers, flakes, or particles representing hair, cellulose, pollen, skin flakes, and other biological components. These particles represent a major portion of common Background Building dust.

To facilitate the comparison between WTC Dust and typical background dust, the respective dust constituents based on SEM data were plotted on a “ternary” diagram and data was grouped into three distinct classes to reflect differences in origin (**Figure 1**).

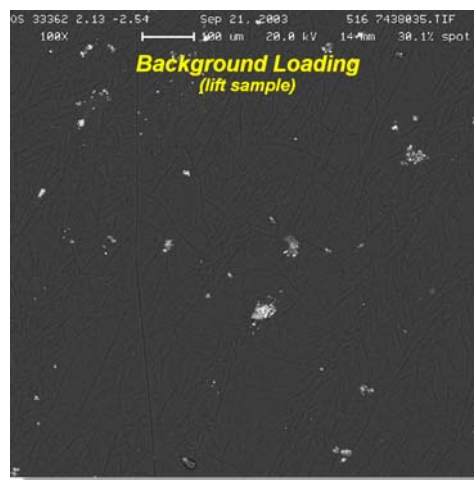
Figure 2. Typical dust loading on Background Building samples

**Figure 2** shows a typical loading on a lift sample collected from a Background Building and **Figure 3** shows the particle loading of a lift sample collected from a WTC Dust impacted location within the Building. The images in these figures depict the same magnification. The shear amount or dust loading differential between the two samples is obvious. At higher magnifications, it can be seen that materials residing on the WTC Dust lifts possess morphological characteristics that are different from the Background Building samples. The particulate components on the WTC Dust sample appear angular or pulverized and accompany spherical heat affected particles. Also, the fibrous component exhibited in the WTC Dust sample is largely absent from the Background Building sample.

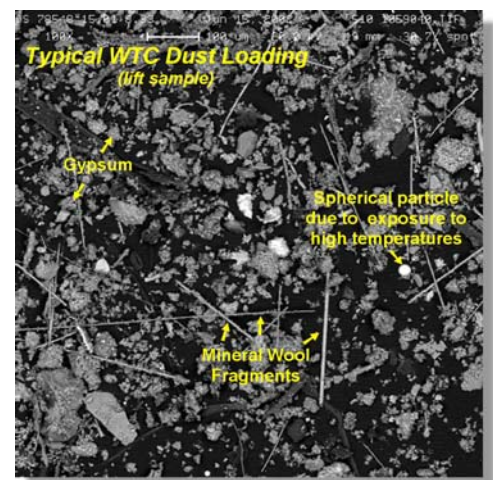
Figure 3. Dust loading from a WTC Dust impacted location

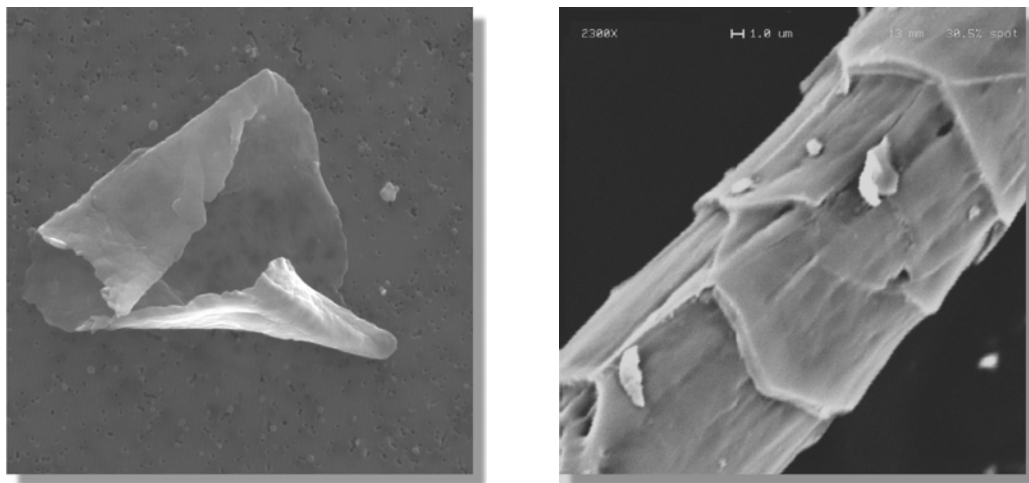
Figure 4. SEM image of skin flake and a hair fiber found in Background Buildings.

**Figure 4** shows examples of the organic components that comprise a significant portion of the total particulate and fibrous material associated with the Background Building samples. This type of matter comprises only a trace amount within the WTC Dust. The WTC Dust contains hydrolyzed or partially consumed components of carbonaceous material exhibiting a vesicular typically sub-spherical morphology.

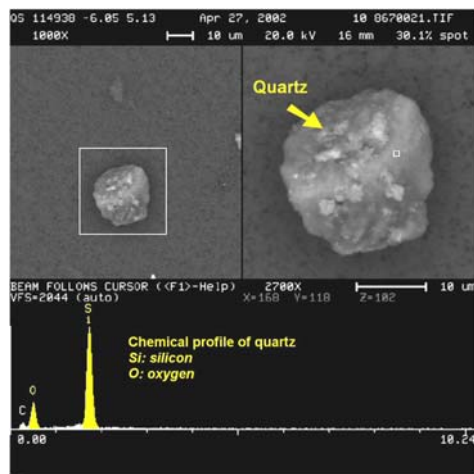
Figure 5. SEM image with EDS of silicon-rich particle (i.e., quartz)

Samples collected within the WTC towers in the spring of 2000 were examined to provide further evidence of the particle types expected within buildings surrounding the WTC site prior to the WTC Event. **Figure 5** and **Figure 6** include SEM images of “typical” dust particles that were indicative of the particles types present at the WTC site prior to the WTC Event. The left image of each photomicrograph shows a field of view with a white box. The right image is at a higher magnification and is the region within the box of the left image. The lower portion of the figure shows the elemental spectrum acquired inside the small box seen in the right image. These background particles include common soil/mineral particles such as quartz, clays and even rust particles.

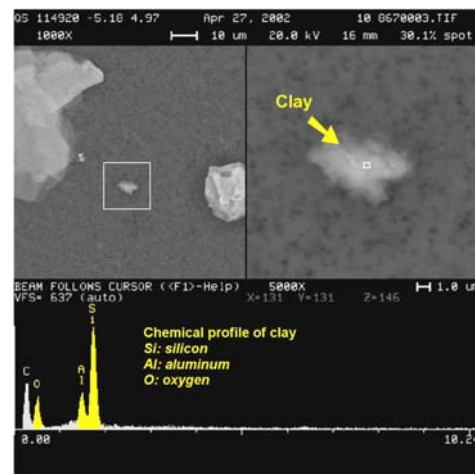
Figure 6. SEM image with EDS of silicon/aluminum-rich particle (i.e., clay).

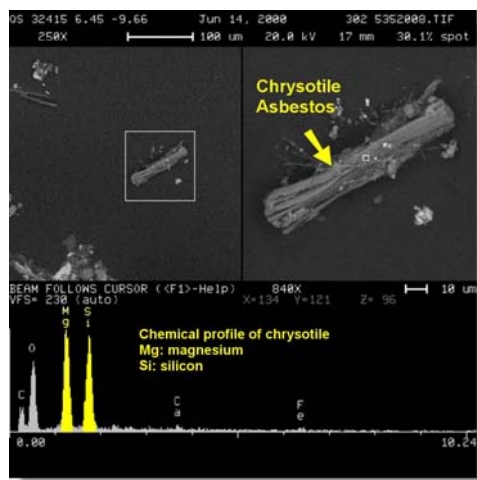
Figure 7. SEM image and EDS of chrysotile asbestos fiber bundle in WTC-1 (Pre-WTC Event)

Chrysotile asbestos was positively identified in the WTC prior to the WTC Event as evidenced in studies performed by RJ Lee Group in 2000 (**Figure 7**). **Figure 8** shows chrysotile asbestos associated with gypsum within the WTC Dust (post-WTC Event).

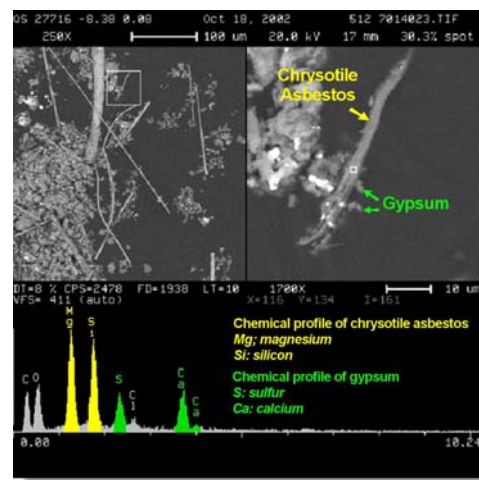
Figure 8. SEM image and EDS of WTC chrysotile with gypsum (Post-WTC Event)

As a result of the extreme forces produced by the WTC Event, the chrysotile fiber bundles within the WTC Towers were commonly broken down to thin bundles and fibrils.

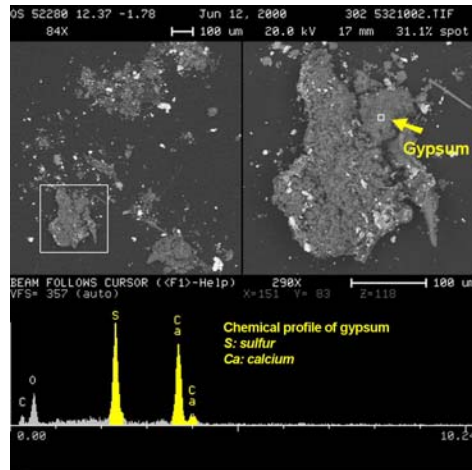
Figure 9. Image and EDS of gypsum in the WTC (Pre-WTC Event)

**Figure 9** illustrates gypsum is coarse and fewer fine particles are observed in the pre-WTC Event debris. **Figure 10** shows a typical SEM image of gypsum debris from within the WTC Dust.

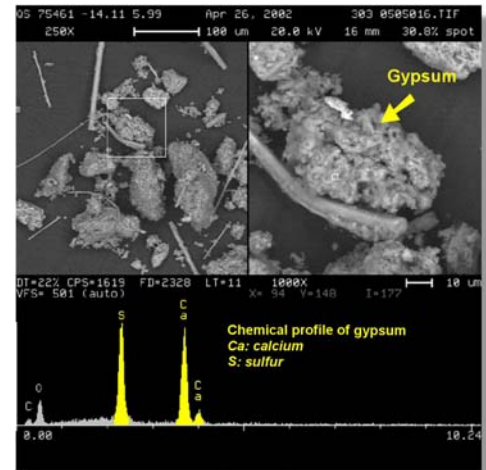
Figure 10. SEM image and EDS of WTC gypsum (Post-WTC Event)

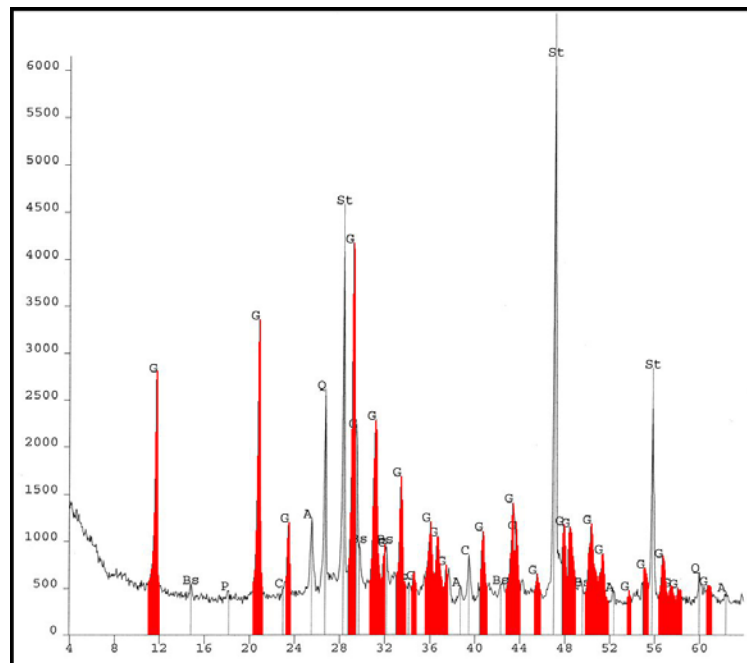
Figure 11. XRD spectrum of WTC Dust.

**Figure 11** shows an X-ray diffraction (XRD)<sup>2</sup> pattern of the bulk WTC Dust. Gypsum and other calcium sulfate phases were found to comprise up to 30% of the WTC Dust by mass. Other crystalline phases were quartz and calcite with concentrations of approximately five weight percent.

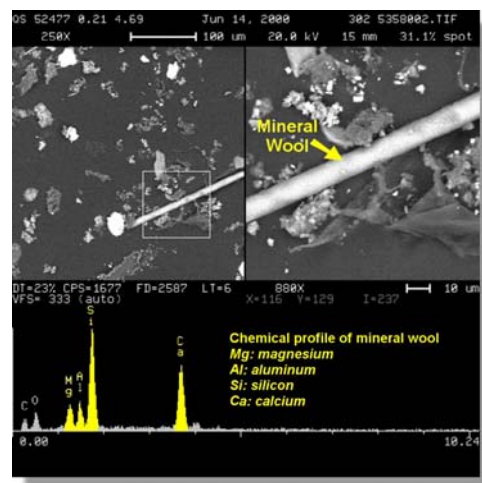
Figure 12. SEM image and EDS of mineral wool in the WTC-2 prior to the WTC Event.

Synthetic vitreous fibers (SVFs) or man-made vitreous fibers (MMVF) are a class of insulating materials used widely in commercial buildings. They are made primarily from glass, rock, slag, or clay. Typical mineral wool applications include use in structural fire protection and ceiling tile. Mineral wool has also been widely reported as a major constituent of WTC Dust. Mineral wool found in Background Buildings typically existed as long fibers as opposed to the short, fractured fibers found in WTC Dust. **Figure 12** shows a typical mineral wool fiber observed in the WTC prior to the WTC Event. After the WTC Event, many of the mineral wool fibers were observed to have a short and fractured nature, which can be attributed to the catastrophic failure of the WTC as compared to normal degradation (Figure 13 through **Figure 14**).

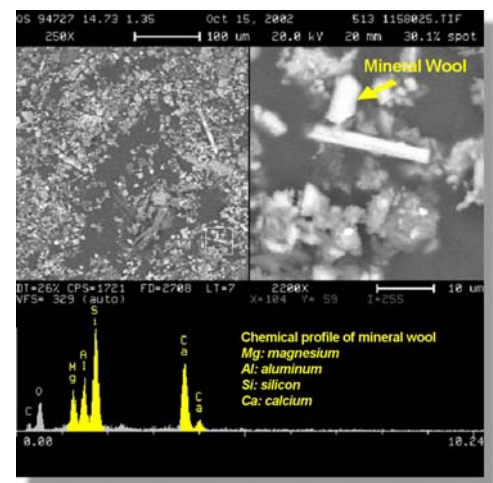
Figure 13. SEM image and EDS of WTC mineral wool fragment after the WTC Event.

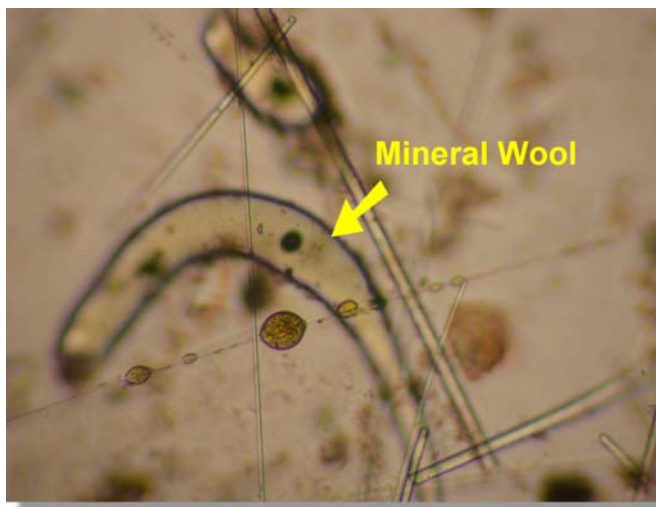
Figure 14. Optical microscopy image of mineral wool fragment.

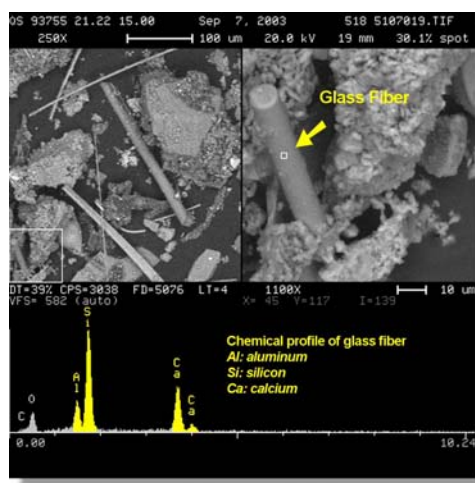
Figure 15. Glass fiber in WTC Dust

In addition to mineral wool, fractured glass fibers are also a WTC Dust Marker for WTC Dust. The major uses of glass fibers are in thermal insulation, noise-control (acoustic) products, linings for air-handling ducts, pipe insulation and air filters. Representative glass fibers from the WTC Dust are shown in **Figure 15** and **Figure 16**.

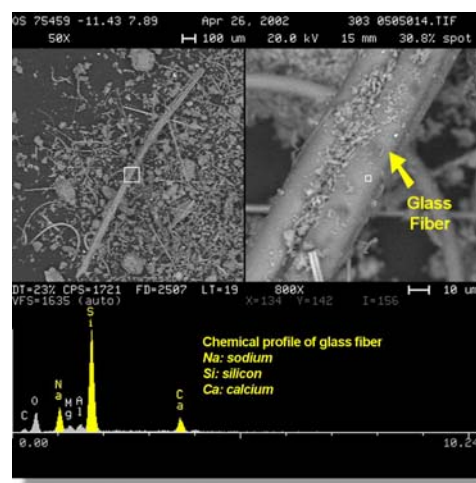
Figure 16. Glass fiber in WTC Dust.

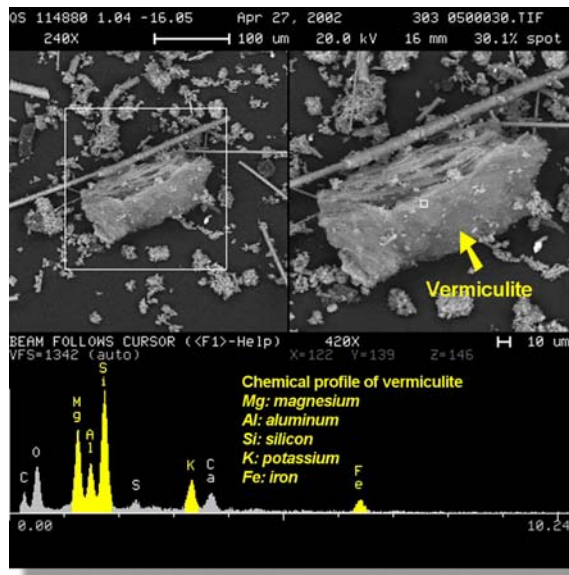
Figure 17. Vermiculite particle in WTC Dust

qualities. The mineral does not burn and provides excellent heat resistance properties. Vermiculite was present in the plaster on exterior walls within the WTC towers and is commonly observed in the WTC Dust. **Figure 17** is an SEM micrograph of the vermiculite observed in the WTC Dust.

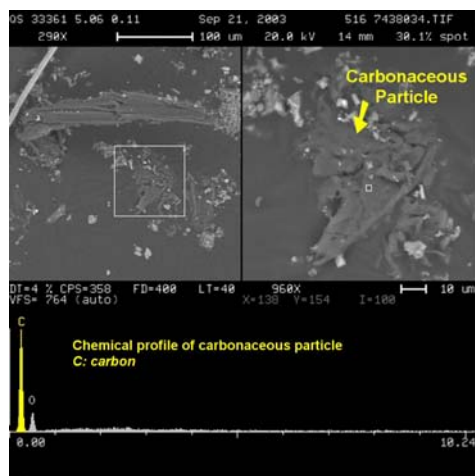
Figure 18. SEM image and EDS of carbonaceous material in Background Building

There were considerable amounts of plastics in the WTC buildings, that upon heating and liberation of volatiles produced spherical (or nearly so) carbon-rich particles with vesicles related to emission of volatiles. **Figure 18** shows typical carbonaceous materials from a Background Building and **Figure 19** shows porous heat affected particulate in the WTC Dust. **Figure 20** shows a PLM image of porous heat affected particulate in the WTC Dust.

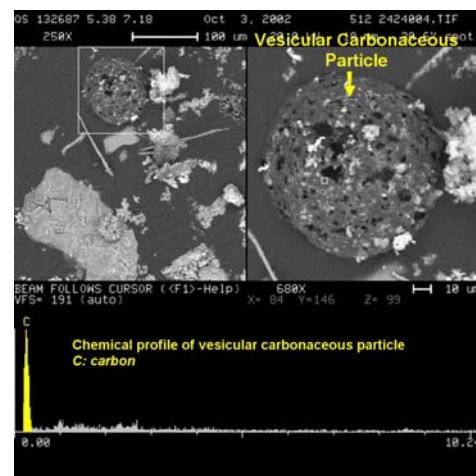
Figure 19. SEM image and EDS of a vesicular carbonaceous particle

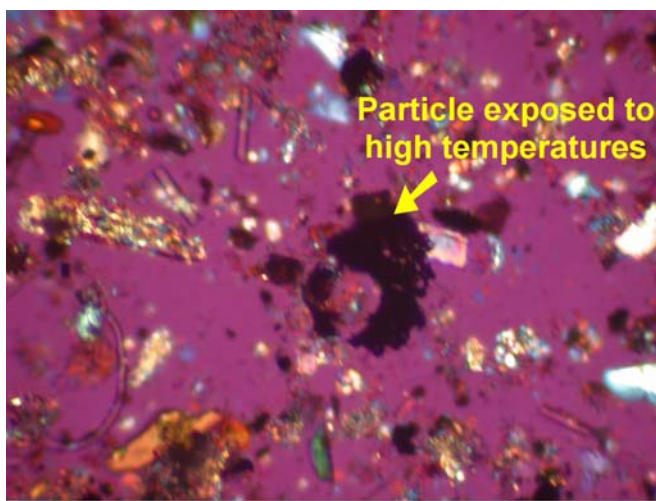
Figure 20. Optical microscopy image of a particle formed by high temperature.

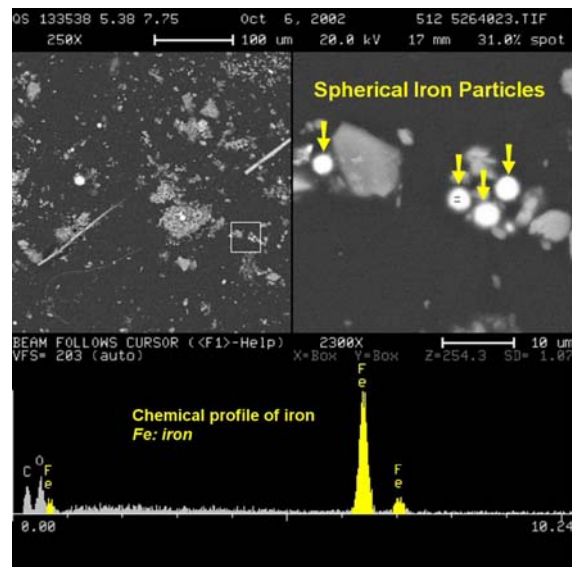
Figure 21. SEM image and EDS of spherical iron particle

Various metals (most notably iron and lead) were melted during the WTC Event, producing spherical metallic particles. Exposure of phases to high heat results in the formation of spherical particles due to surface tension. **Figure 21** and **Figure 22** show a spherical iron particle resulting from the melting of iron (or steel).

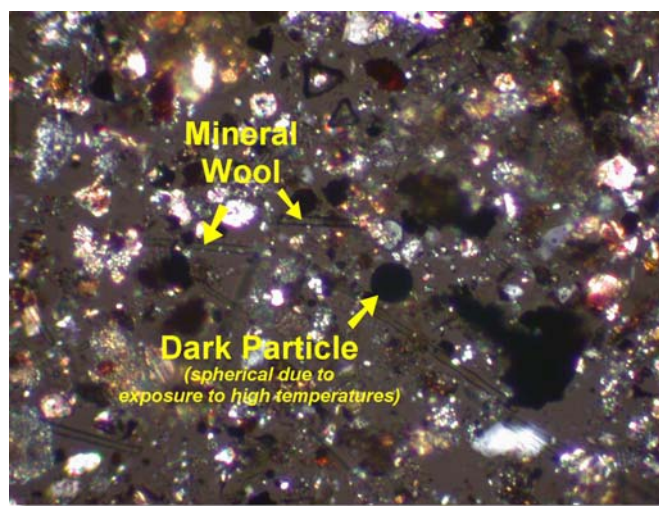
Figure 22. Optical microscopy image of a dark particle formed by high temperature.

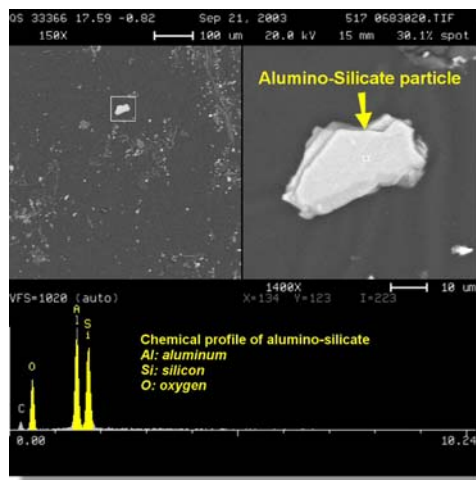
Figure 23. SEM image and EDS of alumino-silicate in Background Building

Silicates (abundant in building materials) can be melted producing spherical or vesicular silicate particles. **Figure 23** and **Figure 24** show the difference between an angular non-porous non-heat affected particle within a Background Building and a porous WTC Dust silicate heat-affected particle.

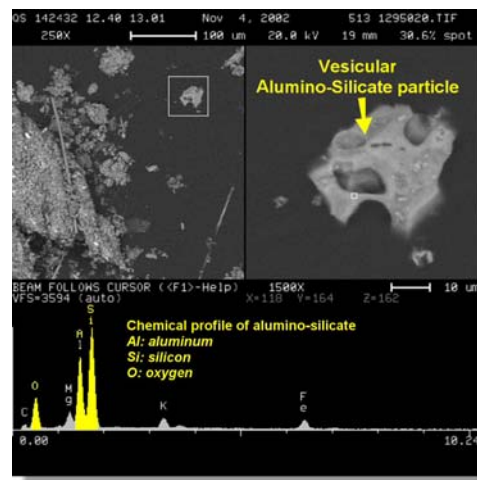
Figure 24. SEM image and EDS of vesicular alumino-silicate

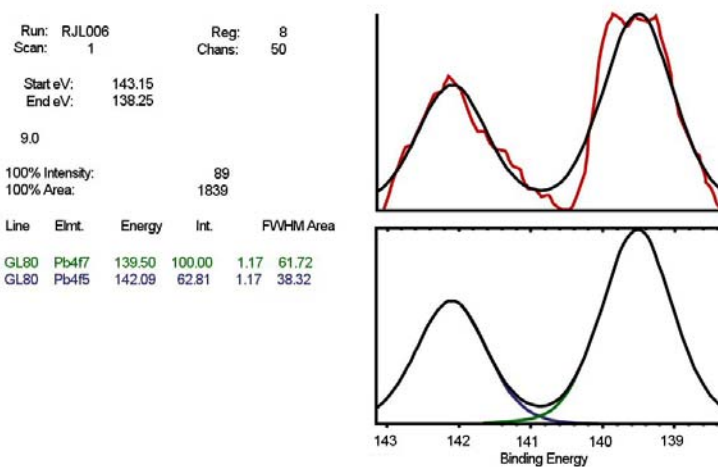
Figure 25. Lead peaks on mineral wool by high resolution XPS. The red trace represents the observed spectrum. The black trace represents the best fit derived from the observed spectrum.

The XPS results indicate the presence of a thin contaminating film or coating associated with the surface of particles. These surface species could be a significant factor affecting the toxicity of the WTC Dust if the coatings on particles and fibers are composed of hazardous substances. The coatings vary in thickness from nanometers (monolayer) to finely dispersed sub-micron particles. The particles and coatings have been detected by low accelerating voltage back-scattered electron imaging, X-ray microprobe analysis, and high resolution XPS. For example, lead peaks from the surface of mineral wool were identified by XPS. The high-resolution, narrow-range XPS scan (**Figure 25**) led to the identification of two lead peaks representing lead oxide or lead sulfate. The presence of lead oxides on the surface of mineral wool indicates the exposure of high temperatures at which lead would have undergone vaporization, oxidation, and condensation on the surface of mineral wool. In addition to the trace amounts of lead, **Table 2** indicates the presence of carbon, nitrogen, oxygen, sodium, silicon, sulfur, chlorine and calcium on the surface of the mineral wool.

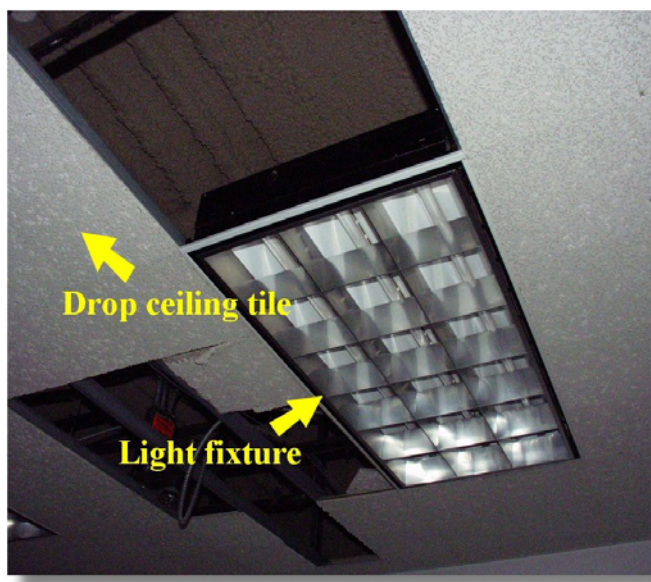
Figure 26. Typical drop ceiling light used for above-ceiling samples

Upon arrival in the predetermined grid location, a below-ceiling undisturbed area was selected. The sampling areas included, for example, file cabinets, tables or credenzas. In the same vicinity of the below-ceiling sample, an above-ceiling sampling area was selected. These areas were often the tops of drop ceiling lights (**Figure 26**).

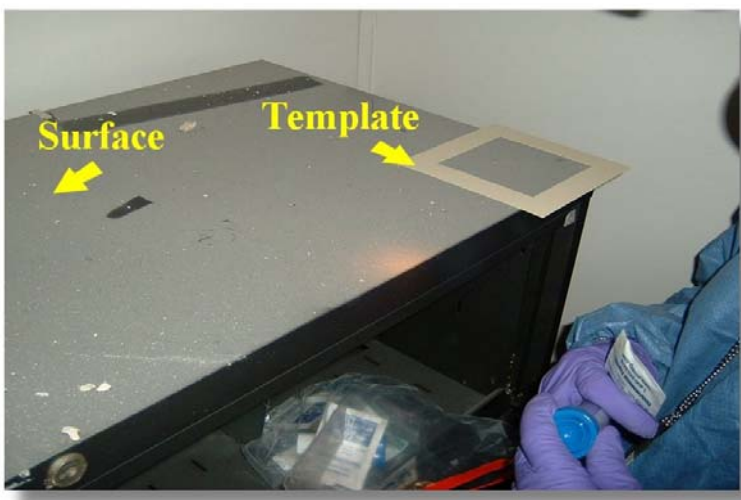
**Figure 27.** Below-ceiling sampling surface and template

In order to sample a finite area, a disposable template (usually 100 cm<sup>2</sup>) was utilized (**Figure 27**). The actual area sampled was documented for each wipe and microvac sample collected.

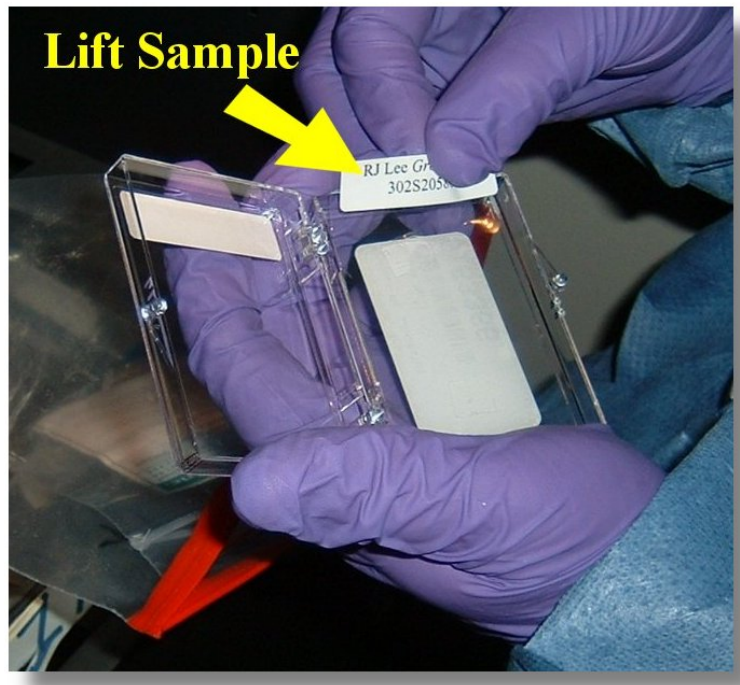
Figure 28. Lift sampling media

Dust characterization samples were collected using adhesive “lift” samples. A lift sample is a plastic strip with an adhesive coating on one side as shown in **Figure 28**.

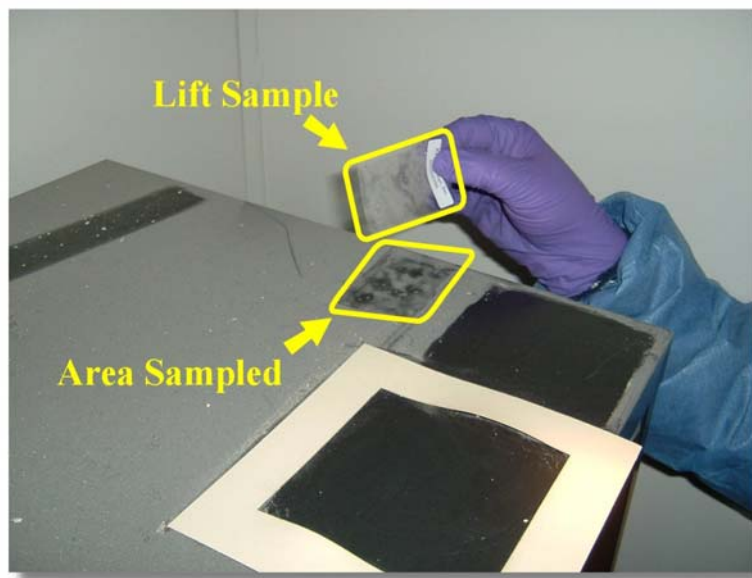
**Figure 29.** Dust adhered to lift sampling media

The lift was placed on the surface to be sampled, adhesive side down. Using finger pressure, the lift was pressed onto the surface, allowing dust to adhere to the lift (**Figure 29**). The lift was placed in a plastic box that was then put into a plastic bag.
