NIST NCSTAR 1-3

**Federal Building and Fire Safety Investigation of the
World Trade Center Disaster**

**Mechanical and Metallurgical
Analysis of Structural Steel**

September 2005

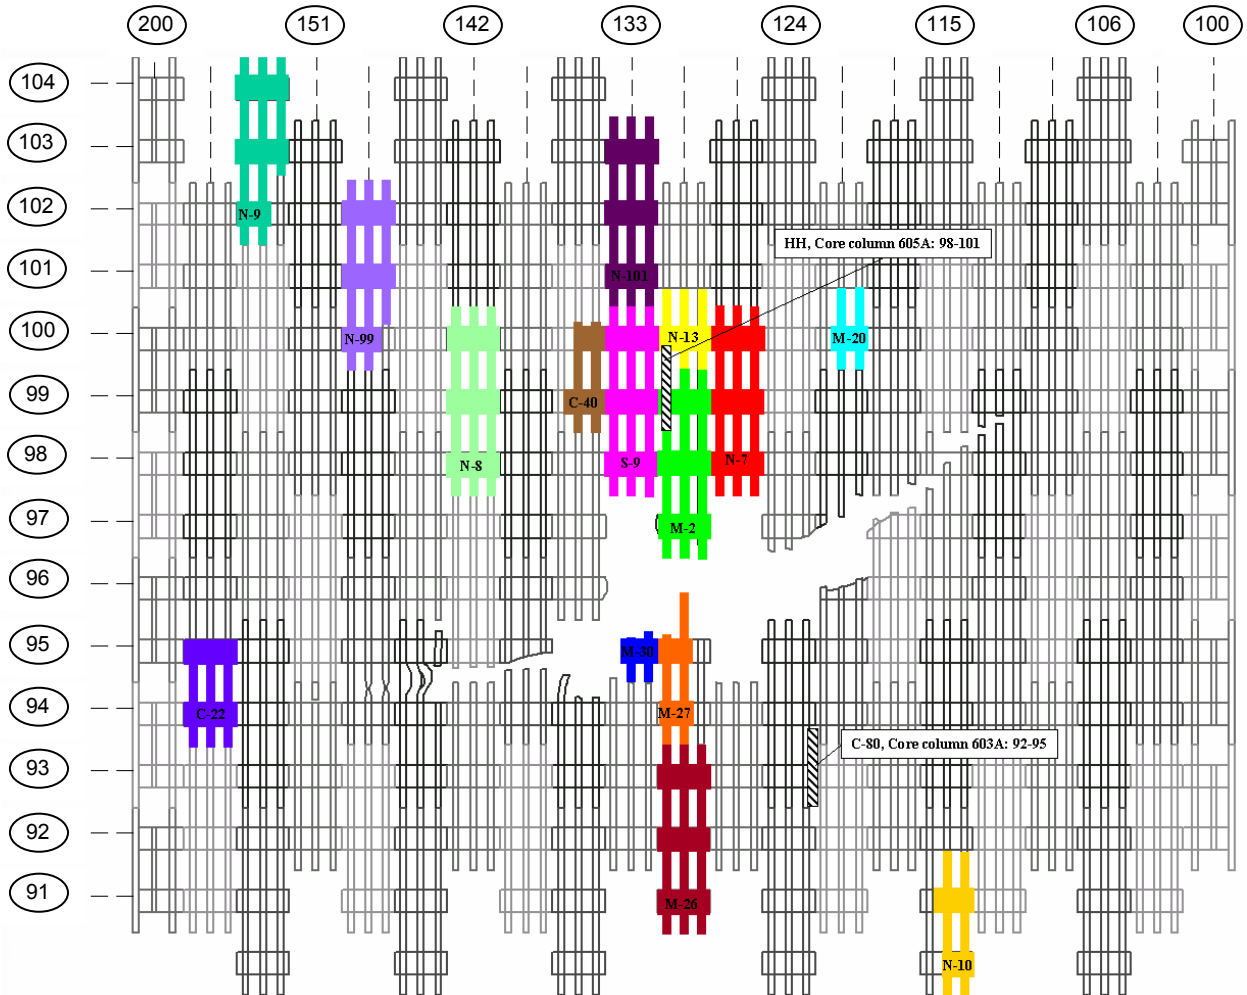
Photographic evidence indicated that damage to WTC 1 due to aircraft impact occurred from the 94th to 99th floors and was bounded by columns 111 through 152. For WTC 2, the impact area was lower, with damage found from the 77th to 85th floors. While the damage appeared to be bounded by column lines 411 and 440, the starboard wing of the aircraft may have struck columns even closer to the southeast corner of the building. This area was persistently obscured by smoke, however, and no clear images were available. From this information, NIST was able to determine which perimeter panels and core columns could be used to comment on damage (physical and fire) and possible failure mechanisms in this area. Fig. 5–5a shows an overlay of the recovered exterior panels in and around the impact zone of WTC 1. Samples C-80 and HH, both core columns, were also identified as residing near the impact zone. The recovered portion of each column is approximately represented in this image. No similar impacted exterior panels were recovered for WTC 2; however, two core columns were recovered, Fig. 5–5b.

Figure 5–5a. Interpreted column damage, from photographic evidence, to north face of WTC 1, with overlay of recovered steel identified by NIST. Colored regions represent recovered portions. Both core columns (#603 and #605) are in the second row from the north face of WTC 1.

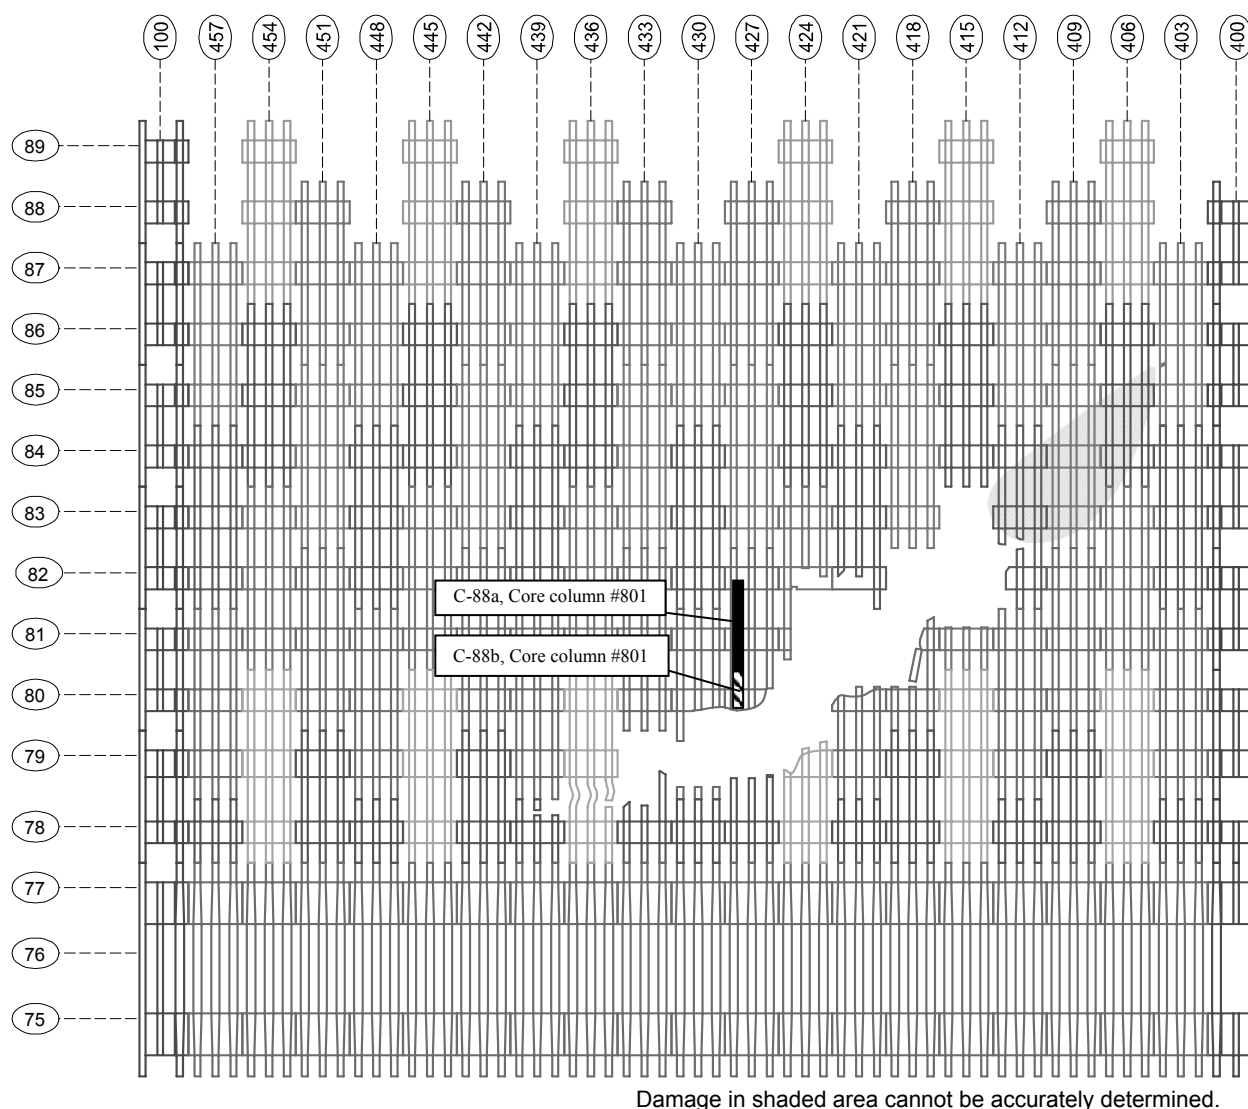
Figure 5-5b. Interpreted column damage, from photographic evidence, to south face of WTC 2, with overlay of recovered steel identified by NIST. Samples shown represent recovered portions. Core column line 801 is in the row closest to the south face of WTC 2.

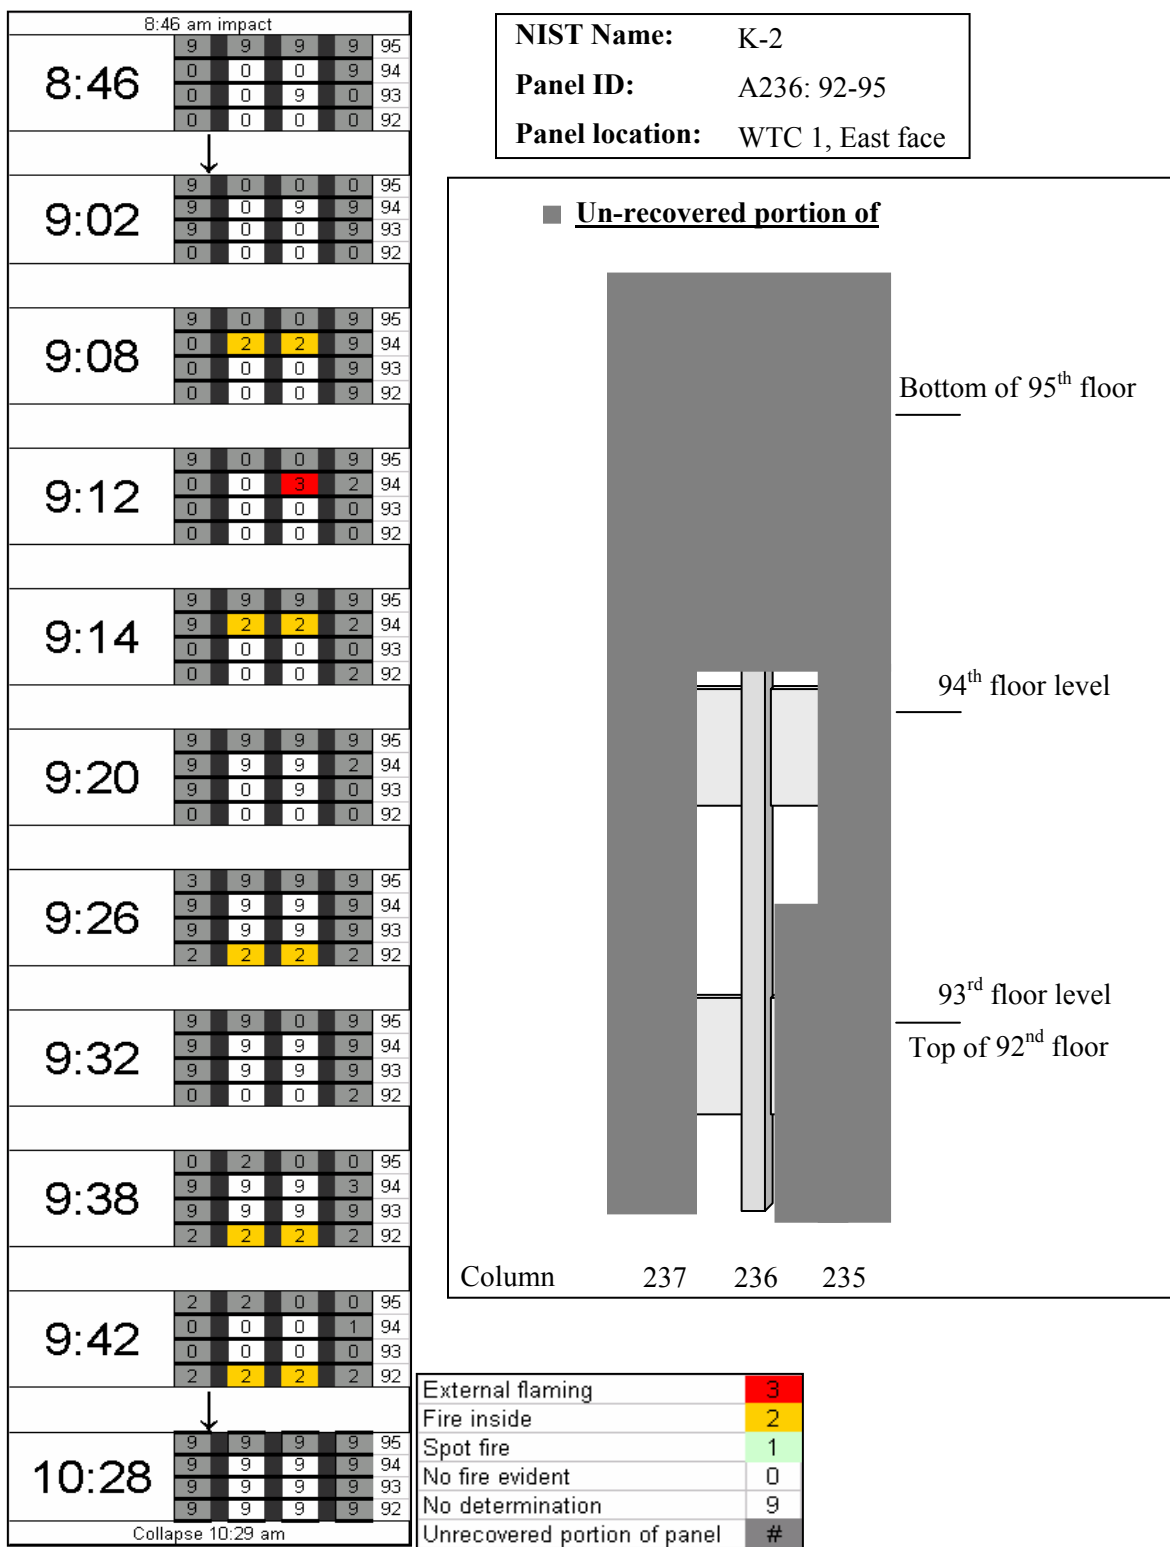
Figure 6–13. Time-fire exposure map for panel K-2 (A236: 92-95). Fire can be observed on the 92nd and 94th floors of the panel.

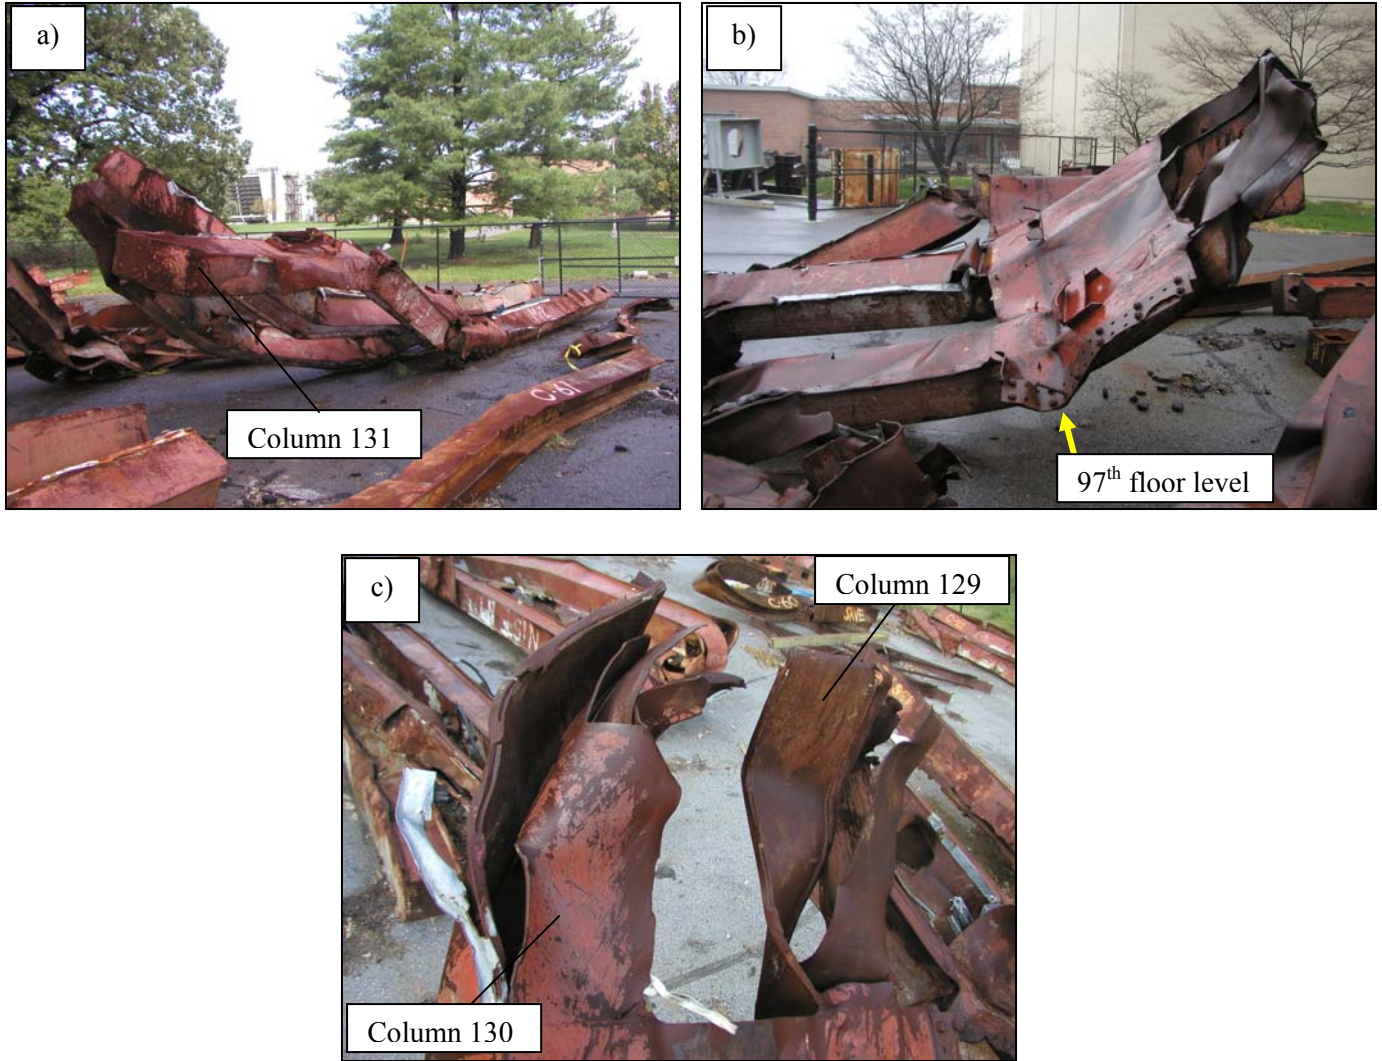
Panel M-2 (WTC 1, column line 130, floors 96 to 99) was struck by the upper part of the airplane's fuselage and the vertical stabilizer of its tail. In the photographic images (Fig. 6-1 [top]), the condition of the panel appeared remarkably similar to its as-recovered condition, Fig. 6-22a. The damage observed on the recovered panel was largely a result of the impact. The lower part of all three columns was bent into the building with the 97th floor concrete slab acting as a fulcrum point, Fig. 6-22b. Also, the lower end plates of columns 129 and 130 were ripped off with column plate fracture occurring near welds with the butt plates, Fig. 6-22c. This gave the columns a "splayed" appearance. The end plate for column 131 was still intact, and the lower portion of the column was relatively undeformed. In the pre-collapse images, the lower portion of this column is also bent inward just below the 97th floor spandrel; however, it was bent back out sometime during or after the collapse.

Figure 6–22. a) Overall view of panel M-2 (A130: 94-97). Bottom of panel is on the left-hand side of the picture and the outside of the panel is facing down, b) major bend in panel located at the 97th floor level, and c) splayed bottoms of columns 129 and 130.

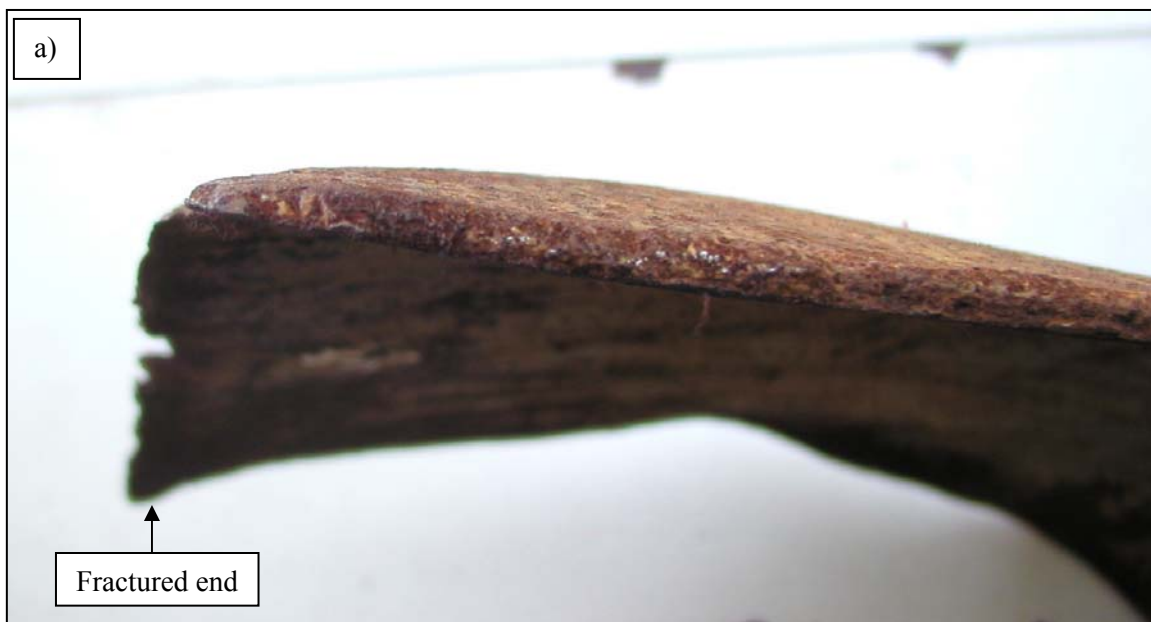
Damage to the lower portion of panel M-2 (WTC 1, column line 130, floors 96 to 99) was clearly associated with impact, which led to the missing endplates for columns 129 and 130. The inner and outer web plates of both columns have thinned in this area due to plastic deformation, Fig. 6-23a. The fracturing of the plates propagated as a 45 degree slant crack, oscillating between positive and negative 45 degrees with respect to the normal of the plate. The necking (thinning) of the outer web plate, plotted in Fig. 6-23b, indicates significant ductility, even at the high-strain rates associated with impact. Large buckles were observed on both flanges for columns 129 and 130 with some splitting occurring in the base material of the flanges (Figs. 6-24a and 6-24b) and spandrels (Fig. 6-24c). However, the welds found near this bending point remained intact (Fig. 6-24d).

Figure 6–23. Thinning of outer web from column 130 of panel M-2 (A130: 96-99).
a) Photograph showing thinning, b) graph indicating plate thinning near fracture surface.

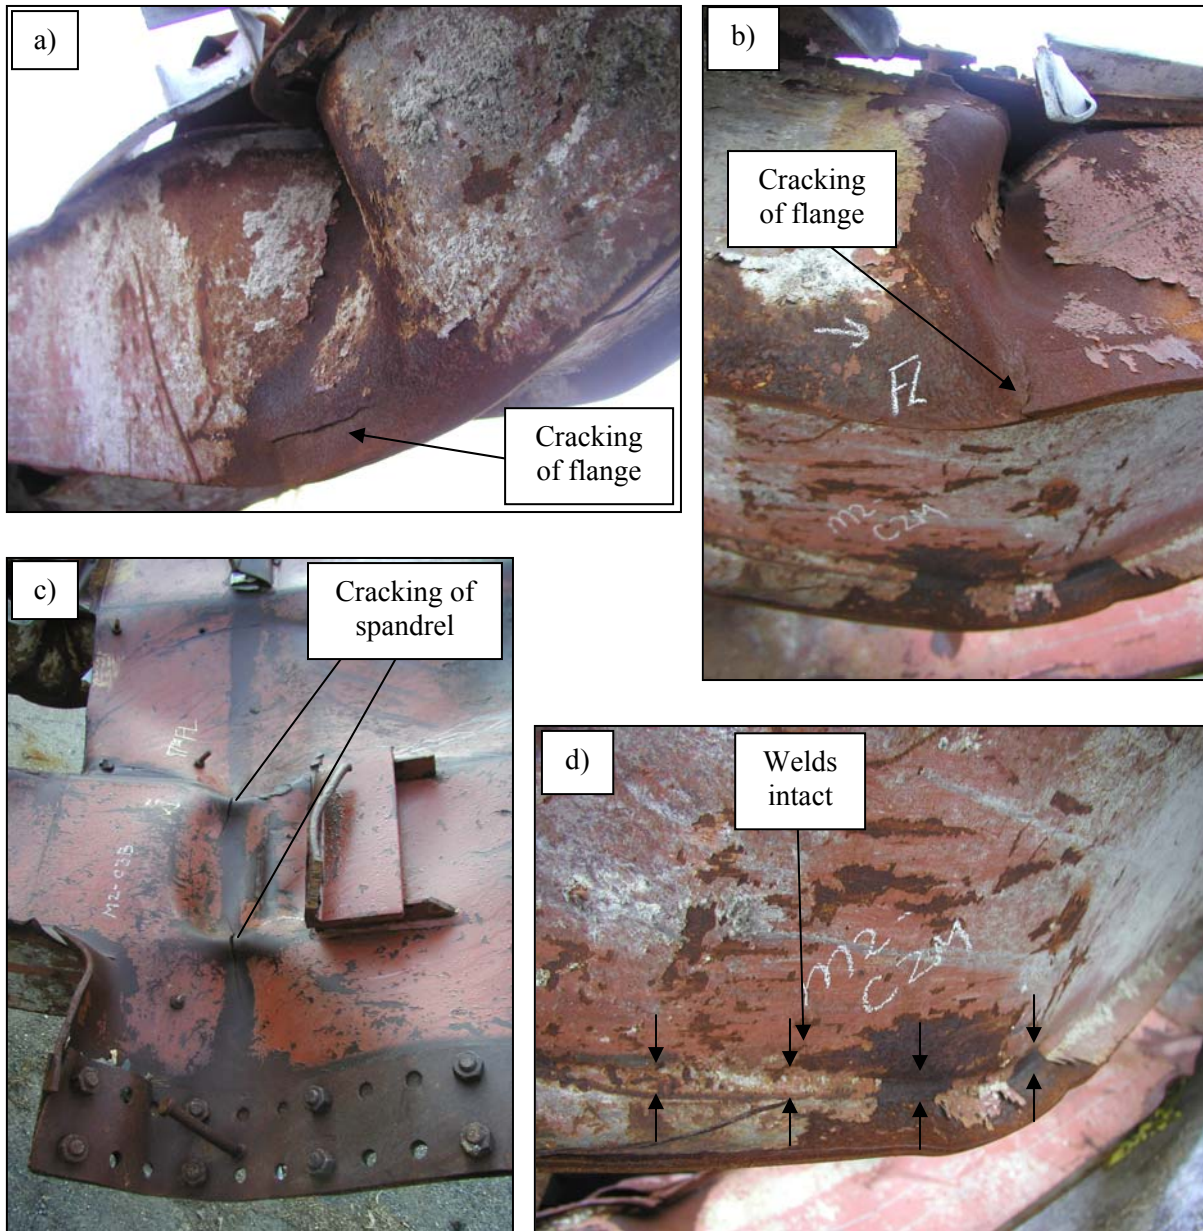
Figure 6-24. Damage images from sample M-2 (A130: 96-99). a) Large buckles observed on the flange plates of column 130, b) cracking of the flange plates on column 130, c) cracking of spandrel at 97th floor level, and d) no cracking of the welds in this area on column 130.

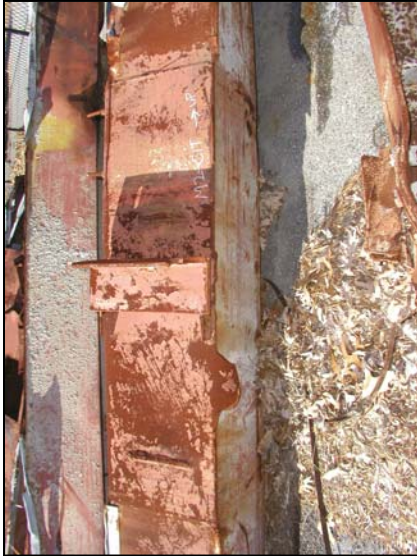
M2-C1T

Column 131, 99th floor

Failure mode: Type 4a, fracture of spandrel

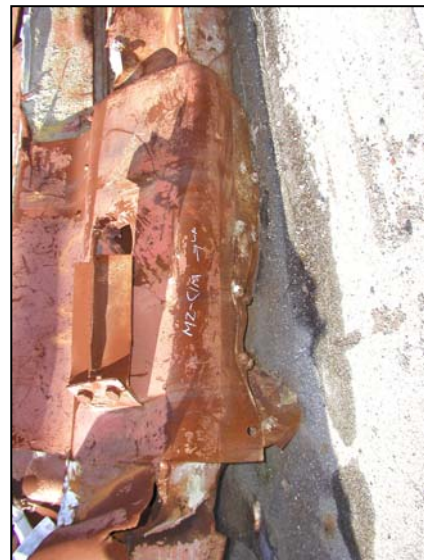
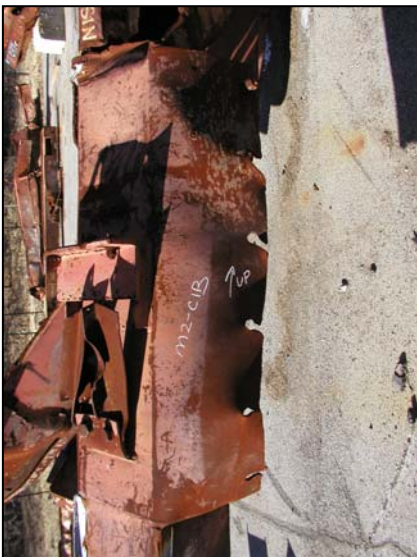
M2-C1B

Failure mode: Type 3, mixed mode of fracture and bolt hole tear out, portion of spandrel from S9-C3B still attached

Column 131, 97th floor

Failure mode: Type 1a, bolt hole tear out

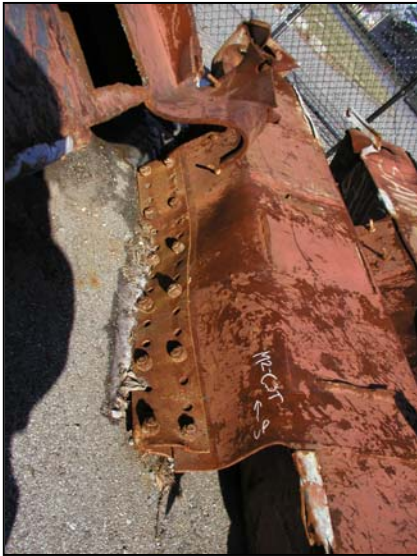
M2-C3T

Column 129, 99th floor

Failure mode: Type 1b, bolt hole tear out

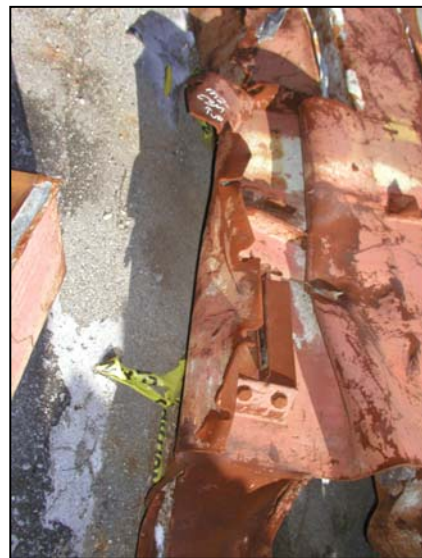
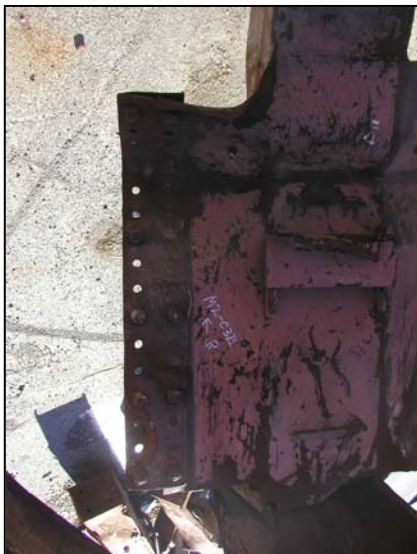
M2-C3B

Failure mode: Type 1a, bolt hole tear out

Column 129, 97th floor

Failure mode: Type 1b, bolt hole tear out

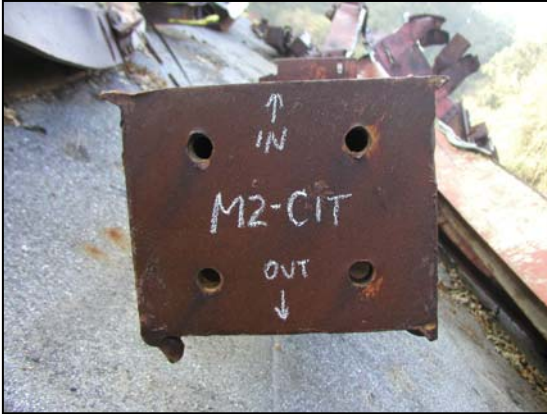
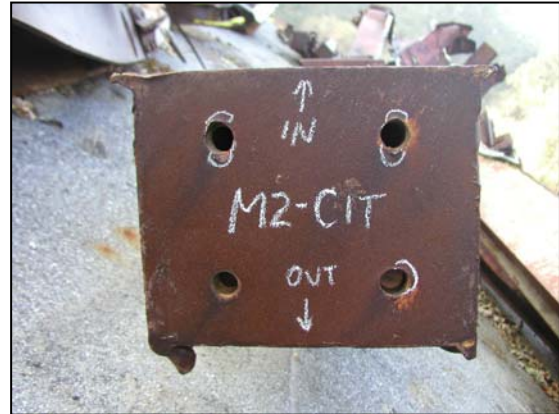
M2-C1T
WTC1
Col 131
F1 99

Figure 6–26. Photographs of recovered end plate connections from sample M-2 (A127: 97-100). Both ends of column 131 had bolt failure that resulted in deformation of the bolt holes in the end plates.

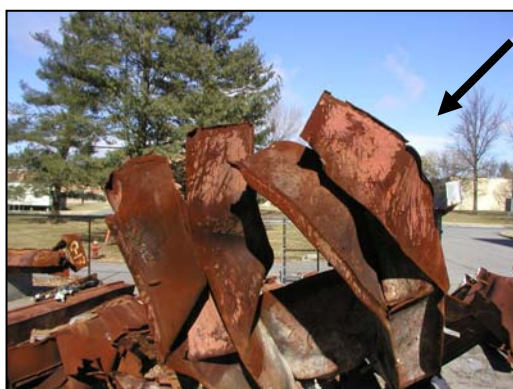
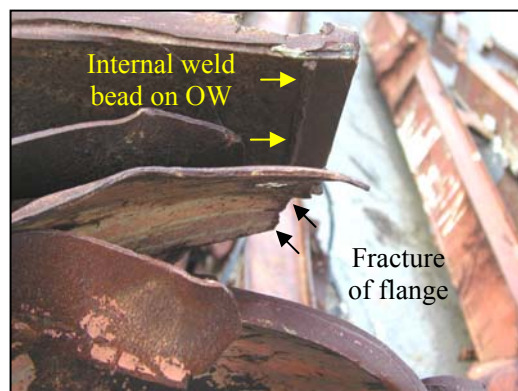
M2-C2B

The state of the recovered bottom portion of columns 129 and 130 was nearly identical to the condition after the impact for panel M-2 (A130: 96-99). Both end plates were ripped completely out of the column, Fig. 6–26. Failure was a mixture of fracture in the base plates (portion of the flange/web still attached to the end plate) and clean separation of the end plate from the flange/web (complete flange/web recovered with internal weld bead visible). Bolt hole deformation for column 131 indicated that the connection was broken by bending inward of the lower column of the connection. Finally, while bolt failure was observed at the 99th floor splice of column 129, it can be noted that some separation existed between the flange plates of the column and the endplate.

Figure 6–26. Photographs of recovered end plate connections from sample M-2 (A127: 97-100). The upper end plate experienced bolt hole failure. The bottom end plate of column 130 was ripped out upon impact of the airplane. Failure was found to be a mixture of fracture in the base plates (portion of the flange/web still attached to the end plate) and clean separation of the end plate from the flange/web (complete flange/web recovered with internal weld bead visible) (continued).

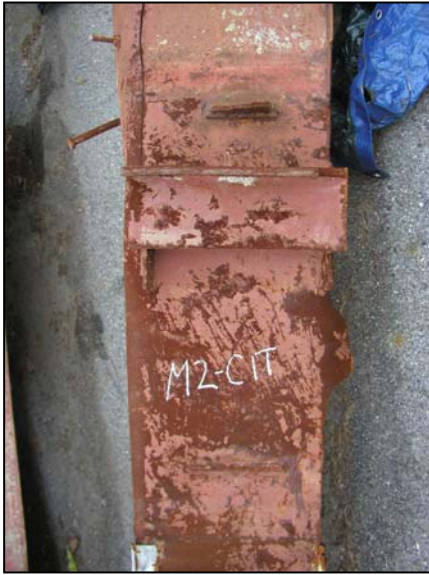
M2-C1T (Co 131, FI 99)

1 standoff plate remains, seat and other standoff plate ripped off at welds;

Gusset plate with damper unit intact, bent up.

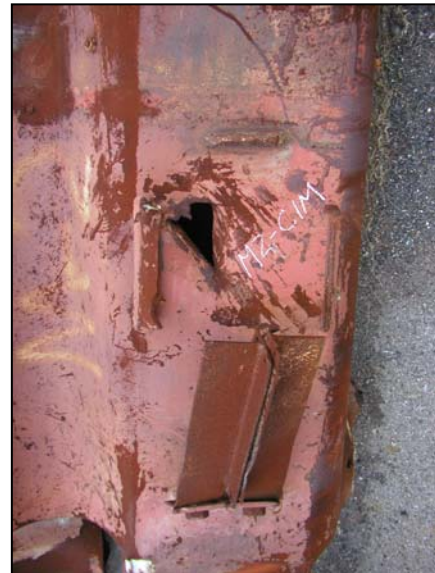
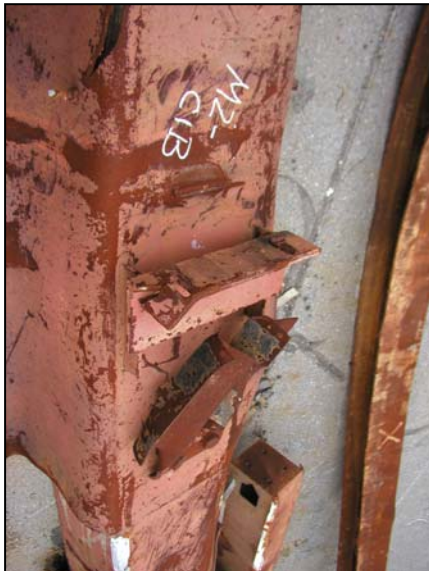
M2-C1B (Co 131, FI 97)

Panel M-2 (A130: 96-99), Fig. 6-27, is shown as an example of perimeter wall truss connections. Of the six truss seats on the panel, four were damaged but intact (e.g., bending up/down, bolt hole failure), and the other two were completely ripped off of the column. The center column of this panel also had three gusset plates, used to anchor diagonal bracing straps to provide horizontal shear transfer between the floor slab and exterior wall, as well as out-of-plane bracing for the perimeter columns not directly supporting the floor trusses. Only portions of the gusset plates remained on the middle column of the panel with the diagonal bracing straps ripped from these plates.

Figure 6–27. Floor truss connectors for panel M-2 (A130: 96-99).

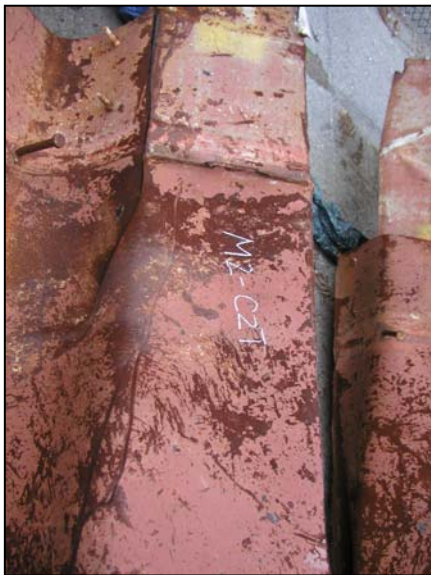
M2-C2T (Co 130, Fl 99)

Portion of tab plate remains, bent up.

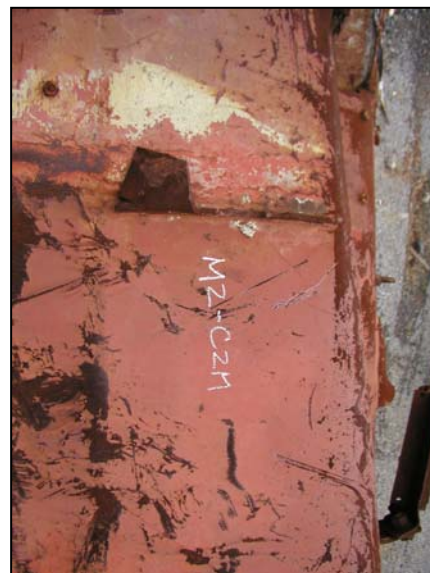
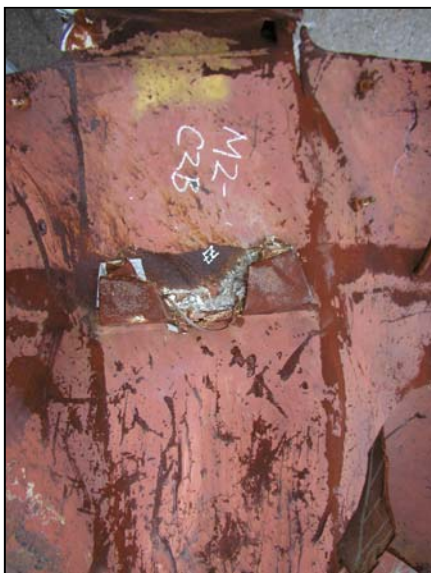
M2-C2B (Co 130, 97)

Figure 6–27. Floor truss connectors for panel M-2 (A130: 96-99) (continued).

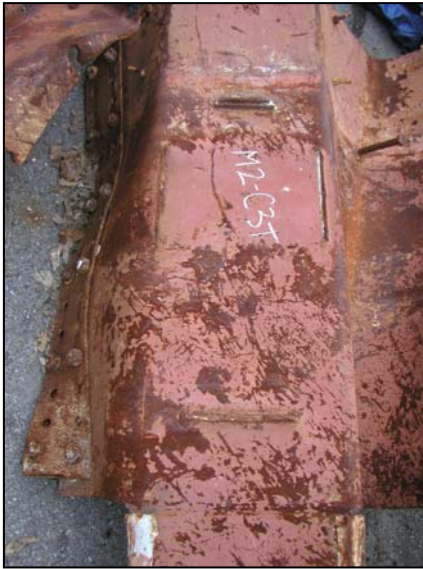
M2-C3T (Co 129, Fl 99)

Tab plate remains;

Seat intact, bent down, 1 bolt hole remains intact with bolt, other ripped out;

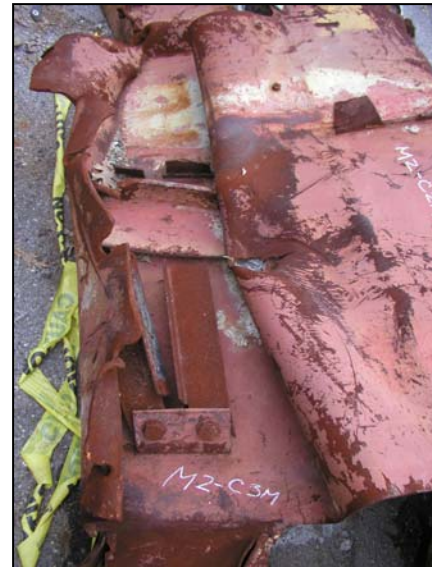
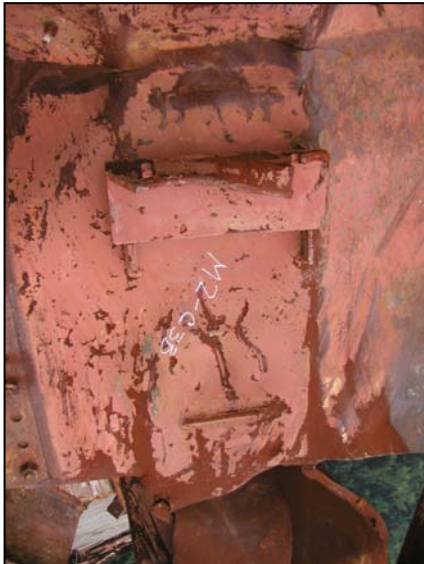
M2-C3B (Co 129, Fl 97)

Figure 6–27. Floor truss connectors for panel M-2 (A130: 96-99) (continued).

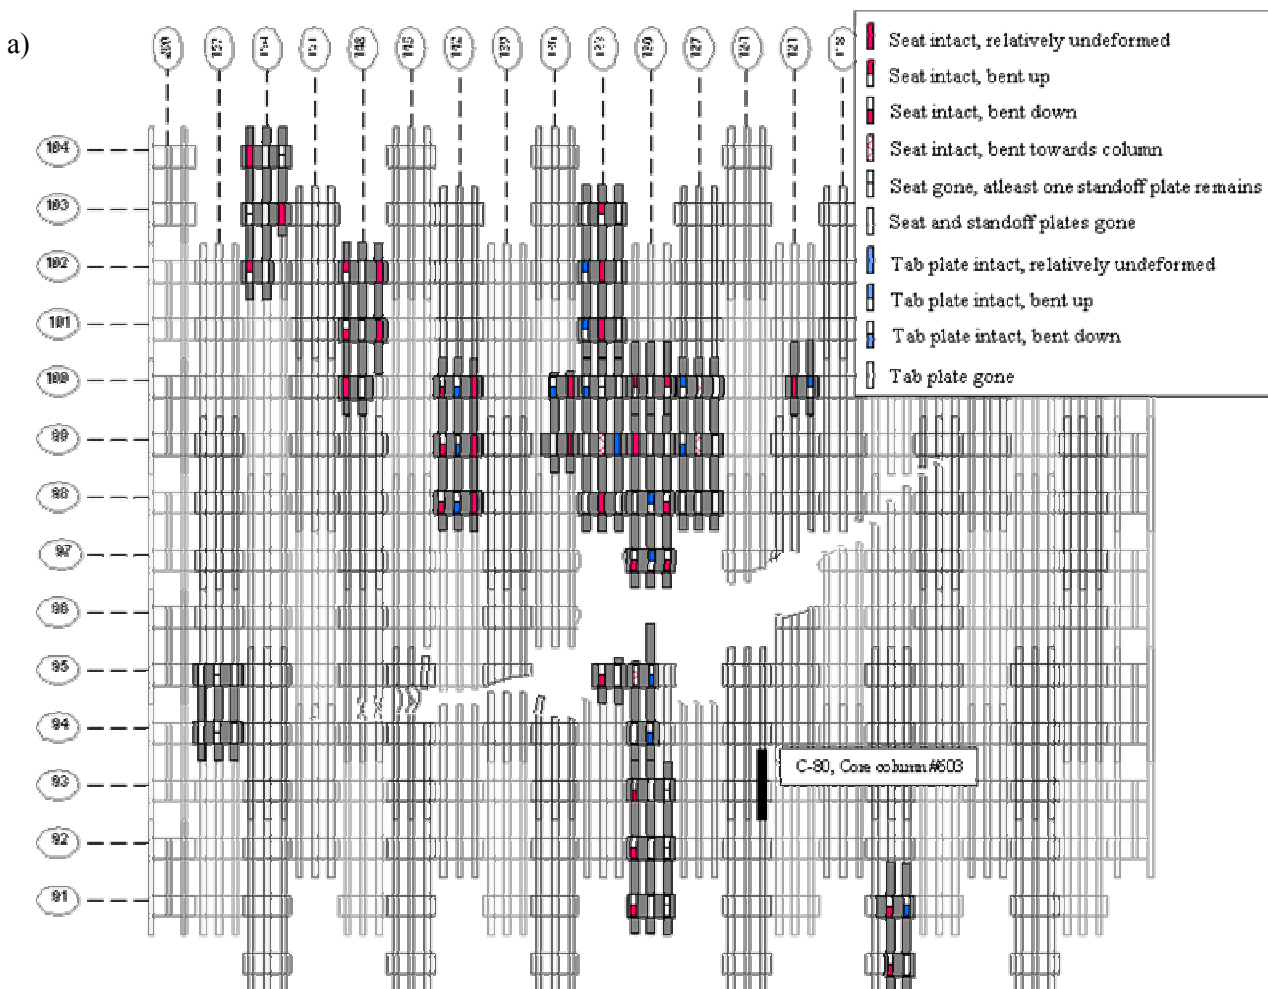
The most significant observations were made when the panels were categorized by their as-built elevation within the building, Fig. 6-28. Of the 28 floor truss connectors at or below the impact floors for WTC 1, 93 percent were either missing or bent downwards. Only 37 percent of the 38 floor truss connectors above the impact floors had similar characteristics. Comparable results were found for WTC 2 where 88 percent of the floor truss connectors below the impact floors were bent down or missing, while only 55 percent of the floor truss connectors above this region had such damage characteristics. This occurrence was most likely a result of the overloading of the lower floors (“pancaking” mechanism) during collapse of the building.

Figure 6-28a. Damage diagram overlaid with recovered samples and damage of connectors.

Figure 6–28b. Damage of connectors. At or below the 95th floor, all connectors are either bent down or missing.

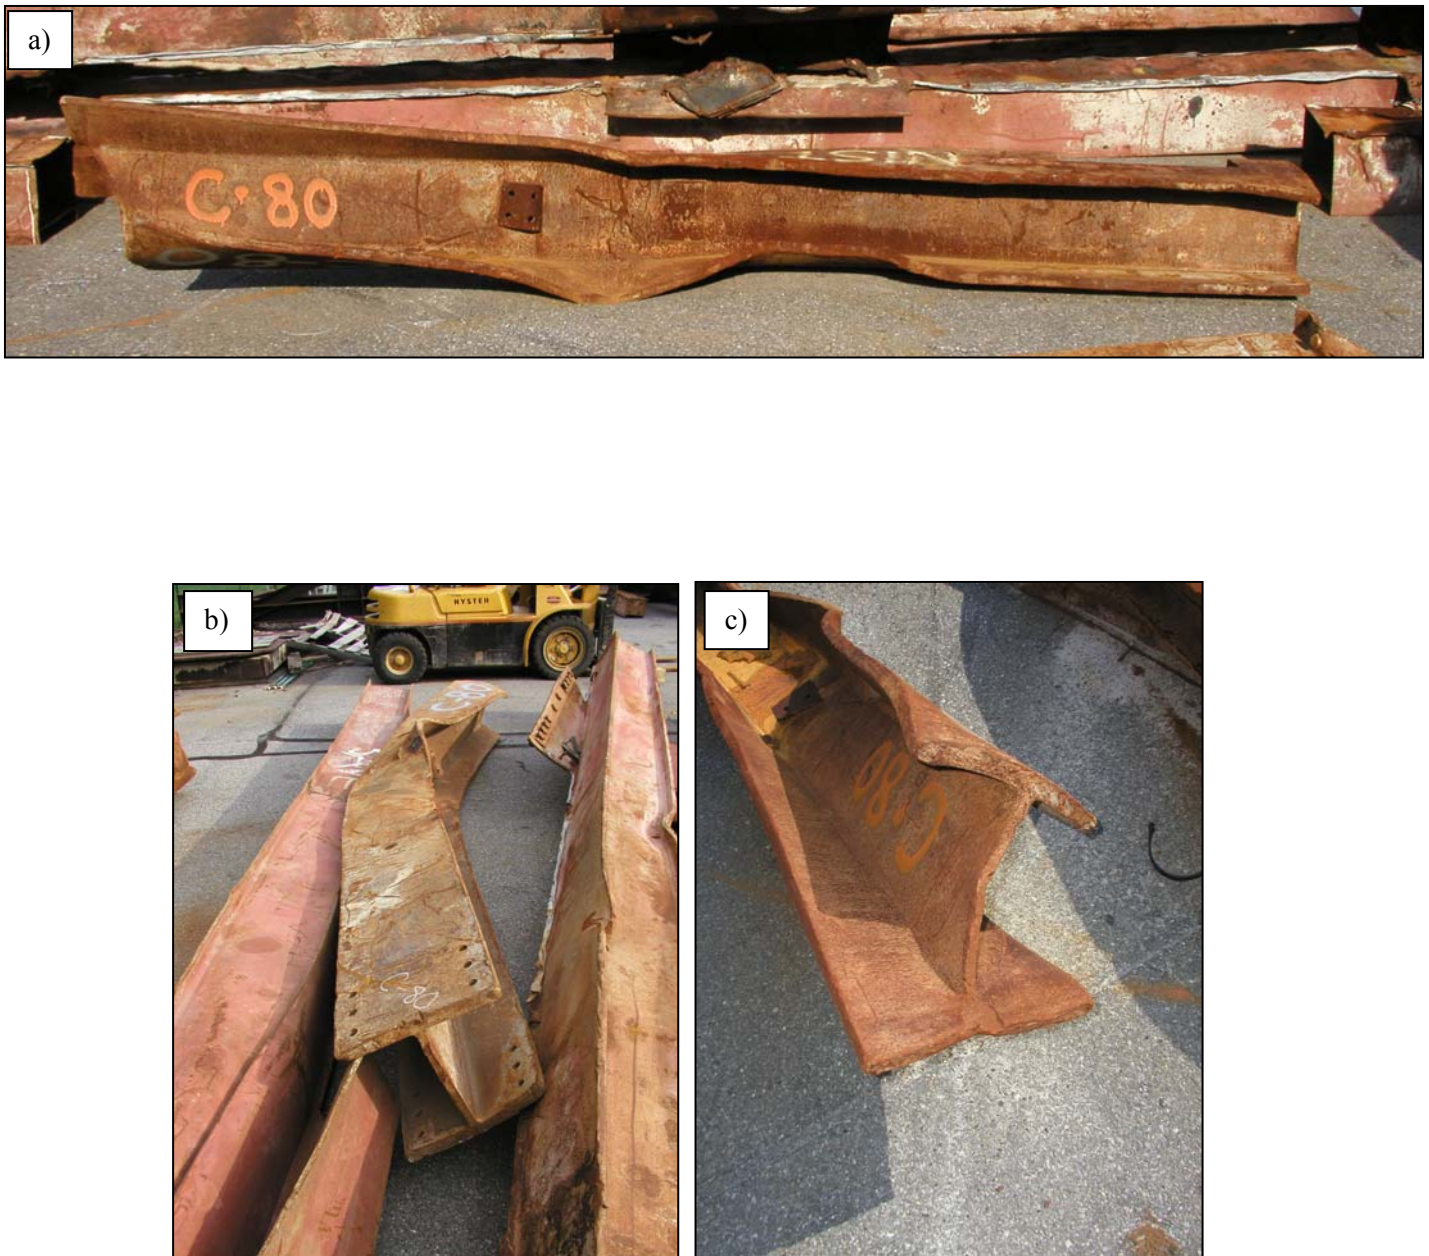
Sample C-80 (Fig. 6-30a), from WTC 1, was a 36 ksi wide-flange located in the middle of the second row of core columns along the north face. Only the lower third of the column was recovered (approximately 13 ft). The location of the column indicated that it did not sustain impact damage. Consistent with the column's position, modeling results indicated that this column was not in the path of the aircraft debris (NIST NCSTAR 1-2). Different failure modes were observed for each end (Figs. 6-30b and 6-30c). Bolt fracture occurred at the lower portion of the column (92nd floor region), while the upper portion of the wide-flange was torn through its section (near the 93rd floor region). No visible necking (localized reduction in area) was observed in the immediate vicinity of the fracture.

Figure 6–30. Core column C-80 (603A: 92-95). a) Overall view of recovered column, b) view of connection in the 92nd floor region, failure as a result of bolt fracture, and c) torn end of column near the 94th floor region.

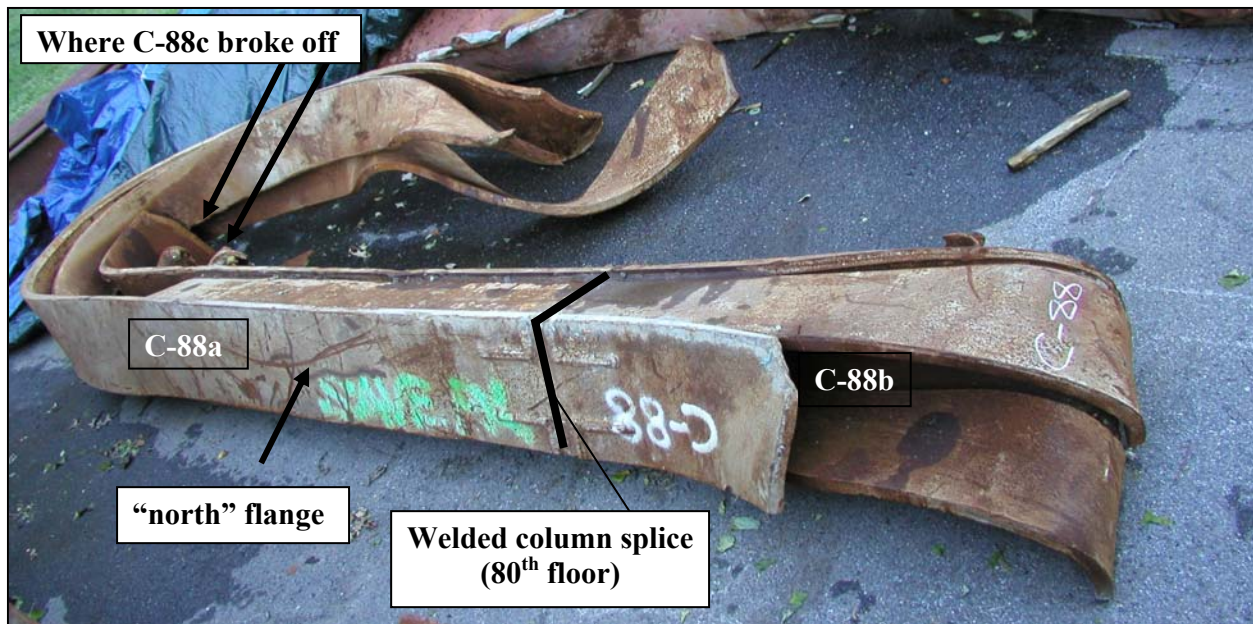
Core columns C-88a and C-88b, from WTC 2, were unique among the recovered core elements in that the columns were still connected at the welded column splice, Fig. 6–31. Both columns were 42 ksi built-up box columns with their shared splice in the 80th floor level. The lower 16 ft of C-88a was recovered (floors 80 through 82), whereas the upper 8 ft of C-88b was still attached (primarily within the 80th floor). The location of the column C-88b suggested that impact damage may have been sustained. Both webs and the “south” flange were severely bent to the east and had flame cut ends, Fig. 6–32. The bends occurred just below the connector for the channel associated with the 80th floor. The “north”

Figure 6–31. Overall view of recovered core columns C-88a (801B: 80-83) and C-88b (801B: 77-80).

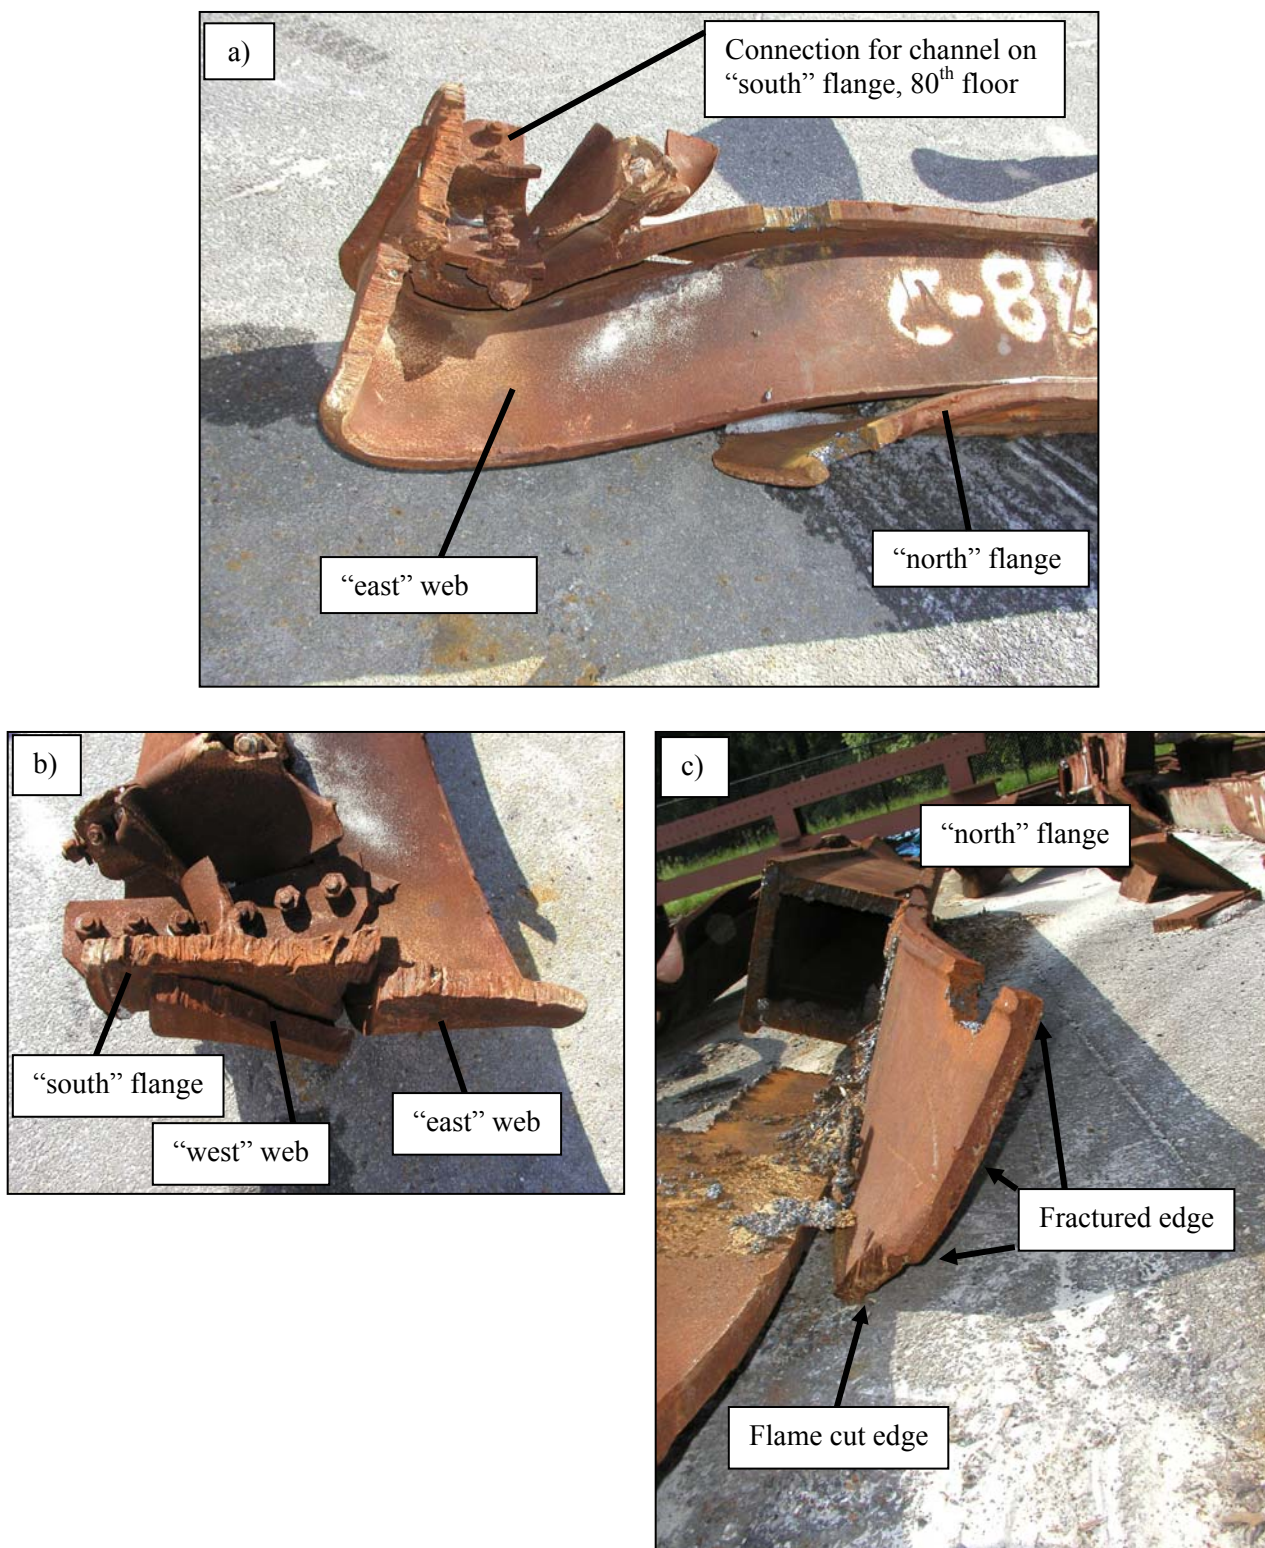
Figure 6–32. Damage associated with core column C-88b (801B: 77-80). a) Overall view of failed end, b) bottoms of "south" flange and both webs bent towards the east just below the 80th floor level, ends were flame cut, and c) "north" flange bent towards the north, majority of plate was fractured with some flame cutting.

flange had a less significant bend toward the north, with approximately 80 percent of the failed end of the plate as a fracture. There was no visible necking of the plate in the area of failure, with the remaining portion of the plate having been flame cut during the recovery effort. This flange was fractured roughly 2 ft below the splice in the 80th floor level. The fracture surfaces were too corroded for analysis. It was believed that the damage of the south flange and the two webs occurred during collapse of the building as the direction of bending was not consistent with the travel of the airplane. However, the damage to the north flange may have been a result of impact damage, as the severity and location of the plate failure was different from the other three plates of the column, and the direction of the bend was consistent with the travel of the airplane. The baseline analysis of the damage model indicated that this core column was not damaged as a result of the impact (NIST NCSTAR 1-2). However, another analysis with parameters set to increase the amount of damage indicated that impact damage was sustained. Core column C-88a did not sustain impact damage as (1) the damage (81st floor level) was above the floors of impact in this region (79th floor level), (2) the columns were bent downward indicating overloading of the column from above, and (3) the bending direction of the plates was opposite to the direction of the travel of the plane. This is also consistent with the modeling results (NIST NCSTAR 1-2).

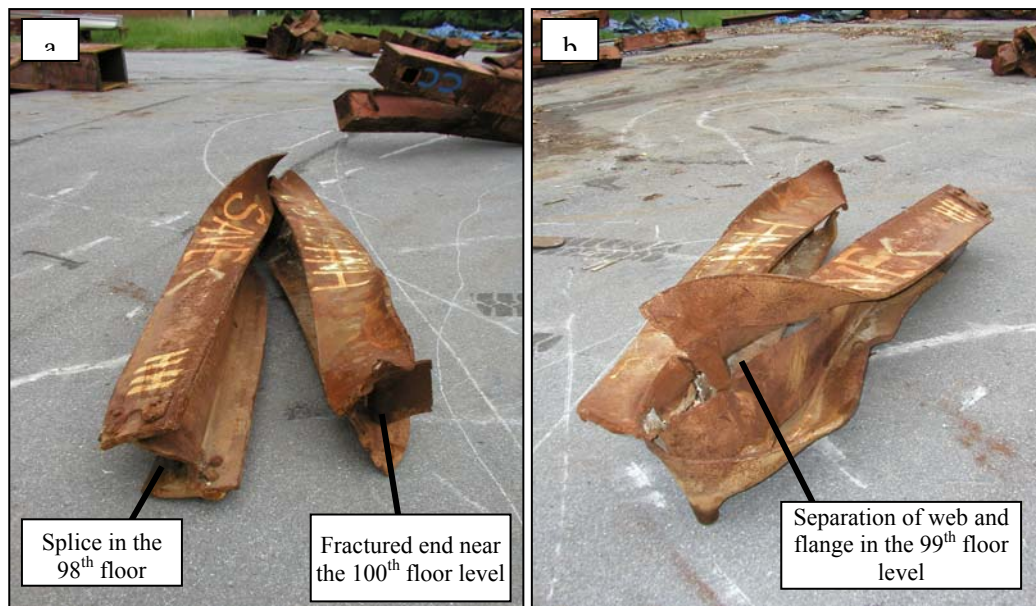
Aside from the three columns discussed above, only one other core column was recovered from within the fire region. Sample HH from WTC 1, Fig. 6–33, was a 42 ksi wide-flange positioned near the middle of the second row of core columns along the north face. The bottom half of the column was recovered (approximately 16 ft). The location of the column was such that damage could not have occurred during the impact. This was corroborated by the modeling results that indicated the core column was not hit during the impact (NIST NCSTAR 1-2). The failure mode of each end was different (Fig. 6–33a). Fracture of the plates used in the bolted connection occurred at the lower portion of the column (98th floor region), while the upper portion was torn through the material (100th floor region). Additionally, the sample was nearly bent in half (99th floor region), with complete fracture of one flange. Figure 6–33b shows that the flanges have become separated from the web in the region of the bend.

Figure 6–33. Core column HH (605A: 98-101). a) Fracture at both ends and b) separation between flange and web in the 99th floor region.
