NIST NCSTAR 1-3

**Federal Building and Fire Safety Investigation of the
World Trade Center Disaster**

**Mechanical and Metallurgical
Analysis of Structural Steel**

September 2005

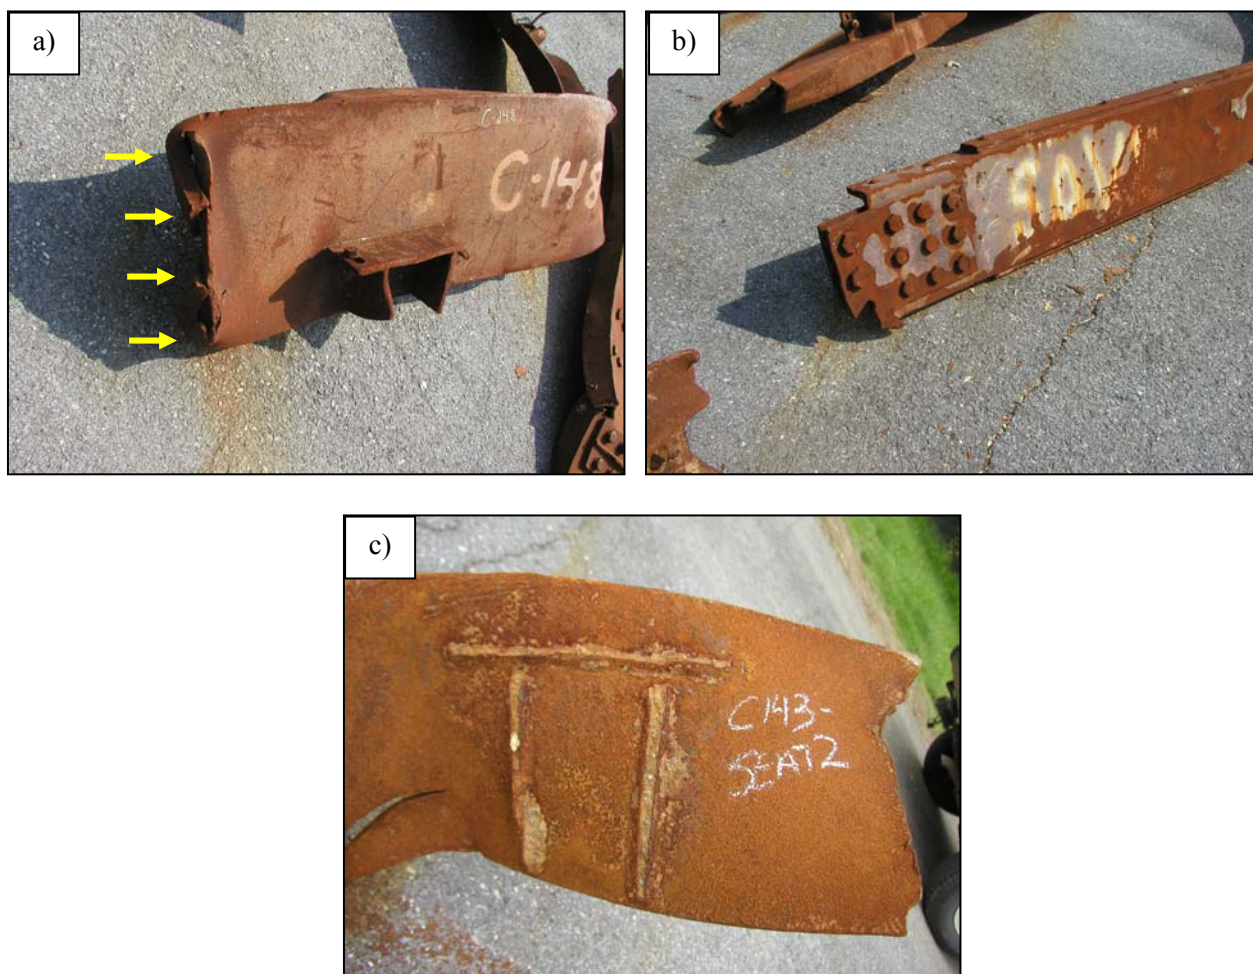
An analysis was conducted to evaluate the failure modes of the recovered channel material and the condition of the core truss seats. Of the 24 channels used to support the floor trusses, half failed at both ends within the channel itself, Fig. 6–34a, while the others failed at one or both of the end connectors, Fig. 6–34b. Twenty-one pieces of channel had seats or remnants of seats attached. Over 90 percent of the seats (31 total) were still intact with the majority of these somewhat deformed. Only two seats had been ripped completely from the channel at the welded joint between the seat and the channel, as shown in Fig. 6–34c. Half of the retained seats were observed to have both bolt holes still intact, while the other half had at least one bolt hole ripped out.

Figure 6–34. Failure modes of core channels. a) Fracture through channel as indicated by arrows, b) failure associated with end connector, and c) seat ripped off at welded connection to channel.

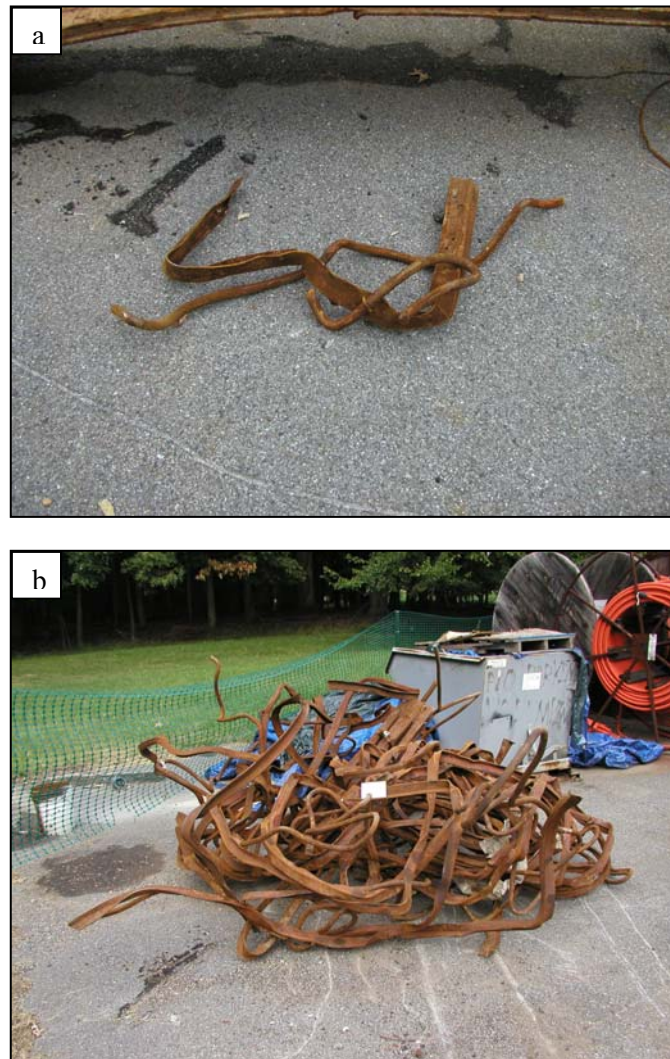
Samples received at NIST were either small sections (less than 3 ft to 4 ft in length) of chord and rod material (Fig. 6–35a) or large, entangled masses in the form seen in Fig. 6–35b. According to Structural Engineers Association of New York (SEAoNY) volunteer members involved in the recovery effort, it was necessary to “ball up” any truss pieces of significant size to facilitate removal from the WTC site and subsequent handling in the recovery yards. This was necessary since the primary and bridging trusses for a given floor were welded together into huge grids. During the collapse, these lightweight floor sections were severely damaged and could not be easily removed. Thus, it is unknown when specific damage features occurred. Further, it is likely that sections of multiple trusses were “balled” together and labeled as a single unit rather than that NIST labeled samples consisting of just one pre-fabricated truss unit.

Figure 6–35. Examples of recovered floor truss material. a) Small sections of rod and chord (sample C-53) and b) “balled-up” sections of rod and chord (C-137f).

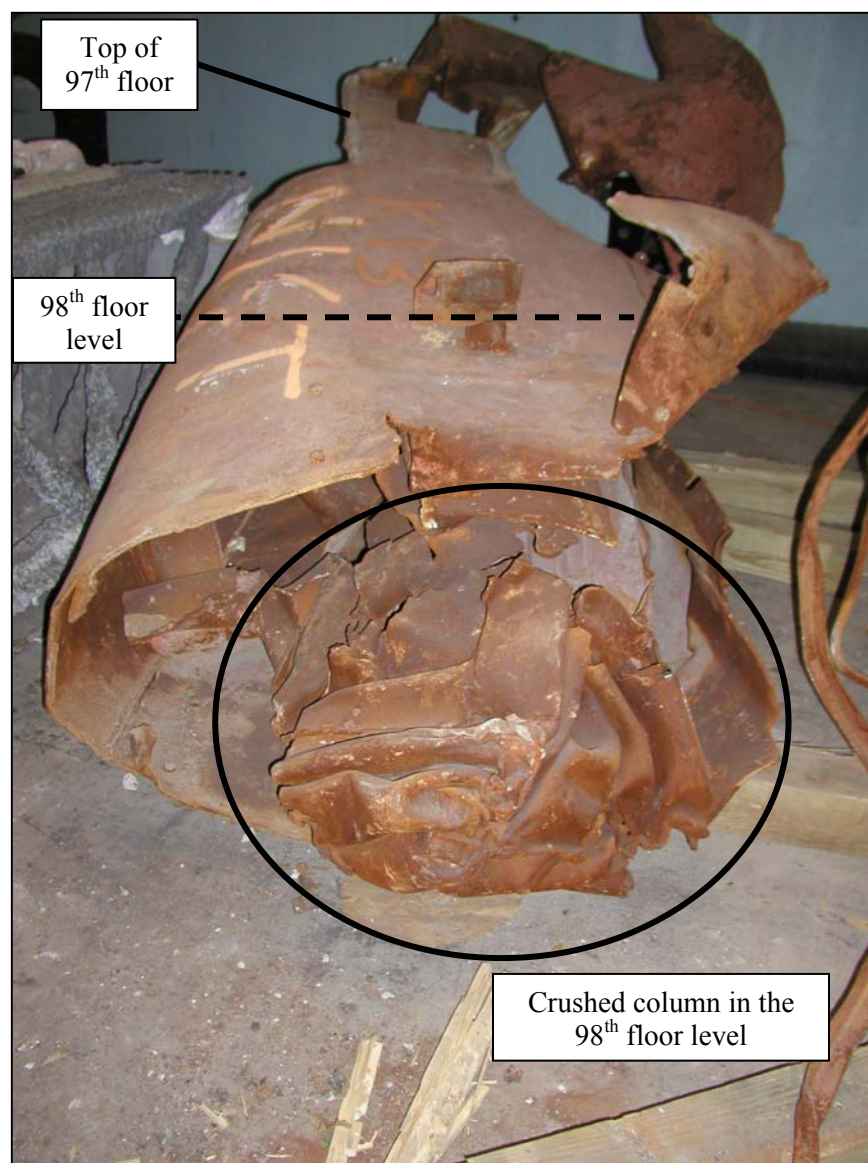
1. Panel K-1, WTC 1, column 210, flange and inner web of 98th floor region. Prior to the collapse of WTC 1, the panel was observed to have experienced varying degrees of fire exposure for a minimum of 31 cumulative minutes in this area. A unique feature of this panel is that the upper portion of the column was crushed while generally maintaining concentric axial alignment with the lower portion of the column, Fig. 6–36. This suggests that deformation occurred at the onset of collapse, while the lower portion of the column was still constrained due to the bolted splice (endplates).

Figure 6–36. Crushed portion of column 210 in the area of the 98th floor (from sample K-1, A209: 97-100). Paint had mud cracking characteristic in this region.

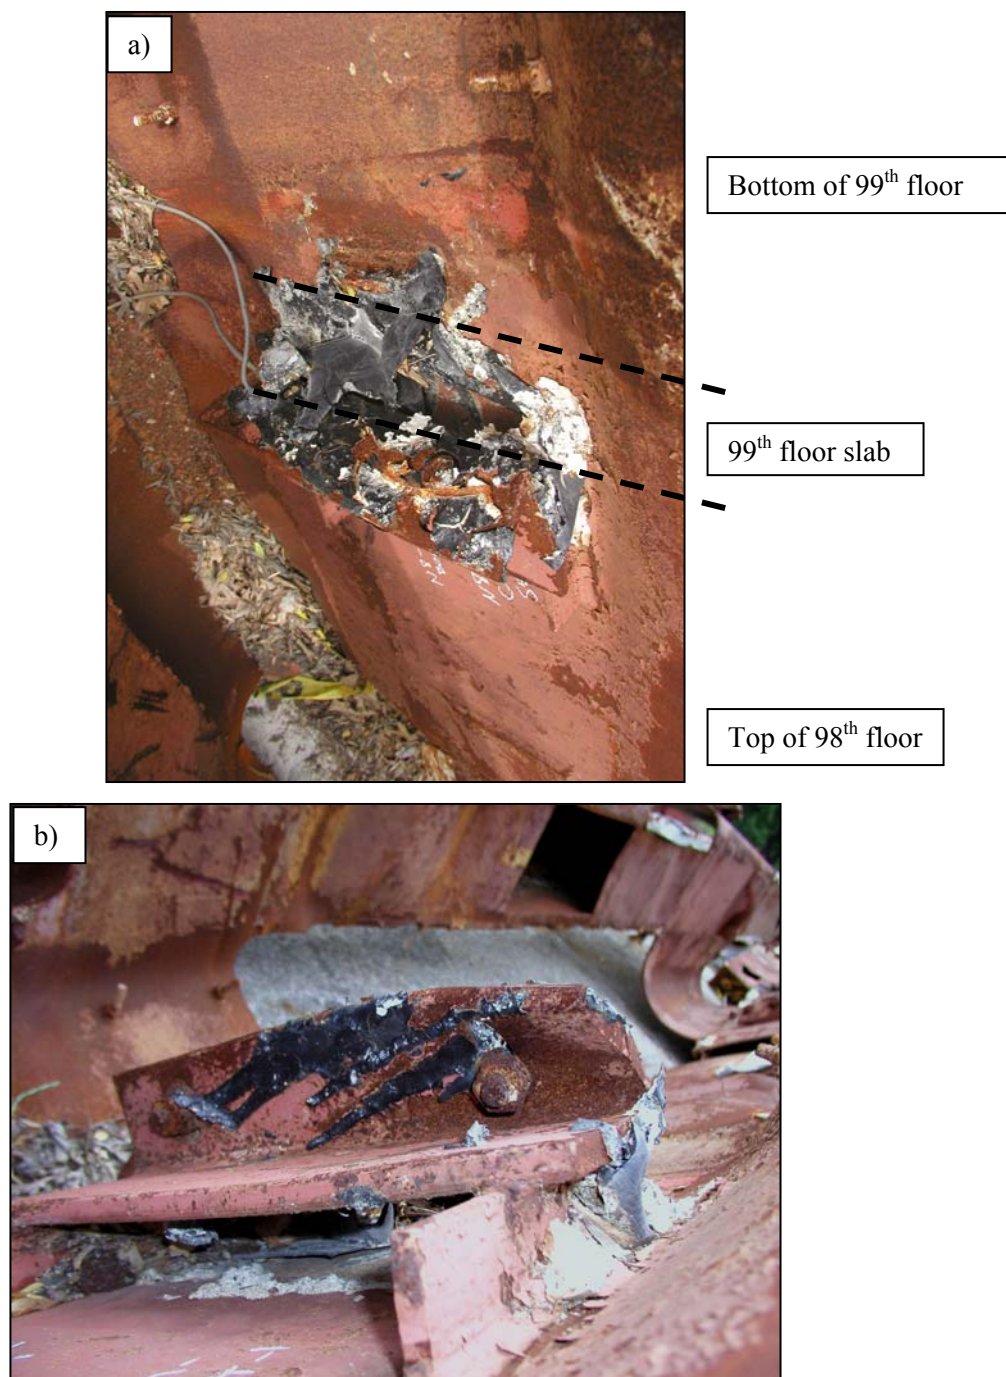
3. Panel N-8, WTC 1, column 143, seat and standoff plates of the 99th floor. This seat (Fig. 6–38) was exposed to fire for a minimum of 18 cumulative minutes before collapse. Mud cracking was not observed on the spandrel plate to which the seat was welded.

Figure 6–38. Truss seat of the 99th floor on column 143 of sample N-8 (A142: 97-100). a) Top view showing the re-solidified black plastic with embedded papers, most likely a binder of some type and b) bottom view showing the drip pattern. It was unknown when the high-temperature excursion may have occurred.

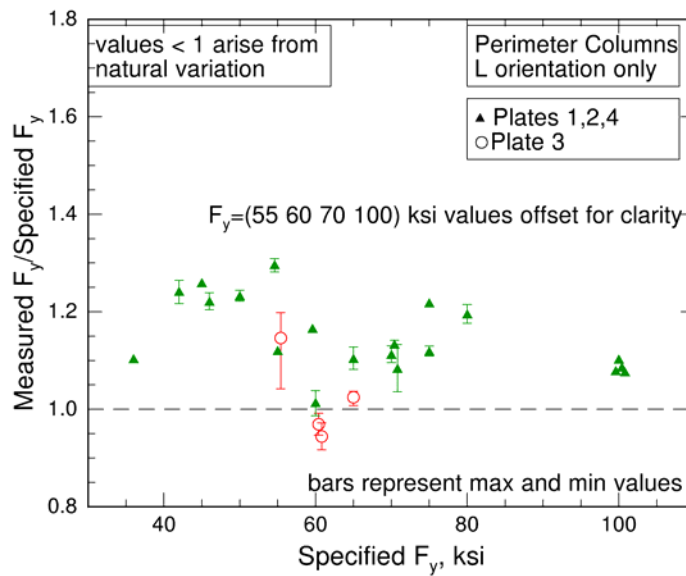
Figure 7–3. Ratio of measured yield strength or yield point to specified minimum yield point for WTC perimeter column steels.

Four issues complicated the task of positively assessing the likelihood that the properties of the recovered steel were consistent with the requirements of the relevant specifications. The first was that the WTC steels could be supplied to many different, overlapping specifications. No documents exist that identify the ASTM specification for a given column. Only the specified minimum yield strength was known. Secondly, differences between the NIST test procedures and the mill test procedures that originally qualified the steel, including testing rates, specimen sizes, and test locations, could result in values for the NIST-measured yield strengths that were less than the requirements of the relevant specification. Thirdly, the natural variability of steel properties within a heat can cause some locations to have yield strengths that are lower than the minimum required by the relevant standard. Finally, even slight damage to the steel, caused by the collapse of the WTC towers or subsequent recovery efforts, could remove the yield point behavior in the tensile test. Most low- and medium-strength steels are qualified using the stress measured at the yield point, rather than the 0.2 percent offset yield strength. For standards that define the yield strength as the yield point, the absence of yield point behavior in a NIST-conducted test can lead to values of yield strength that are less than the minimum required by the specification.

damage to the column and differences between the protocol NIST used for determining yield strength and the protocol under which the steels were originally qualified. Because these effects are testing artifacts, they do not indicate that the steel was of insufficient quality. The recovered core wide-flange columns were more heavily distorted than the core and perimeter box columns; in most cases, it was not possible to find undeformed sections to test. Low strength steels, like the core wide-flange columns are qualified based on the yield point, or the maximum stress reached before permanent deformation. After yielding, the stress drops immediately by as much as 5 ksi. Small strains can remove this yield point behavior entirely, and result in yield strengths that are less than the specified minimums. In each case where tensile test specimens from the wide-flange columns did not exhibit a definite yield point, the measured distortion of the column was sufficient to induce a strain that could remove that yield point. A second confounding factor that could have further reduced the reported yield strength arose because NIST tests employed a slightly lower testing rate than would have been used in the mill test. Because the strength of steel increases slightly with the testing rate, this difference could further reduce the NIST-measured yield strength by several ksi.

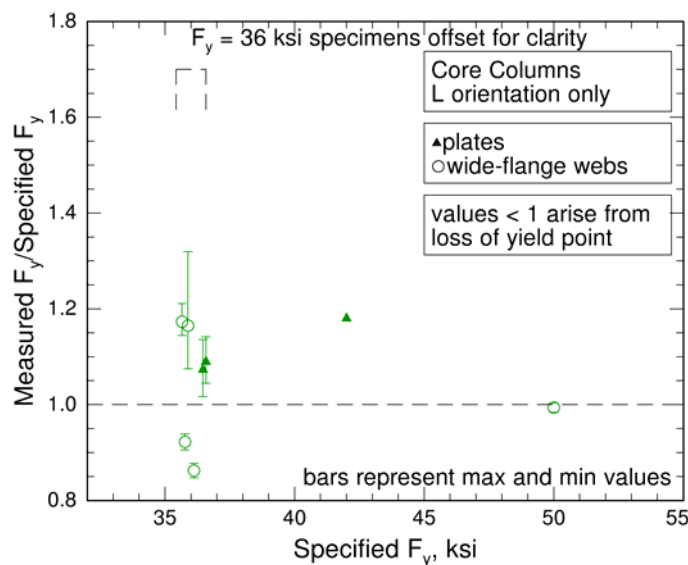
Figure 7–4. Ratio of measured yield strength or yield point to specified minimum yield point for WTC core column steels.

The mechanical properties and chemistry of the core column steels were generally consistent with the requirements of the intended specifications. Some, primarily wide-flange shapes, had NIST-measured strengths that were lower than called for in the specifications, but this may have arisen from mechanical damage that removed the yield point, the natural variability of structural steel, and slight differences between the NIST and original mill test report testing protocols. However, the yield strengths of undamaged steels in the rolled core columns were lower than the historical literature indicates as typical. The observed distributions are accounted for in the typical design factor of safety for allowable stress design.

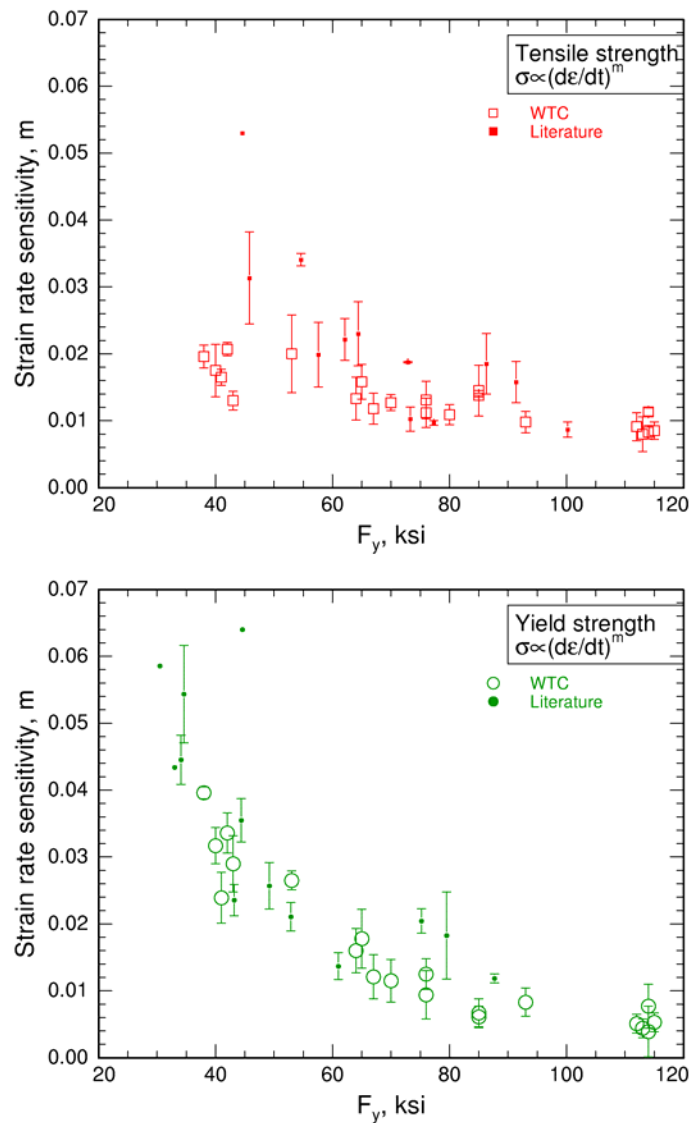
Figure 7-6 compares the strain rate sensitivities for the WTC steels characterized to structural steels from other studies. The behavior of the WTC steels is entirely consistent with the literature data. The magnitudes of the strain rate sensitivities are similar and lie in the range $0.01 < m < 0.06$. The strain rate sensitivity also decreases with increasing yield strength. The total elongations, El_t , of the WTC steels, not shown, are not a strong function of rate. The total elongation increased with rate in seven of the eight WTC steels characterized, but the increase was only 2 to 3 absolute percent. This behavior is similar to

Figure 7–6. Strain rate sensitivity as a function of specified minimum yield strength for WTC steels.

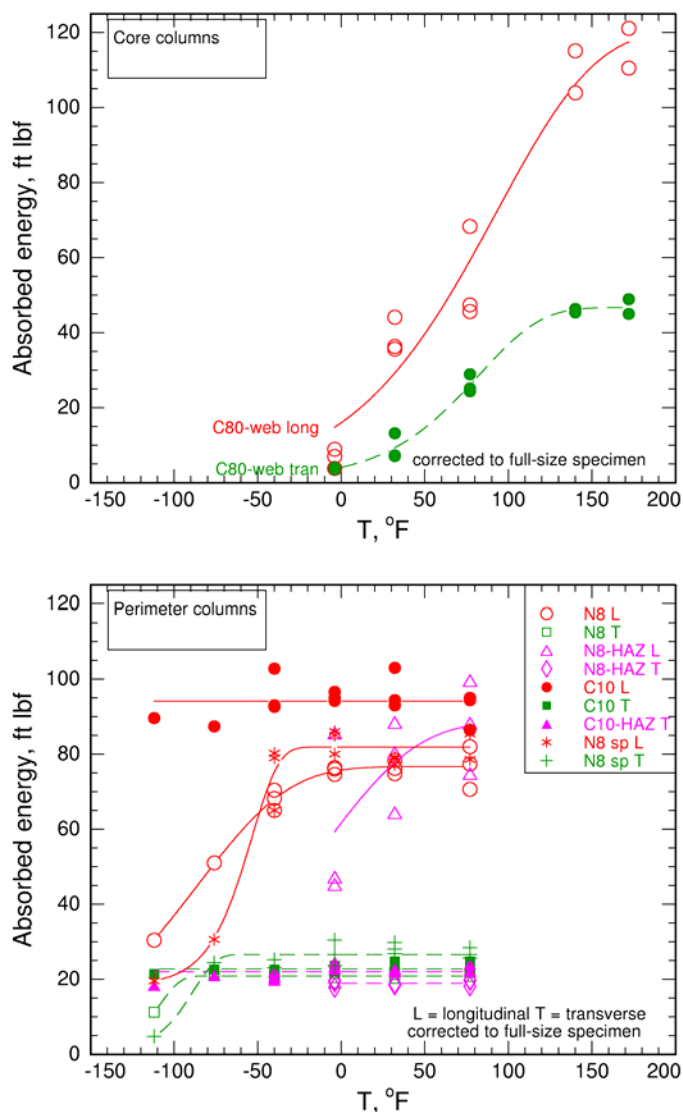
Figure 7–7 summarizes the results of Charpy tests on perimeter and core column steels. All the perimeter column steels have large upper shelf energies and transition temperatures well below 0 °F. The transition temperatures of the web of the wide-flange specimen, Fig. 7–7, and the truss rods and angles, not shown, are near room temperature, but they still possess adequate toughness for use as structural steels. The transition temperatures of the truss seat steels are above room temperature, and the absorbed energy of the steels even at room temperature is low, indicating a propensity for low-energy failure.

Figure 7–7. Summary data for Charpy tests. Lower figure: perimeter column steels; upper figure: core column steels.

Current building construction specifications, as well as those of the WTC construction era, do not generally specify minimum requirements for Charpy absorbed energies. The room temperature absorbed energy values of the WTC steels tested are similar to those of construction steels of the WTC era.

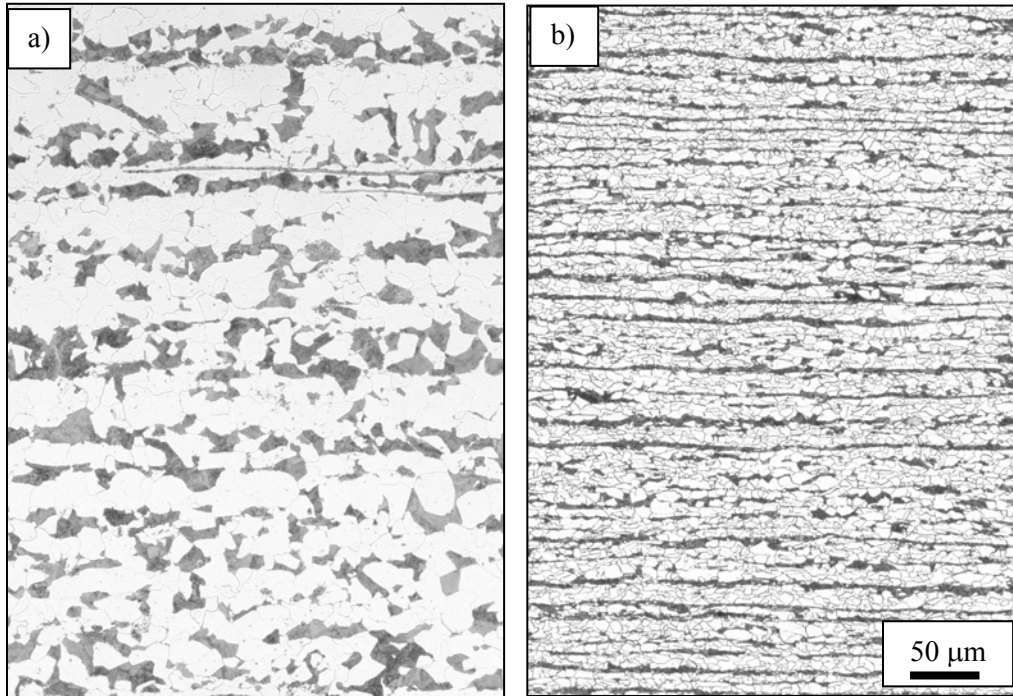
For the exterior panel sections, two different microstructural types were observed. Flange, web, and spandrel plates with specified minimum yield strengths less than 70 ksi were ferrite-pearlite (Fig. 8–1). Additionally, inner webs with F_y of 70 ksi and 75 ksi were ferrite-pearlite. For the Yawata produced plates (flange, outer web, and spandrel), this type of microstructure was expected given the measured plate thickness and specified minimum yield strength (refer to NIST NCSTAR 1-3A). Plates with F_y less than 70 ksi were typically hot rolled unless the following sizes were exceeded for a given F_y : 0.5" for 65 ksi, 1.25" for 60 ksi, and 1.5" for 55 ksi. For these specified plates, as well as those with minimum yield strengths equal to or greater than 70 ksi, “quenched-and-tempered” microstructures were observed (Fig. 8–2).

Figure 8–1. Microstructure of ferritic-pearlitic WTC perimeter column flange plate steels. a) $F_y = 45$ ksi (unidentified perimeter column with “45” flange stamping) and b) $F_y = 60$ ksi (WTC 1, column 126, 97th floor).

Microstructure varied within each of the two structure types, depending on product type, gauge, and strength level. Ferrite-pearlite steels had variations in ferrite grain size, ferrite grain shape, pearlite lamellar spacing, and banding of microstructural constituents with a change in specified F_y and gauge of the plate. Examples of these microstructures are shown in Fig. 8–1. Similarly, the quenched and tempered steels had variations with F_y . Plates with $F_y = 70$ ksi had a coarse Widmanstätten morphology of ferrite with coarse cementite precipitates while the higher strength plates had what appeared to be a tempered martensitic structure, as shown in Fig. 8–2.

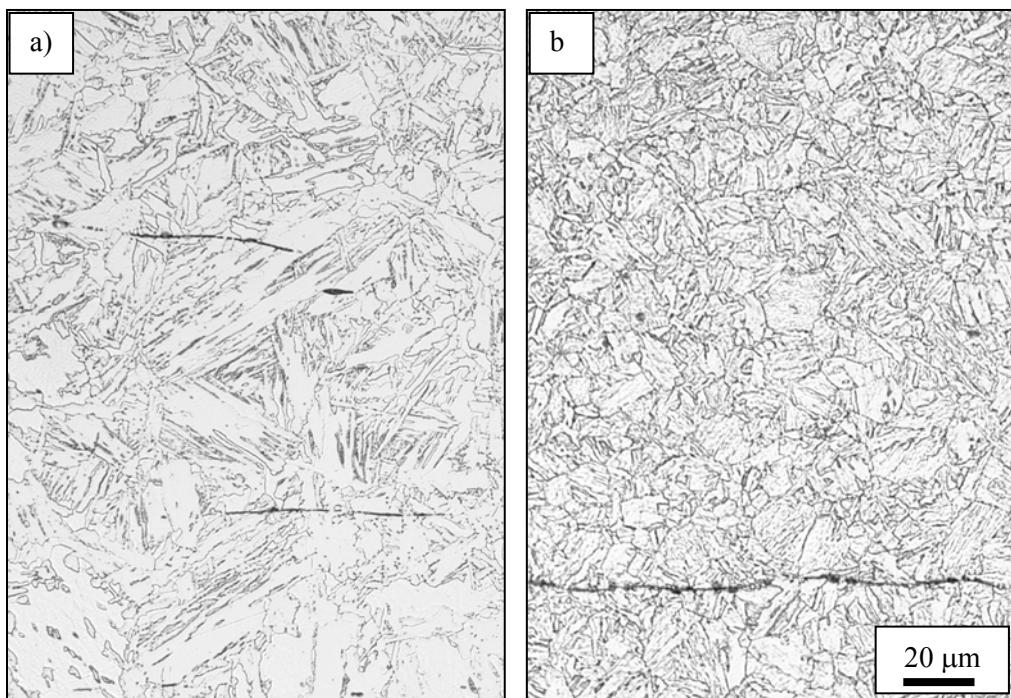
Figure 8–2. Examples of “quenched and tempered” WTC perimeter column flange steel. a) $F_y = 70$ ksi (WTC 1, column 224, 94th floor) and b) $F_y = 80$ ksi (WTC 1, column 207, 89th floor).

For each of the designated minimum yield strengths, the type of structures observed was expected for steels of that era. While the microstructural features may have varied from plate to plate, there was no indication that the practices followed to produce the plates were improper.
