Why Indeed Did the WTC Buildings Completely Collapse?

By Dr. Steven E. Jones

In this paper, I call for a serious investigation of the hypothesis that WTC 7 and the Twin Towers were brought down, not just by impact damage and fires, but through the use of pre-positioned cutter-charges. I consider the official FEMA, NIST, and 9-11 Commission reports that fires plus impact damage alone caused complete collapses of all three buildings. And I present evidence for the controlled-demolition hypothesis, which is suggested by the available data, and can be tested scientifically, and yet has not been analyzed in any of the reports funded by the US government.

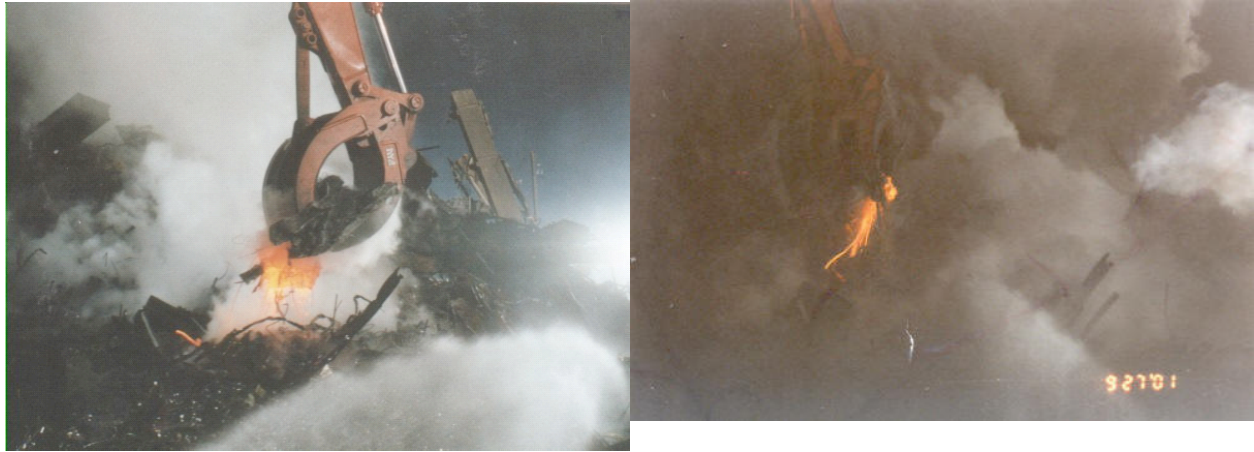
We start with the fact that large quantities of molten metal were observed in basement areas under rubble piles of all three buildings: the Twin Towers and WTC7. A video clip provides eye-witness evidence regarding this metal at ground zero: http://plaguepuppy.net/public_html/video%20archive/red_hot_ground_zero_low_quality.wmv. The photographs below by Frank Silecchia show chunks of the hot metal being removed from the North Tower rubble on September 27, 2001 (according to photographer's aid). Notice the color of the lower portion of the extracted metal -- this tells

us much about the temperature of the metal and provides important clues regarding its composition, as we shall see.

Even without a direct elemental analysis, we can rule out some metals based on available data. The photograph in the introduction shows a chunk of hot metal being extracted at ground zero. The hottest portion of the chunk is the lower portion, which was deepest down in the slag, and the metal is seen to be yellow-hot, certainly above cherry-red hot. The following table (see <http://www.processassociates.com/process/heat/metcolor.htm>) provides data regarding the melting temperatures of lead, aluminum, structural steel and iron, along with approximate metal temperatures by color. Note that the approximate temperature of a hot metal is given by its color, quite independent of the composition of the metal. (A notable exception is falling liquid aluminum, which due to low emissivity and high reflectivity appears silvery-gray in daylight conditions, after falling through air 1-2 meters, regardless of the temperature at which the poured-out aluminum left the vessel. Aluminum does incandesce (glow) like other metals, but faintly, so that with the conditions described in the previous sentence (which prevailed at the WTC on 9/11), falling liquid aluminum will appear silvery-gray. Rapid oxidation of the hot flowing aluminum will contribute to the observed appearance. [Experiments: Jones, 2006])

We see from the photograph above that solid metal from the WTC rubble existed at salmon-to-yellow-hot temperature (approx. 1550 - 1900 °F, 845 - 1040 °C.) The temperature is well above the melting temperatures of lead, zinc and aluminum, and these metals can evidently be ruled out since they would be runny liquids at much lower (cherry-red or below) temperatures. However, the observed hot specimen could be structural steel (from the building) or iron (from a thermite reaction) or a combination of the two. Additional photographs of the hot metal could provide further information and advance the research.

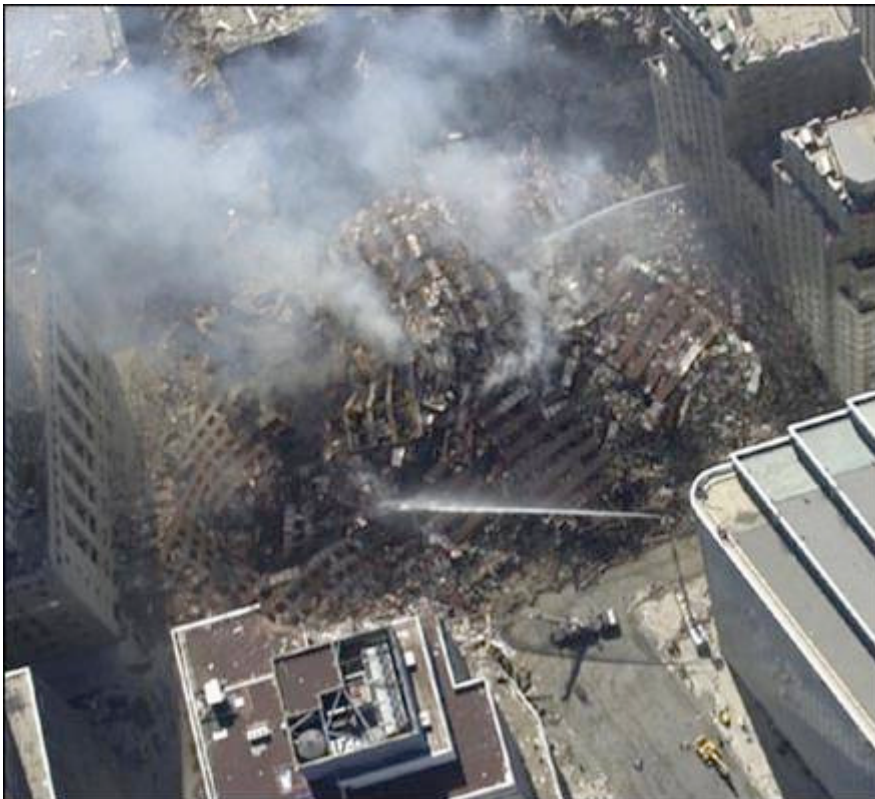
WTC 7 collapsed completely on 9/11/2001, primarily onto its own footprint.

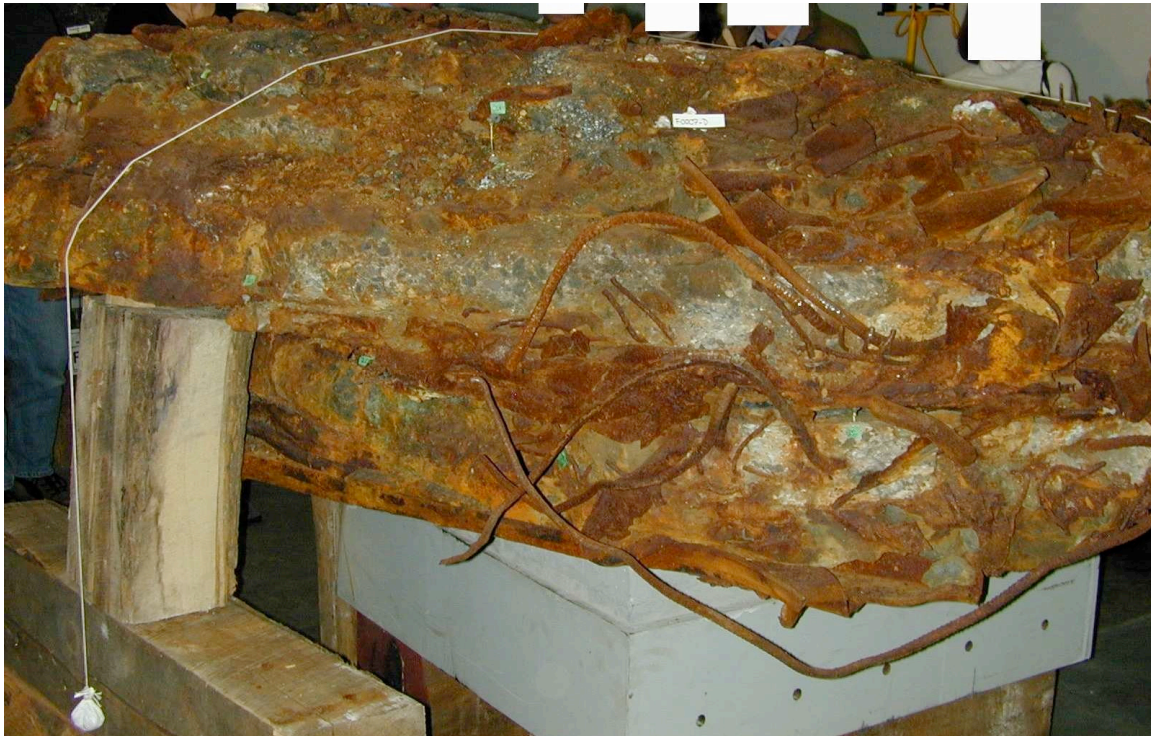
The following photograph has become available, evidently showing the now-solidified metal with entrained material, stored (as of November 2005) in a warehouse in New York:

The abundance of iron (as opposed to aluminum) in this material is indicated by the reddish rust observed. When a sample is obtained, a range of characterization techniques will quickly give us information we seek. X-ray energy dispersive spectrometry (XEDS) will yield the elemental composition, and electron energy-loss spectroscopy will tell us the elements found in very small amounts that were undetectable with XEDS. Electron-backscattered diffraction in the scanning electron microscope will give us phase information; the formation of certain precipitates can tell us a minimum temperature the melt must have reached. We will endeavor to obtain and publish these data, whatever they reveal.

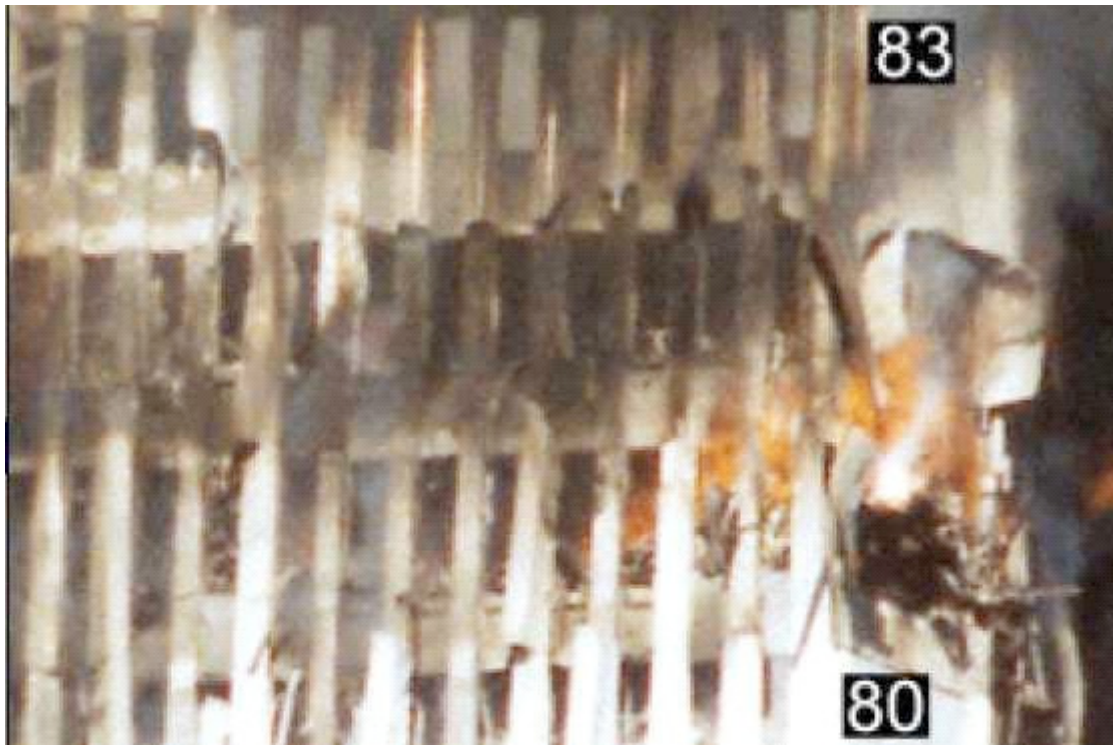
An intriguing photograph found as Figure 9-44 in the NIST report provides evidence for a highly exothermic reaction at the corner of the South Tower just minutes before its collapse. Furthermore, failure occurs at this very corner of the Tower as seen in this video footage: <http://video.google.com/videoplay?docid=-8564772103237441151&q=cameraplanet+9%2F11> .

“An **unusual flame** is visible within this fire. In the upper photograph {Fig 9-44} a **very bright flame, as opposed to the typical yellow or orange surrounding flames**, which is **generating a plume of white smoke**, stands out.” Source: NCSTAR 1-5A Chapter 9 Appendix C NIST Fig. 9-44. p. 344

“NIST reported (NCSTAR 1-5A) that just before 9:52 a.m., a **bright spot appeared** at the top of a window on the 80th floor of WTC 2, four windows removed from the east edge on the north face, **followed by the flow of a glowing liquid**. This flow lasted approximately four seconds before subsiding. **Many such liquid flows were observed from near this location in the seven minutes leading up to the collapse of this tower.**” Source:

Thus it is established that the "glowing liquid" flow is associated spatially and temporally with the "bright spot" observed on the corner of the 80th floor of WTC 2. The photograph below shows, for comparison, a thermite reaction with a white aluminum-oxide dust plume extending from very bright reaction region. (Experiment by the author and colleagues in which thermite-plus-sulfur cut through a steel cup in a fraction of a second. Any thermite reaction is a dangerous reaction and should only be performed by a trained professional capable of assessing the hazards and risks.) The similarities between the known thermite reaction and the hitherto unknown reaction at the WTC Tower are plain to see. These discoveries strongly motivate an immediate in-depth investigation of the use of thermite-type reactions in the destruction of the World Trade Center on 9/11/2001.

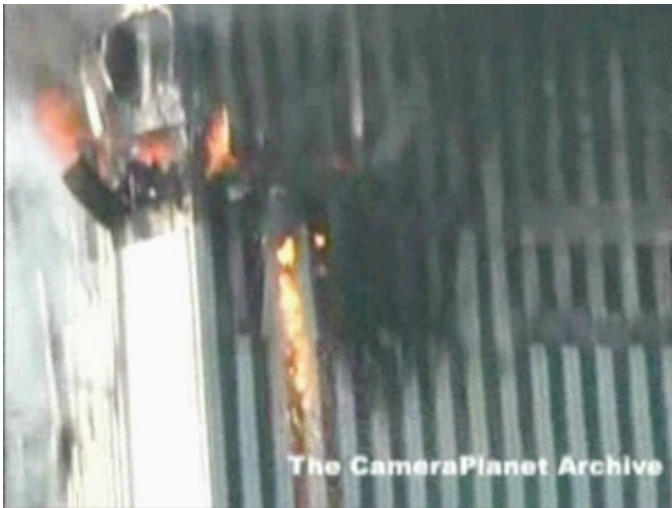
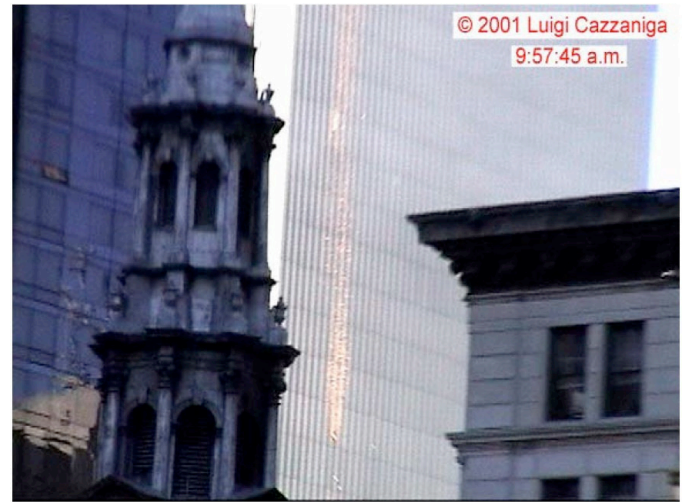
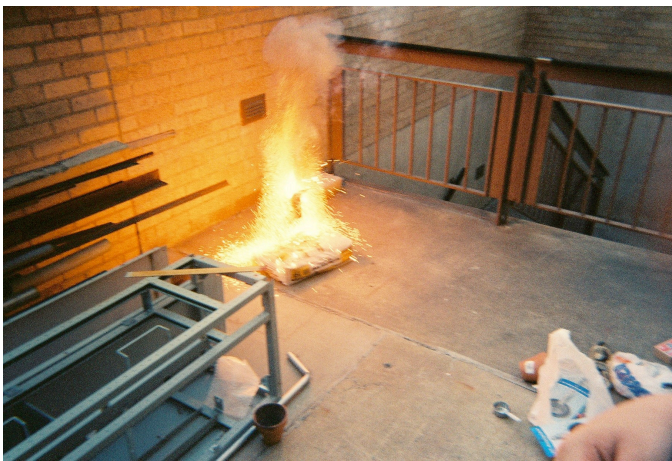
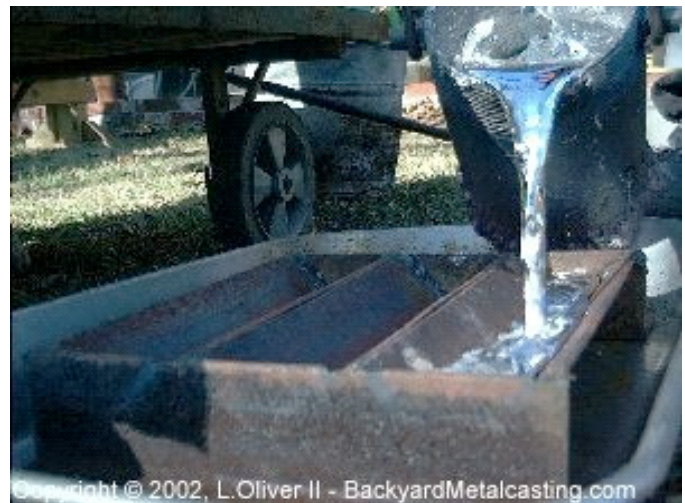
Is the falling molten metal from WTC Tower 2 (Top photos) more likely molten iron from a thermite reaction (lower left) OR pouring molten aluminum (lower right)?

Who can deny that liquid, molten metal existed at the WTC disaster? The yellow color implies a molten-metal temperature of approximately 1000 °C, evidently above that which the dark-smoke hydrocarbon fires in the Towers could produce. If aluminum (e.g., from the plane) had melted, it would melt and flow away from the heat source at its melting point of about 650 °C and thus would not reach the yellow color observed for this molten metal. Thus, molten aluminum is already ruled out with high probability. But molten iron with the characteristics seen in this video is in fact consistent with a thermite-reaction attacking the steel columns in the Tower, thus weakening the building just prior to its collapse, since thermite produces molten iron at yellow-to-white hot temperatures. (As some of the molten metal hits the side of the building in the video clip above, the white-hot interior is evidently exposed as the metal "splashes".) Also, the fact that the liquid metal retains an orange hue as it nears the ground (right photograph) further rules out aluminum, and suggests a mid-flight thermite reaction (typical of thermite). Here are two independent videos of the yellow-white liquid metal pouring out of the South Tower: <http://video.google.com/videoplay?docid=->

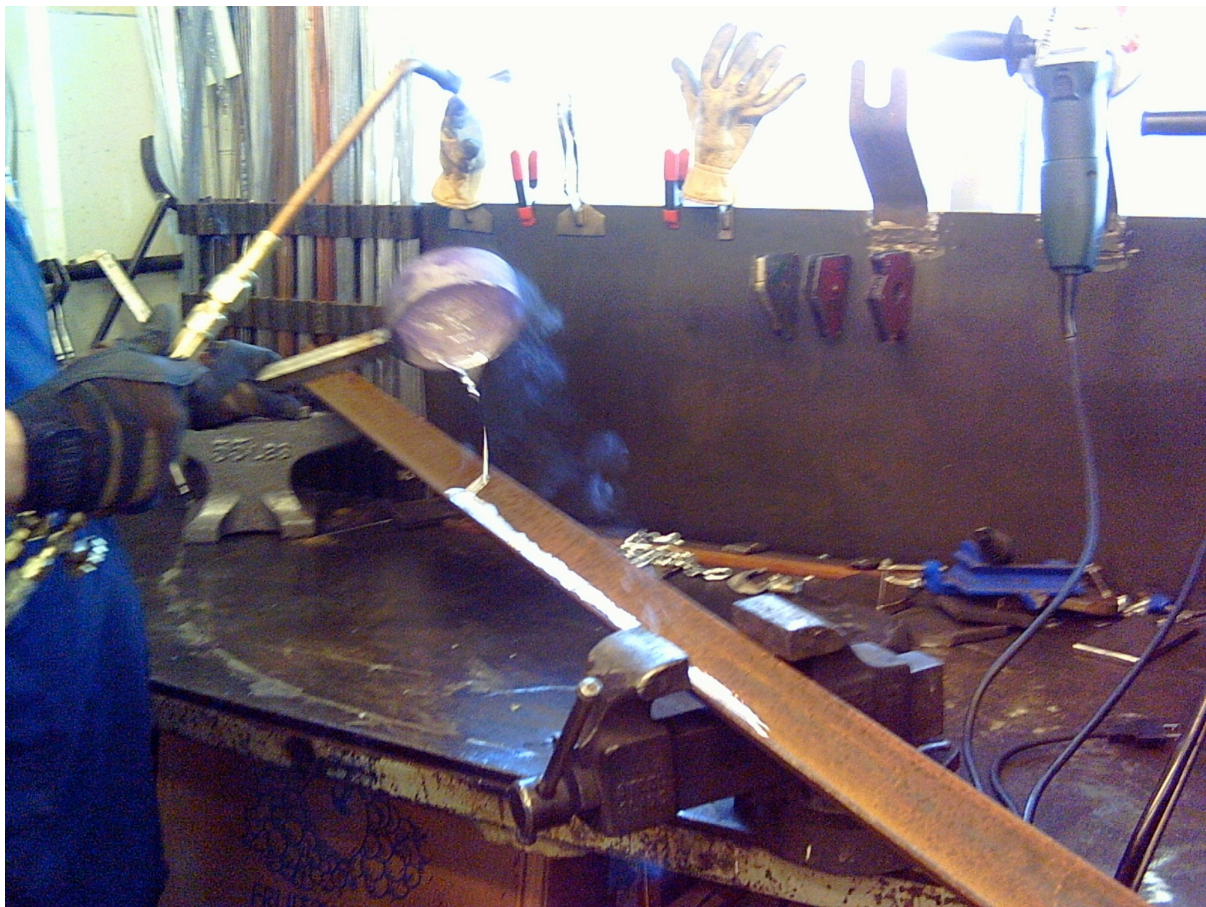
We also noted that while a steel pan holding the aluminum glowed red and then yellow hot, when poured out the falling aluminum displayed a silvery-gray color, adding significantly to the evidence that the yellow-white molten metal flowing out from the South Tower shortly before its collapse was NOT molten aluminum. (Recall also that the yellow color of the molten metal (video clip above) implies a temperature of approximately 1100°C -- too high for the dark-smoke hydrocarbon fires burning in the building.) This is a point worth emphasizing: aluminum has low emissivity and high reflectivity, so that in daylight conditions after falling through air 1-2 meters, molten aluminum will appear silvery-gray, while molten iron (with its characteristic high emissivity) will appear yellow-white (at ~1100°C) as observed in the molten metal dripping from the South Tower just before its collapse (see: <http://www.supportthetruth.com/jones.php>). We also recall that this molten metal, after falling approximately 150 meters (or yards) still retained a reddish orange color (photograph above). This is not the behavior of falling, molten aluminum.

Molten aluminum poured onto rusted steel: silvery flow, and **no** violent reactions observed at all (contrary to predictions by some of a vigorous aluminum-rust “thermic reaction”). Same result -- when the rusty steel piece was pre-heated with the torch.

NIST states the hypothesis that flowing aluminum with partially burned organic materials mixed in, "can display an orange glow." But will it really do this? I decided to do an experiment to find out. Our group melted aluminum in a steel pan using an oxy-acetylene torch. Then we added plastic shavings -- which immediately burned with a dark smoke, as the plastic floated on top of the hot molten aluminum. Next, we added wood chips (pine, oak and compressed fiber board chips) to the liquid aluminum. Again, we had fire and smoke, and again, the **hydrocarbons floated on top** as they burned. We poured out the aluminum and all three of us observed that it appeared silvery, not orange! We took photos and videos, so we will have the recorded evidence as these are processed. Of course, we saw a few burning embers, but this did not alter the silvery appearance of the flowing, falling aluminum.

We decided to repeat the experiment, with the same aluminum re-melted. This time when we added fresh wood chips to the hot molten aluminum, we poured the aluminum-wood concoction out while the fire was still burning. And as before, the wood floated on top of the liquid aluminum. While we could see embers of burning wood, we observed the bulk of the flowing aluminum to be silvery as always, as it falls through the air.

This is a key to understanding why the aluminum does not "glow orange" due to partially-burned organics "mixed" in (per NIST theory) - because they do NOT mix in! My colleague noted that it is like oil and water - organics and molten aluminum do not mix. The hydrocarbons float to the top, and there burn - and embers glow, yes, but just in spots. The organics clearly do NOT impart to the hot liquid aluminum an "orange glow" when it falls, when you actually do the experiment! Videos of our experiments involving organics added to liquid aluminum are available here: <http://www.scholarsfor911truth.org/Experiments-to-test-NIST-orange-glow-hypothesis.html>

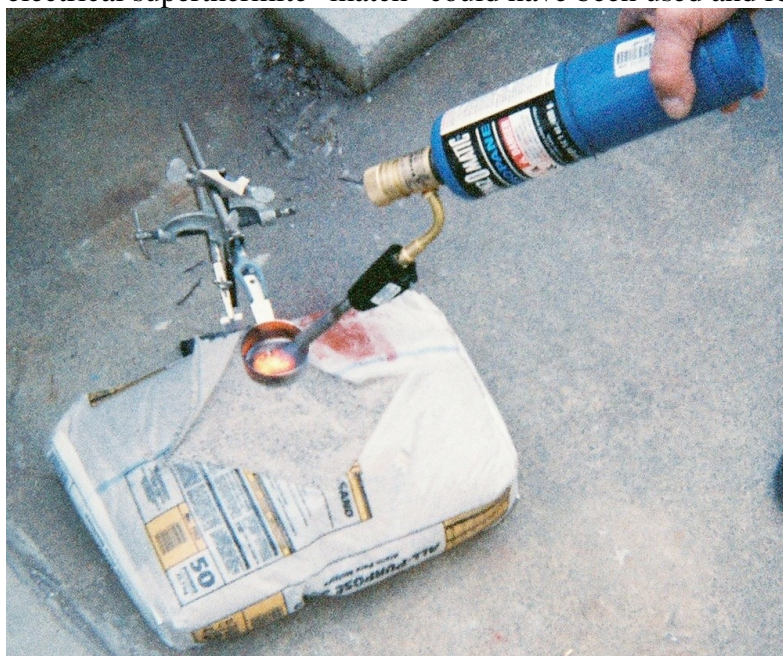
Thermite did not ignite when heated with a propane torch.

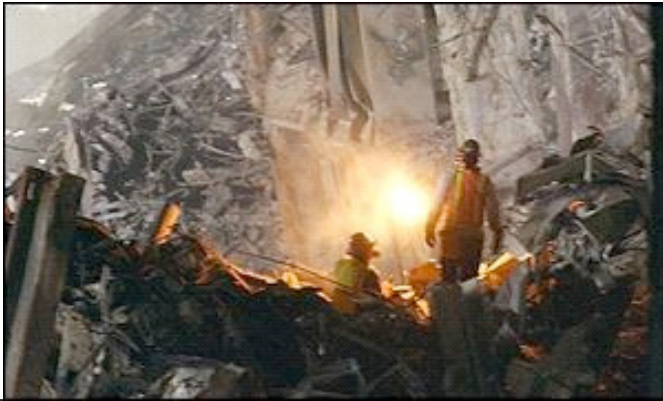
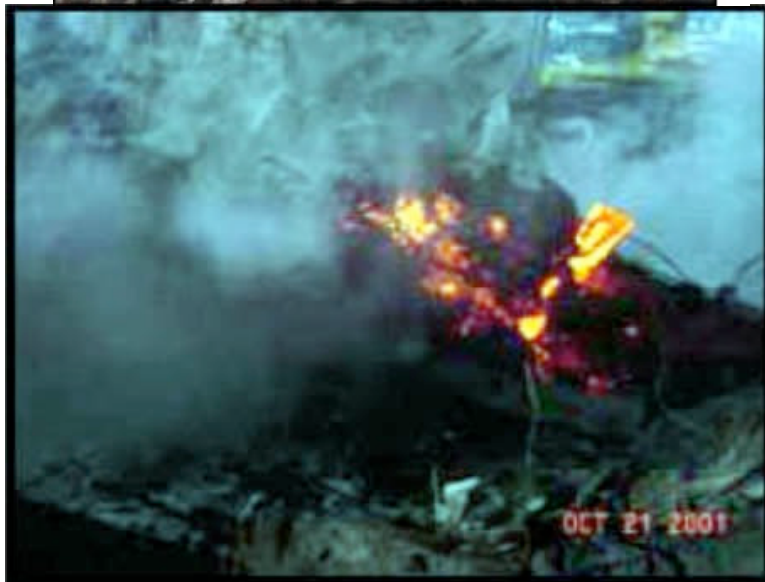
The top photo (<http://news.bbc.co.uk/2/hi/science/nature/1858491.stm>) may show the glow of hot metal in the rubble; the second photo clearly does so. It is labeled "Red Hot Debris" and is published in **LiRo News, Nov. 2001**, <http://www.liro.com/lironews.pdf> . Moreover, there is recorded eyewitness testimony of the molten metal pools under both Towers and WTC 7; see: <http://georgewashington.blogspot.com/2005/12/why-was-there-molten-metal-under.html> . Video clips provide eye-witness evidence regarding this metal at ground zero: http://plaguepuppy.net/public_html/video%20archive/red_hot_ground_zero_low_quality.wmv , <http://video.google.com/videoplay?docid=-3060923273573302287> .

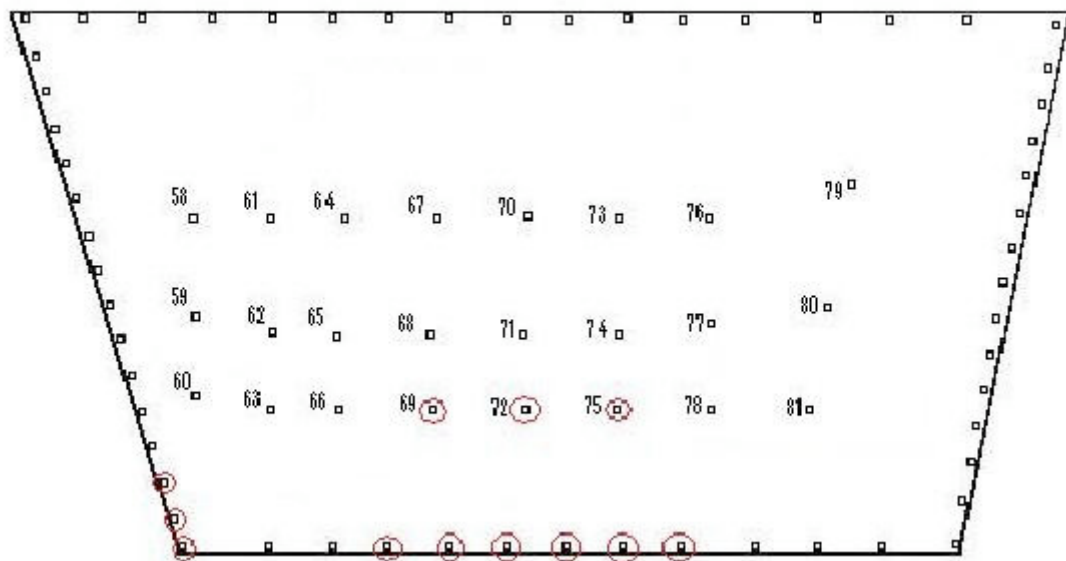
Diagram showing steel-column arrangement in WTC 7, view looking down on the roof. Circled columns were possibly damaged due to debris from WTC 1 collapse, some 350 feet away (NIST, 2005) so the damage was clearly non-symmetrical, and evidently, none of the core columns was severed by falling debris. WTC 7 was never hit by a plane.

As you observed (link above), WTC 7 collapsed rapidly and nearly-straight-down symmetrically -- even though fires were randomly scattered in the building. WTC 7 fell about seven hours after the Towers collapsed, even though no major persistent fires were visible (considerable dark smoke was seen). There were twenty-four huge steel support columns inside WTC 7 as well as huge trusses, arranged non-symmetrically, along with some fifty-seven perimeter columns, as indicated in the diagram below (FEMA, 2002, chapter 5; NIST, 2005).

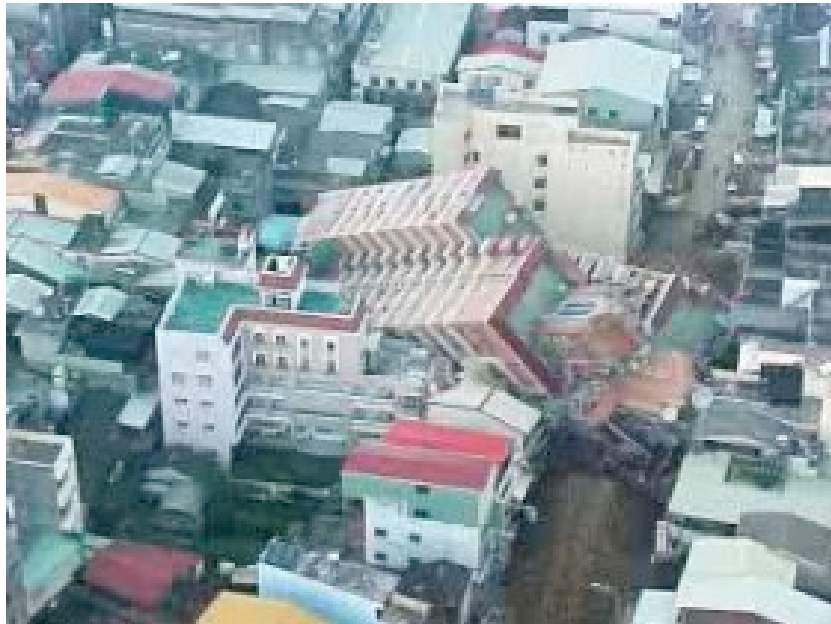
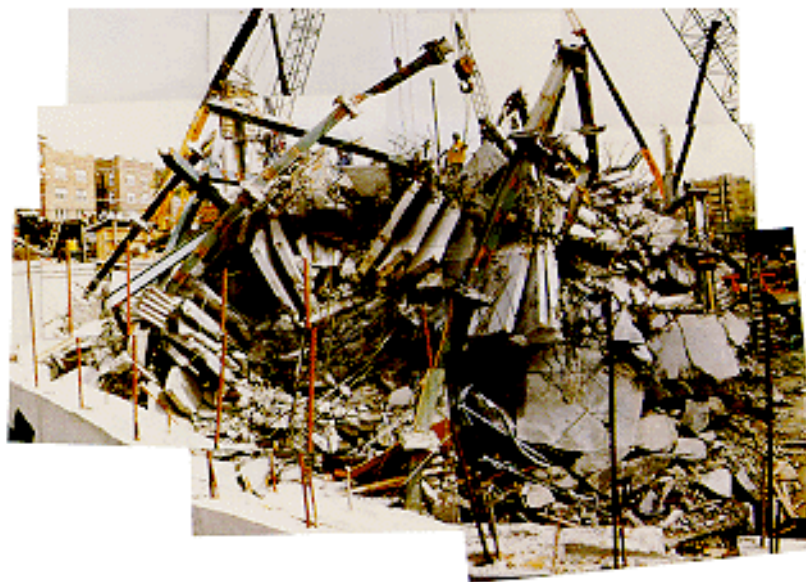
Non-symmetrical collapse of tall buildings when due to random causes. L'Ambiance Plaza collapse (right) shows how pancaked concrete floor slabs are largely intact and clearly reveal stacking effects with minimal fine dust, as expected from random progressive collapse. By contrast, concrete floors in the Twin Towers and WTC 7 were pulverized to dust -- as is common in controlled demolitions using explosives.

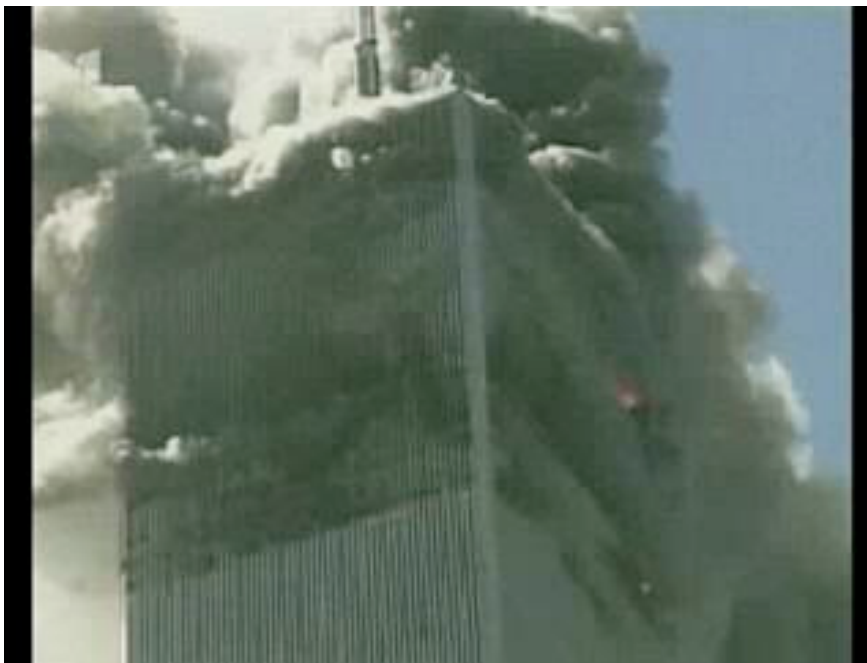
North Tower showing antenna (top) at beginning of collapse.

Review of videotape recordings of the collapse taken from various angles indicates that the transmission tower on top of the structure began to move downward and laterally slightly before movement was evident at the exterior wall. This suggests that **collapse began with one or more failures in the central core area of the building.** (FEMA, 2002, chapter 2; emphasis added.)

Yes, we can see for ourselves that the antenna drops first from videos of the North Tower collapse. (See http://911research.wtc7.net/wtc/evidence/videos/wtc1_close_frames.html; also <http://home.comcast.net/~skydrifter/collapse.htm>.) A NY Times article also notes this behavior:

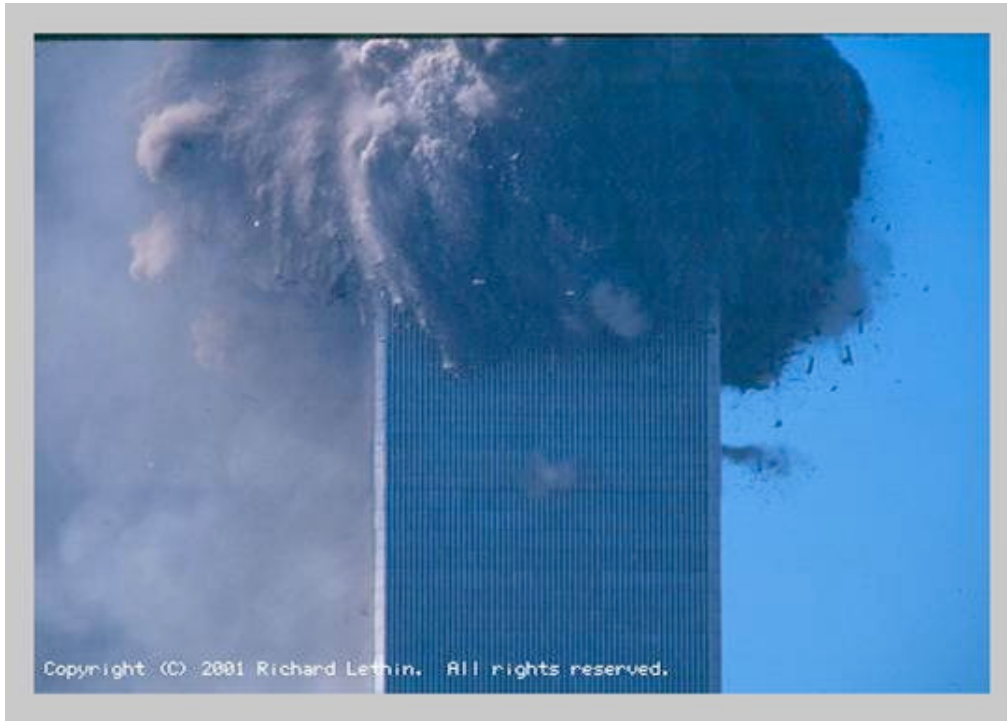
North Tower during top-down collapse.
Notice mysterious horizontal plumes far below pulverization region.

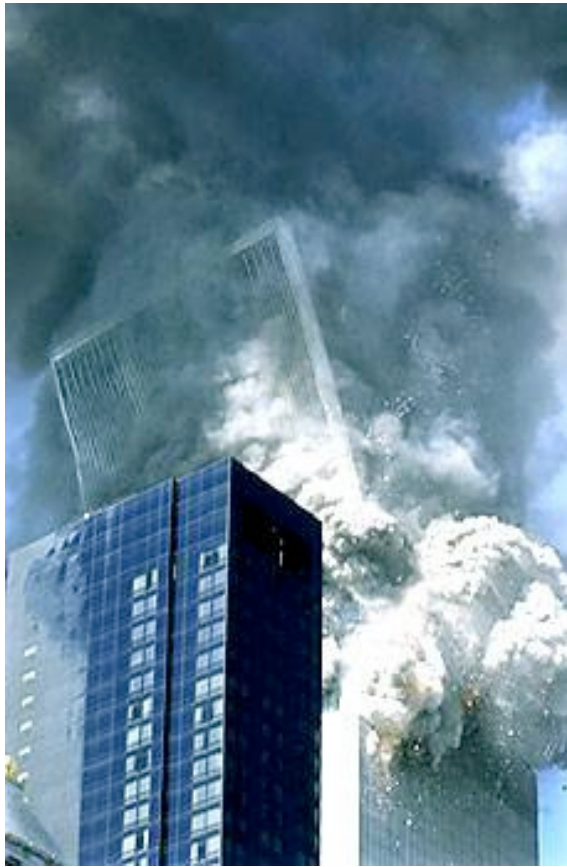
Top ~ 30 floors of South Tower topple over.
What happens to the block and its angular momentum?

We observe that approximately 30 upper floors begin to rotate as a block, to the south and east. They begin to topple over, not fall straight down. The torque due to gravity on this block is enormous, as is its angular momentum. But then – and this I’m still puzzling over – this block turned mostly to powder *in mid-air*! How can we understand this strange behavior, without explosives? Remarkable, amazing – and demanding scrutiny since the US government-funded reports failed to analyze this phenomenon. But, of course, the Final NIST 9-11 report “**does not actually include the structural behavior of the tower after the conditions for collapse initiation were reached.**” (NIST, 2005, p. 80, fn. 12; emphasis added.)

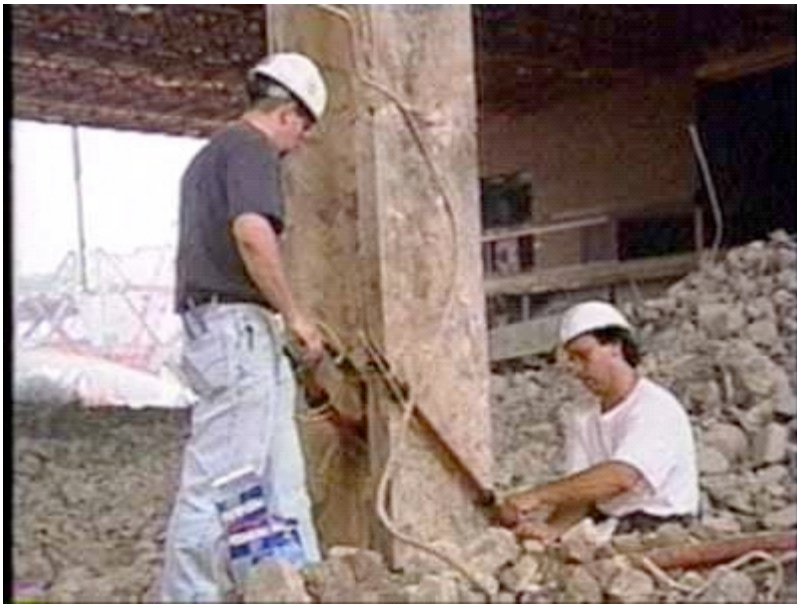
Above: two men install a conventional cutter charge to steel column, preparing for a controlled demolition of the building. Notice the narrow width/size of the explosive cutter charge. From History Channel: “Wrecking ball – Modern marvels” and thanks to Robert Moore and <http://piratenews.org/911con.html> . For comparison, observe some of the angle-cut columns seen at Ground Zero after 9/11/2001, below. (Notice especially the uneven cut at the back of the column and the clinging previously-molten metal on both the outside AND the inside of the column, left photo, suggesting this was NOT cut using an oxy-acetylene torch, but rather that a highly exothermic chemical reaction was involved in cutting through this steel column.)

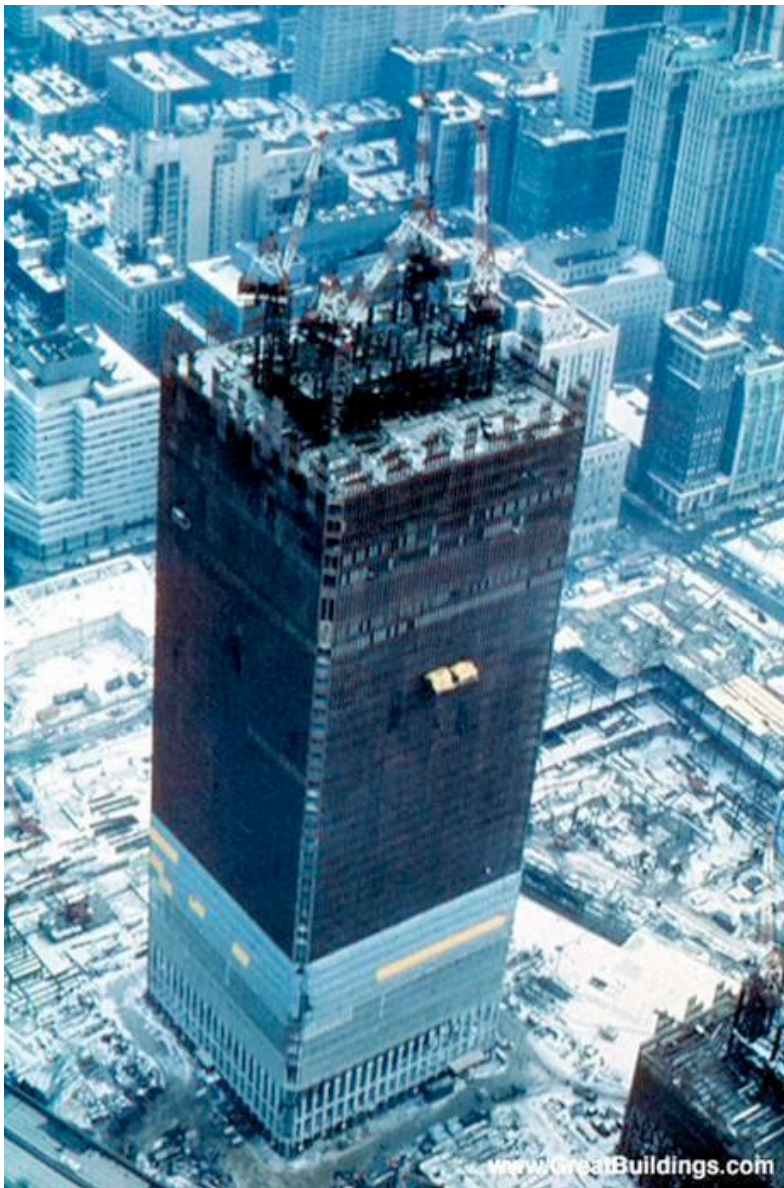
The WTC towers were solidly constructed with 47 steel core columns and 240 perimeter steel columns. 287 steel-columns total.

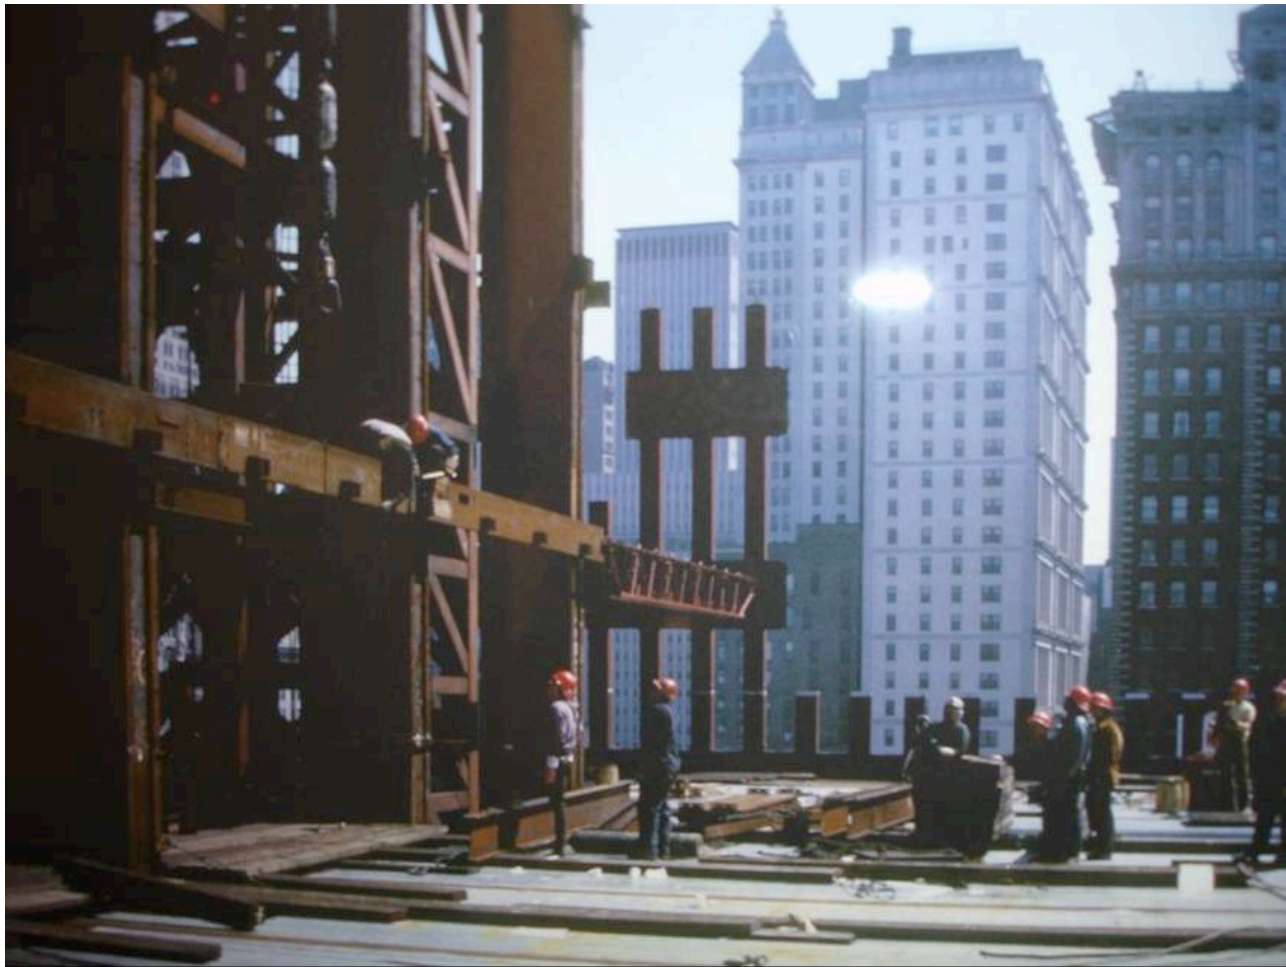
Steel-frame: Huge core (left) is an enormous heat sink. Notice workers standing on floor pan which is firmly attached to the interconnected core columns. Clearly, **the Towers were not “hollow tubes.”**
